SHOP CREEK WETLANDS  
POLLUTANT REDUCTION FACILITY  
WETLAND ASSESSMENT

February 2007

# SHOP CREEK WETLANDS POLLUTANT REDUCTION FACILITY WETLAND ASSESSMENT

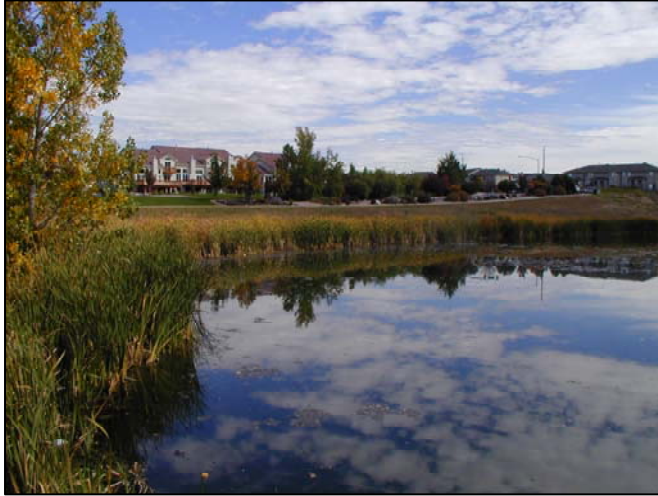
Photo 1 – Pond

The pond is the main aquatic feature of this reach. An approximately 10-foot wide cattail marsh wetland fringe was purposefully established around the pond shoreline, which appears to be expanding inward because of its irregular pond-side boundary. Some of the immediate watershed of the pond is maintained turf and residential development, which limits the habitat potential of the wetlands. However, waterfowl and fish were observed using the pond. Overall, Pond 1 is functioning- at risk. It is at risk in that the watershed and immediate surroundings are urbanized landscapes, which over time limit the functioning of the pond. This pond will likely always be functioning at-risk because of

the upstream watershed conditions and because it's purpose is to settle sediment and protect the downstream wetlands. The pond is meeting it's purpose of trapping sediment that would otherwise flow into the wetlands. However, sediment will accumulate over time, which would facilitate cattail encroachment and reduce the open water surface area and volume of the pond for sediment deposition.

It is recommended that the Pond receive periodic dredging to remove accumulated sediments. This pond appears to be a key sediment trap, which has prevented substantial sediment deposition in the downstream wetlands. As the pond fills, it will become a less effective sediment trap, which could

When sediment removal occurs, it is recommended that the pond cleanout occur in a manner that would maintain the existing 5-10 foot wide wetland fringe around the pond. Pond maintenance should be performed in the winter. The pond should be drained and inflows temporarily piped around the dam during cleanout. We are not aware that the pond is lined, so traditional excavation equipment can be used to clean out the pond. If the pond does have a liner, other dredging methods should be employed to protect the integrity of the liner. The plunge pools below each drop structure should be carefully cleaned out at the time the pond is cleaned out. The plunge pools are part of the soil cement drop structures so sediment removal in these pools should be done with adequate care to avoid damaging the soil cement and perhaps with hand tools.

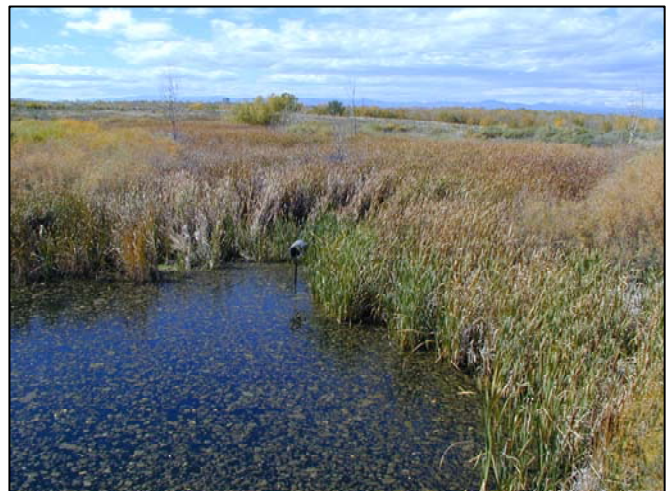
The wetland cells found downstream of the Pond (Reaches 2-7) are in a very similar condition to each other. The wetland plant community is dominated by cattail (*Typha latifolia*), soft-stem bulrush (*Schoenoplectus tabernaemontani*) and coyote willow (*Salix exigua*). Cattail vegetation is present in areas with persistent standing water or saturated conditions and coyote willow vegetation is present in drier areas adjacent to the cattail marsh. The vegetation exhibits high vigor and appears to have adequate hydrology for longer term plant community maintenance. Several non-native Russian olive (*Elaeagnus angustifolia*) and crack willow (*Salix fragilis*) trees were observed in the PRF. Waterfowl, fish, turtles and other wildlife were observed in the PRF. Overall, the wetland system is rated in Proper Functioning Condition, given it's purpose, design, watershed conditions and field observations. There is adequate vegetation and landform present to dissipate energy,

Photo 2 – Typical Wetlands

filter sediment, improve floodwater retention, develop adequate root masses, develop diverse ponding, and support biodiversity. There are reach-specific conditions that do create potential risks, but overall, the system is functioning properly. The plant community appears capable of withstanding high flows that would occur with the presence of the retention pond and significant erosion or vegetation destruction was not observed. The pond in Reach 1 and the soil cement drop structures limit high flows through the wetlands. The pond removes much of the sediment. These are likely the reasons for the condition of the wetland cells. The soil cement drop structures provide vertical channel stability, which allows the wetland areas to develop. These are essential features for the long-term health and maintenance of the wetlands.

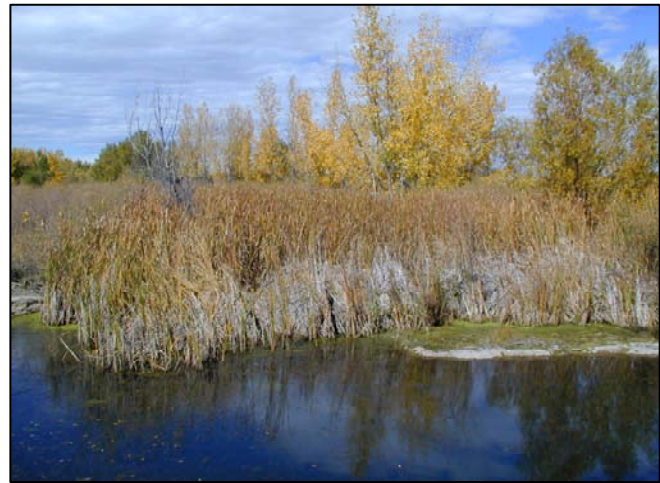
*Photo 3 – Typical Wetlands*

Several dead cottonwoods were observed within the PRF wetland cells. These deaths were likely the result of a rising water table as cottonwoods do not survive in constant inundation or surface saturation. These dead trees will provide wildlife habitat while standing and on the ground once they fall. The rise in water table may be caused by reduced or slowed flow through the wetland cells over time, which backs up water to a higher elevation than occurred when the wetland cells were first constructed. This reduced flow could be caused by sediment deposition. However, since we did not observe significant sediment deposition or buildup in the wetlands, it is more likely caused by the accumulation of cattail and other plant litter above the drop structures rather than high sediment loads. As the plant matter accumulates, flows are slowed, which could raise the water table. Under the saturated conditions above the drop structures, the accumulated plant matter is slow to break down and is likely increasing over time. The accumulation of plant matter in the wetlands is generally beneficial because the additional structure will help reduce flow velocities and aid in sediment removal. Another possible factor is that several of the base-flow culverts within the drop structures are plugged. This plugging has caused flows to overtop the drop, which could also cause a small water table rise.
