# Cherry Creek at 12-Mile Park

## DRAFT Alternatives Evaluation Report

April 2011

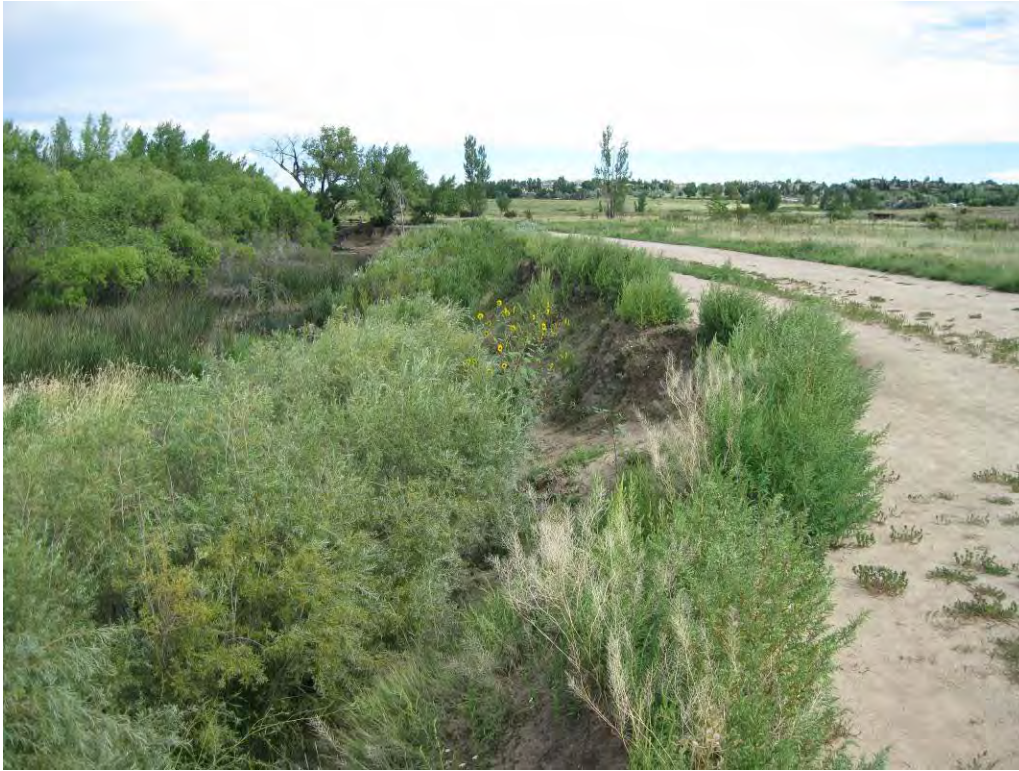
EXHIBIT 1-2  
Reach 1: Upstream Reach  
*Cherry Creek Stream Reclamation at 12-Mile Park Project*

**Reach 1: Upstream Reach** – Characterized by a groundwater fed secondary channel that has a lower invert than the mainstem of Cherry Creek. The east bank is characterized by steep to near vertical banks that are 15 – 20 feet above the invert of the secondary channel with vegetation loss due to park use.

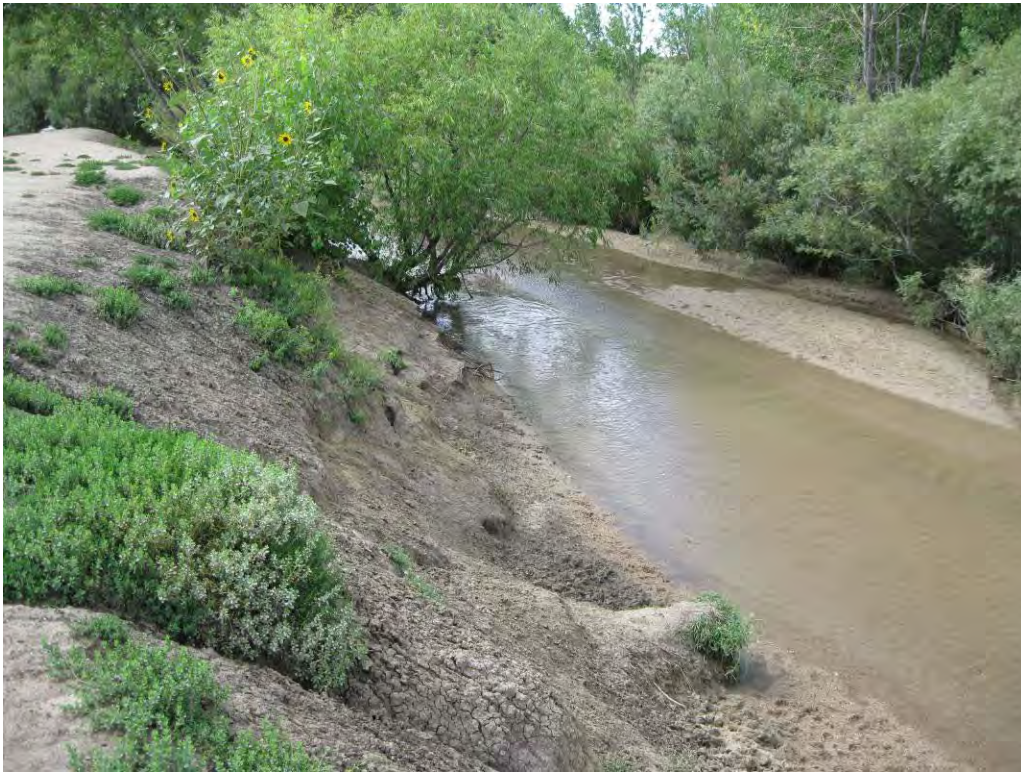
**EXHIBIT 1-3**  
Reach 2: Downstream Reach  
*Cherry Creek Stream Reclamation at 12-Mile Park Project*

**Reach 2: Downstream Reach** – Downstream of Reach 1, the groundwater fed channel joins with the mainstem of Cherry Creek. The eastern bank decreases in height to between five and fifteen feet above the breakout area and approximately three feet downstream of the breakout area. The lowered eastern bank provides easier access to the channel, and as a result there are numerous areas where the vegetation has been trampled and soil erosion has resulted.

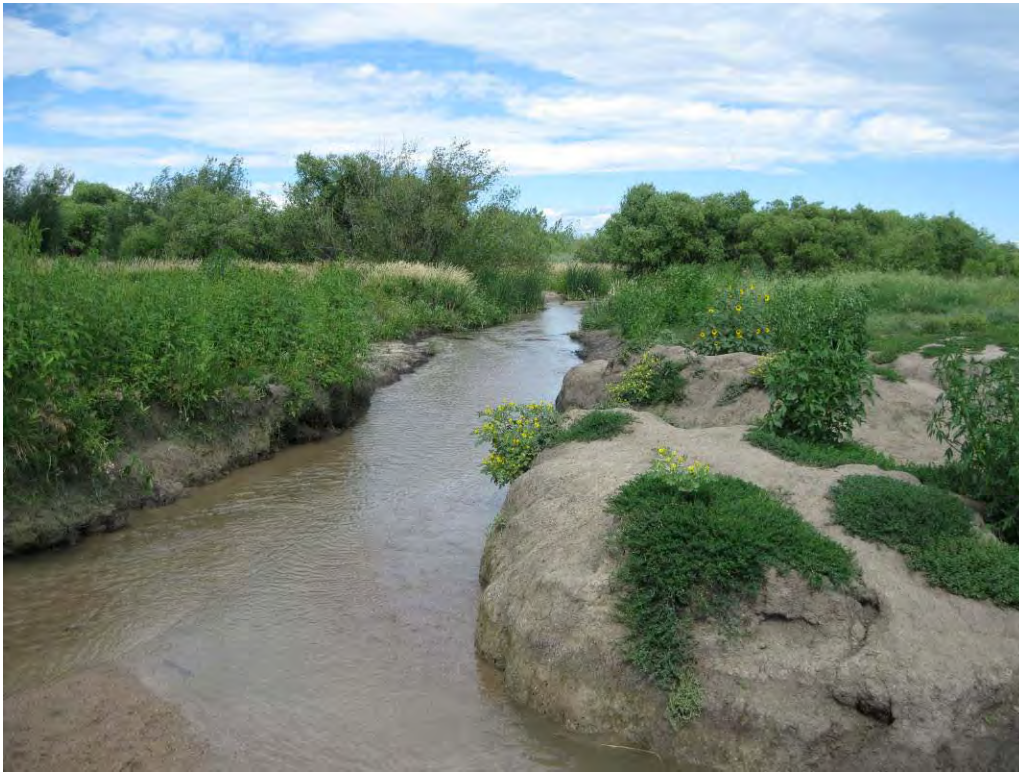
EXHIBIT 1-4  
Reach 3: Channel Breakout Reach  
*Cherry Creek Stream Reclamation at 12-Mile Park Project*

**Reach 3: Channel Breakout Reach** – Within reach 2, Cherry Creek has experienced a breach of the eastern bank resulting in Cherry Creek leaving the historic flow path and flowing north rather than turning to the west as it has for the last 70 years. Based on discussion with State Park staff and Park Concessionaires, it appears that the loss of vegetation in the area due to heavy park use resulted in the vulnerable east bank. The east bank overtopped during a large runoff event in 2009. The overtopping caused localized erosion washing out the east bank created a new channel with an invert lower than the historic flow path. This is the most significant problem identified in the site assessment.

Because the historic channel has been determined to be in a stable condition, the downcutting observed directly upstream of the breakout area is a result of the breakout flow path attempting to reach a stable slope. This is consistent with the aerial photography review which shows that the main channel has experienced little horizontal channel meandering over the last 20 years before the breakout occurred. The conclusion that the historic flow path is at a stable slope is also consistent with recent site visits in which the downcutting was not observed before the breakout occurred.

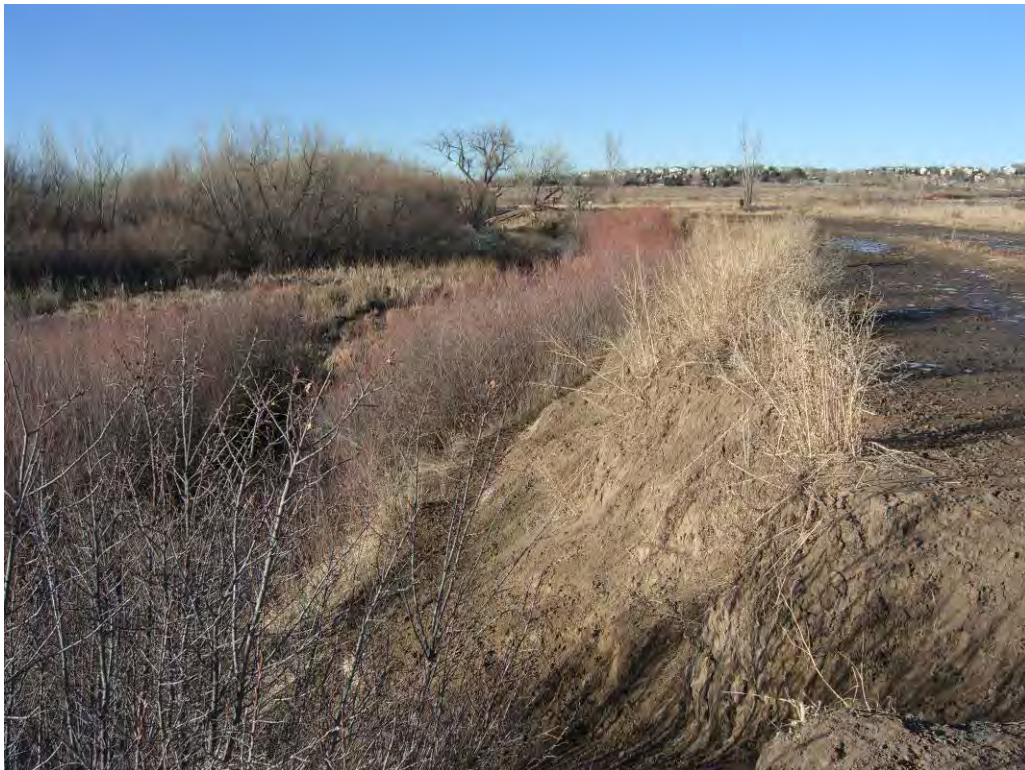
**EXHIBIT 4-1**  
Typical Existing Bank Conditions Upstream of Confluence with Secondary Channel  
*Cherry Creek at 12-Mile Park Alternatives Analysis*

Throughout the Cherry Creek at 12-Mile Park project reach there are two typical existing bank sections. From the upstream limit of the project area to approximately 200 feet downstream of the confluence of the mainstem with the groundwater fed secondary channel, the bank can be characterized as between 10 and 15 feet high with steep side slopes. The second bank conditions exists from approximately 200 feet downstream of the confluence of the mainstem of Cherry Creek with the groundwater fed secondary channel downstream to the breakout area. The bank is approximately 5 feet high with approximately 2:1 (H:V) side slopes. Exhibits 4-1 and 4-2 show the two typical existing bank sections for the project area.
