# Memorandum

**To:** Rick Goncalves, CCBWQA TAC Chairman  
**CC:** Chuck Reid, CCBWQA Manager  
**From:** William P. Ruzzo, P.E.  
**Date:** November 11, 2013  
**Re:** Shoreline PRF Design Approach at Cherry Creek Reservoir

Presented in this memorandum is a summary of the design approach for shoreline pollutant reduction facilities (PRF), discussion of ice related damage and causes, and resulting design changes to minimize damages to shoreline facilities.

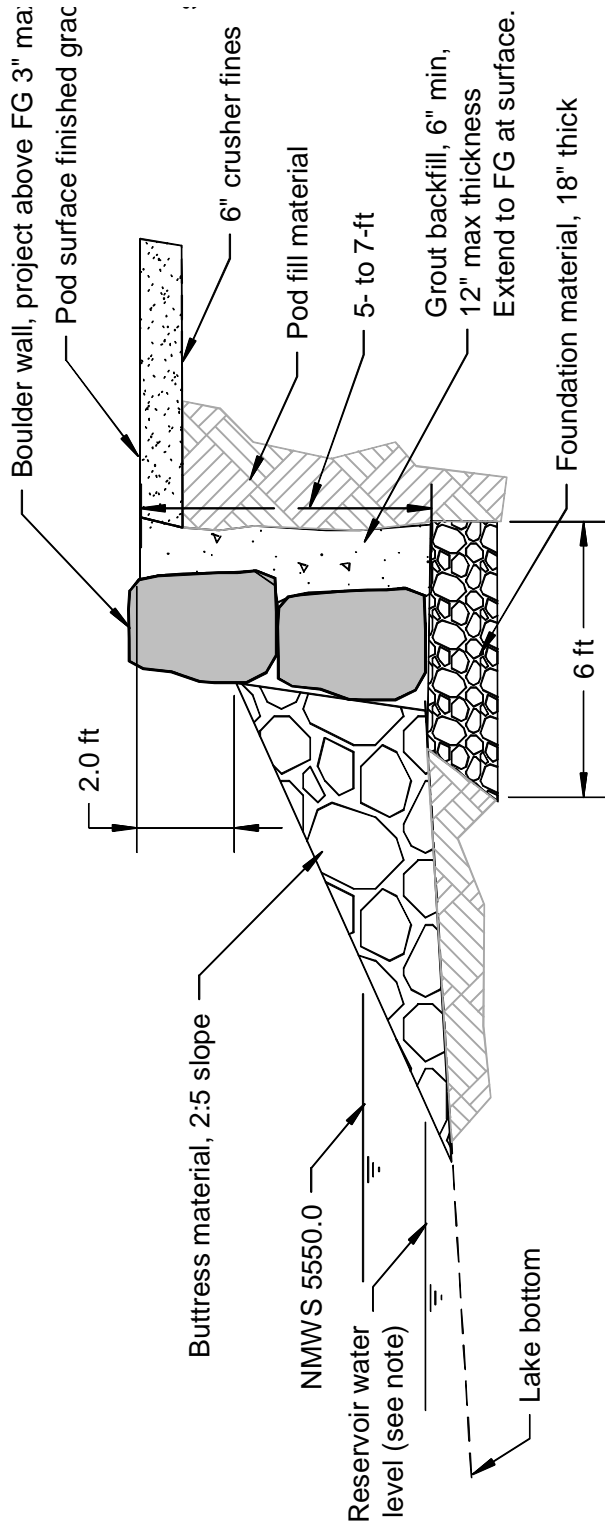
Figure 2 Tower Loop Repair Plan

It was observed that when smaller rock –  $d_{50}$  of 18" and smaller – was placed in front of the large boulders and sloped (i.e.: ~2.5:1 or flatter) away from large boulders, that the ice forces did not result in significant damage to the shoreline protection measures. This design approach is illustrated in the restoration plan for Tower Loop on Figure 2. It is believed that the smaller rock "buttress" caused the ice sheets to be forced upward reducing the forces and minimizing displacement of the large boulders.

TYPICAL SECTION BOULDER WALL REPAIRS

Beginning in 2008, the Authority began a rehabilitation program for the East Boat Ramp, East Shade Shelter, Dixon Grove, and Tower Loop shoreline PRFs that added the rock buttress in front of the large boulders at a cost of around \$134,000. Examples of the buttress can be seen in Photo 4, Tower Loop. This design approach was incorporated into the Mountain and Lake Loop project. See Photo 7.

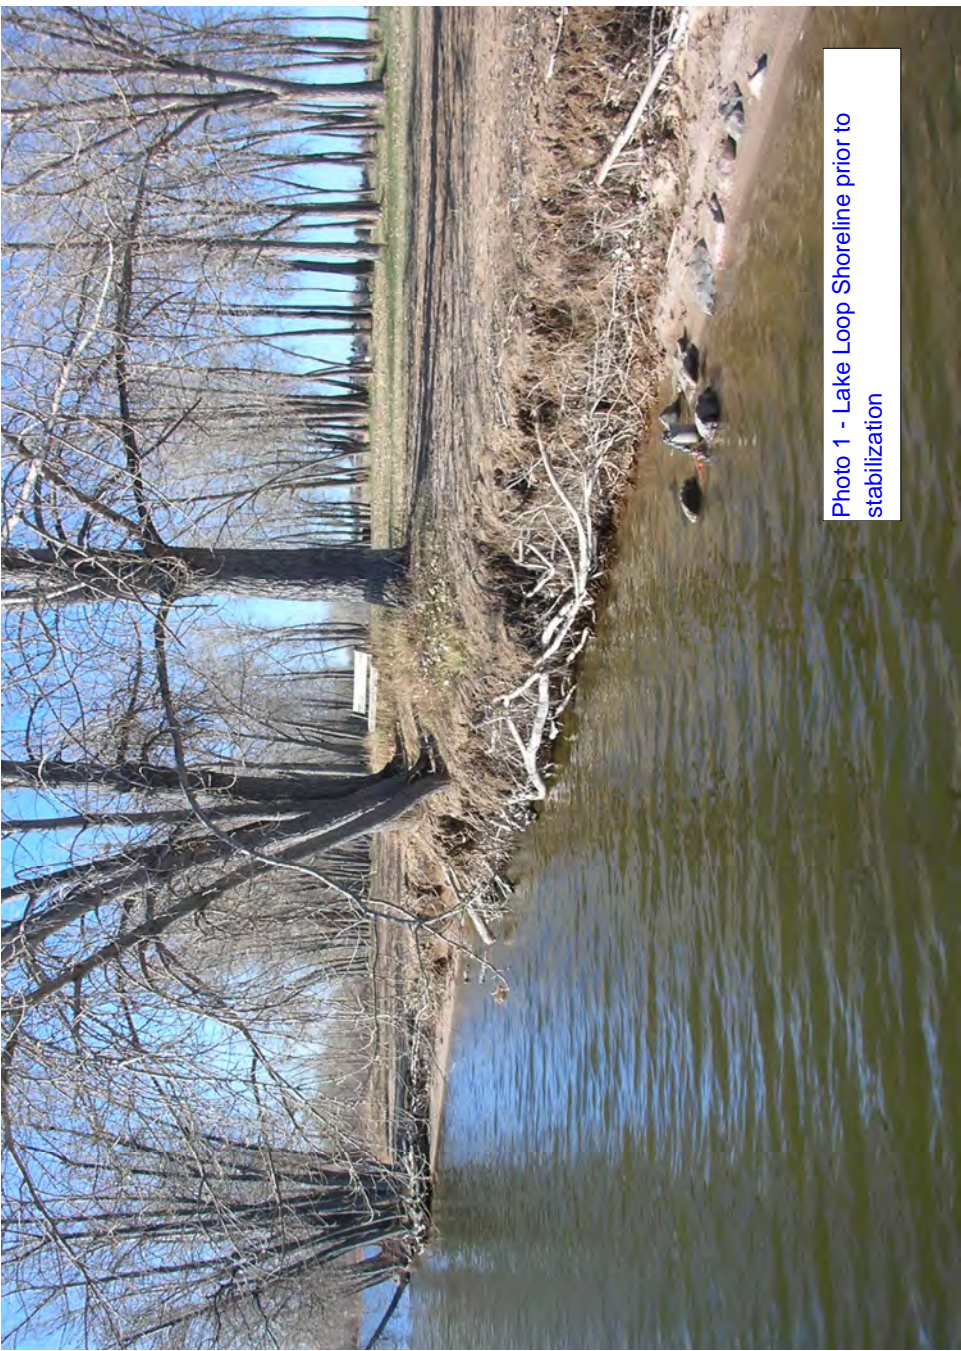
Shoreline stabilization projects qualify as PRF because they minimize the quantity of soil, with attached phosphorus and other pollutants, eroded along the edge of the reservoir that become deposited directly into the lake. In many cases, shoreline erosion and pollutant discharges to the reservoir are aggravated by parking lots that discharge pollutants directly to the reservoir. Erosion is primarily the result of wave and ice forces acting on the shoreline soils, but also from pedestrian and domestic animal uses that destroy vegetation exposing bare soils that are more readily eroded. Examples of shoreline erosion at Cherry Creek are shown on the Photos 1 and 2.

Photo 1 - Lake Loop Shoreline prior to stabilization

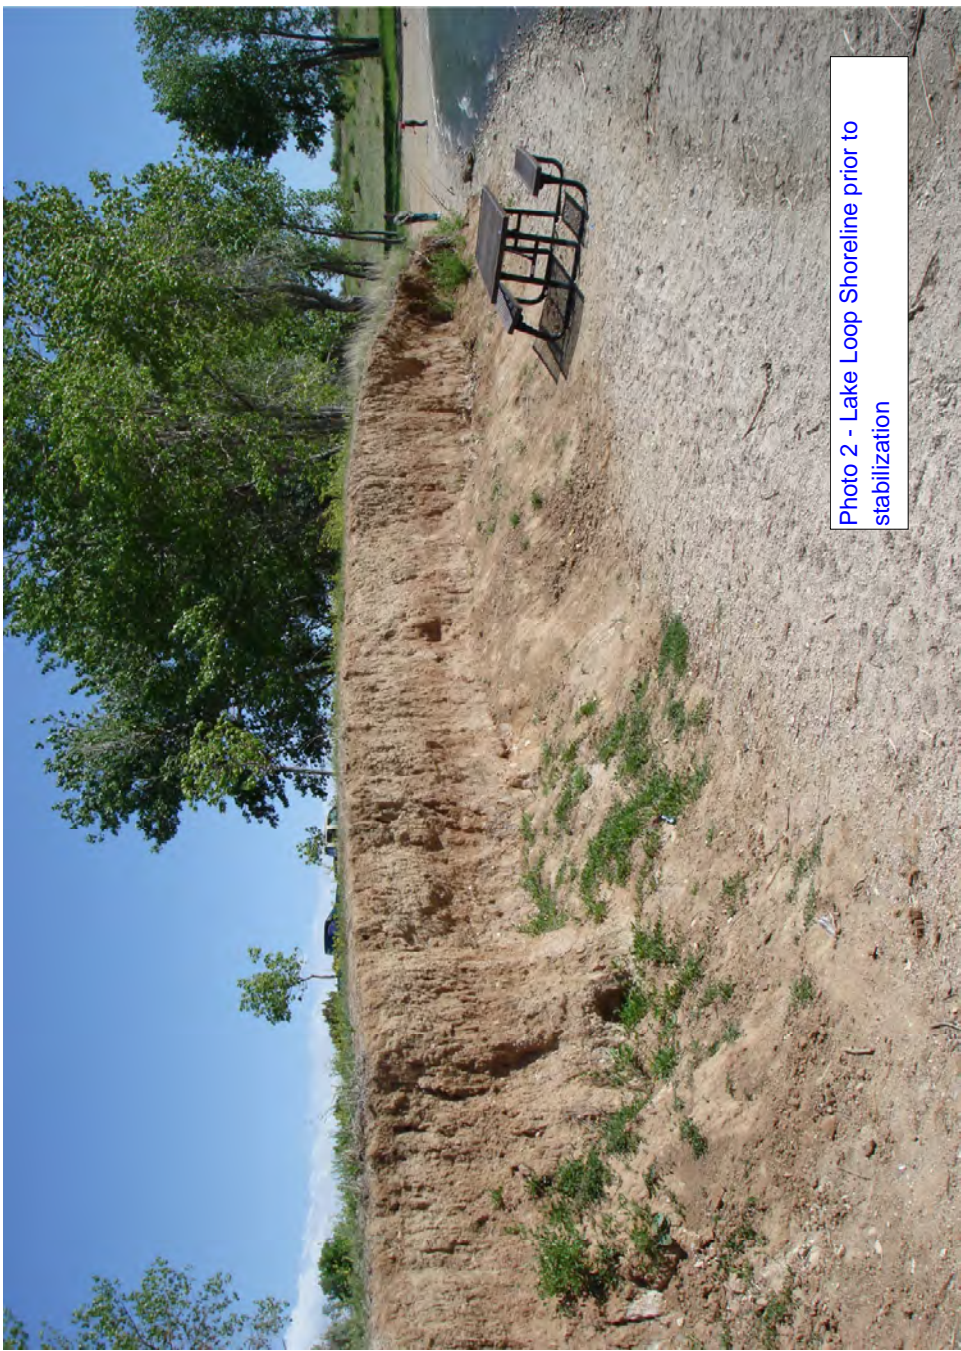
Photo 2 - Lake Loop Shoreline prior to stabilization

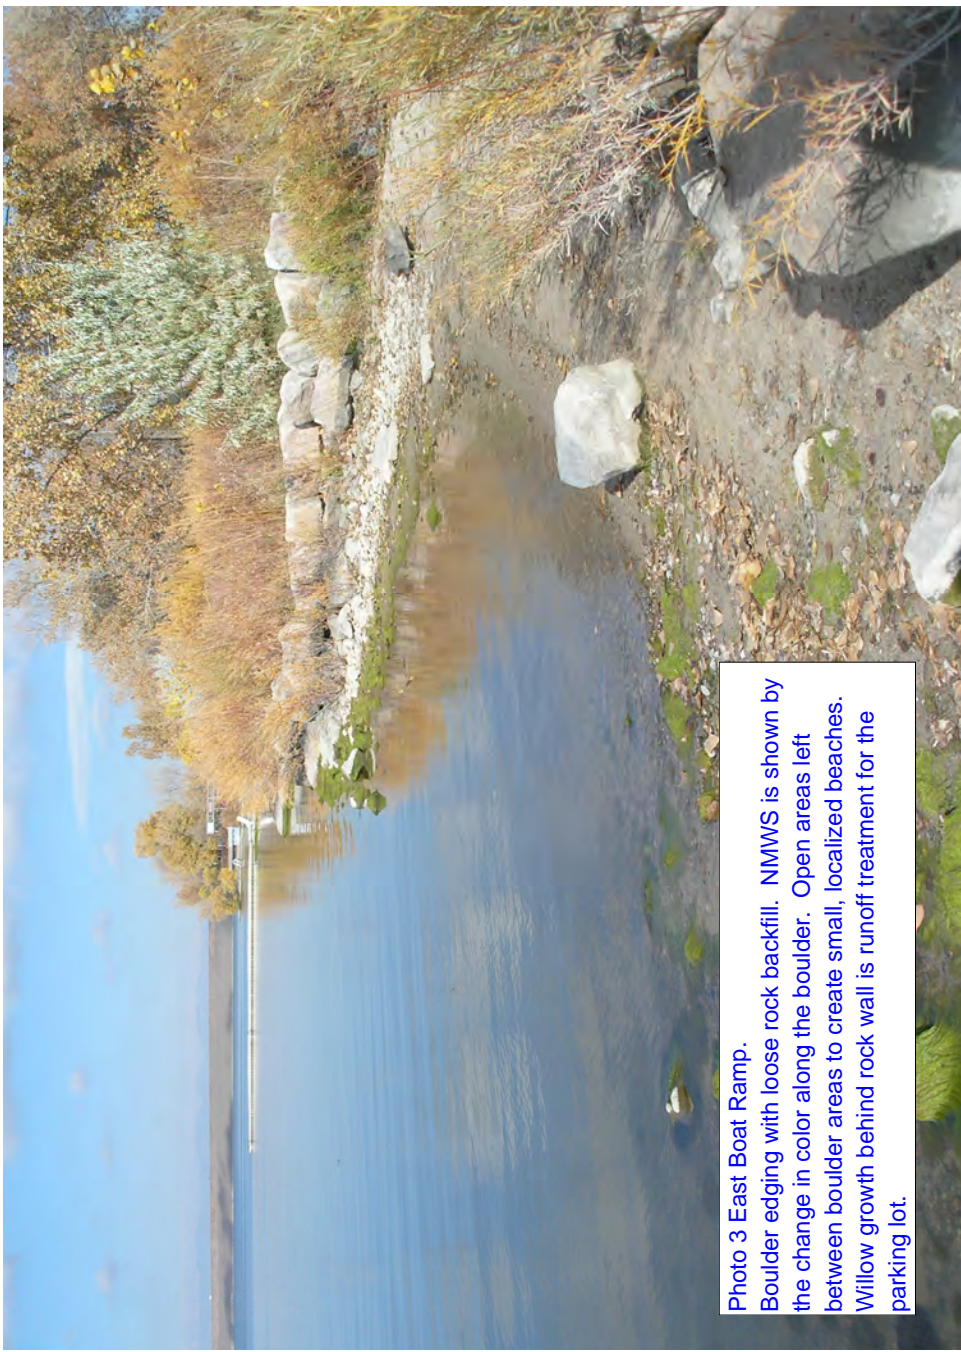
Photo 3 East Boat Ramp.  
Boulder edging with loose rock backfill. NMWS is shown by the change in color along the boulder. Open areas left between boulder areas to create small, localized beaches. Willow growth behind rock wall is runoff treatment for the parking lot.

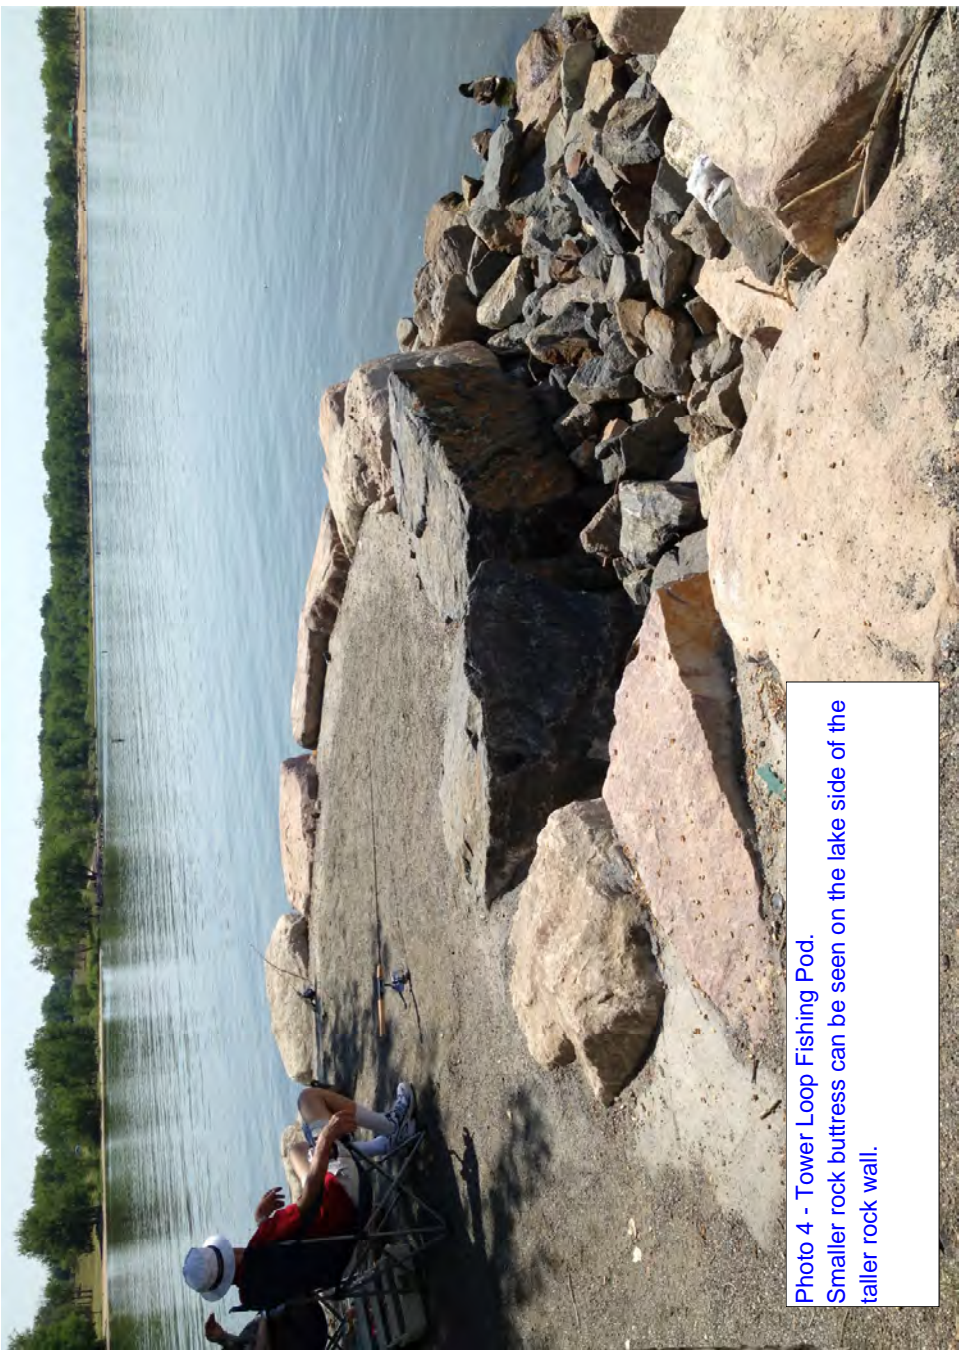
Photo 4 - Tower Loop Fishing Pod.  
Smaller rock buttress can be seen on the lake side of the taller rock wall.

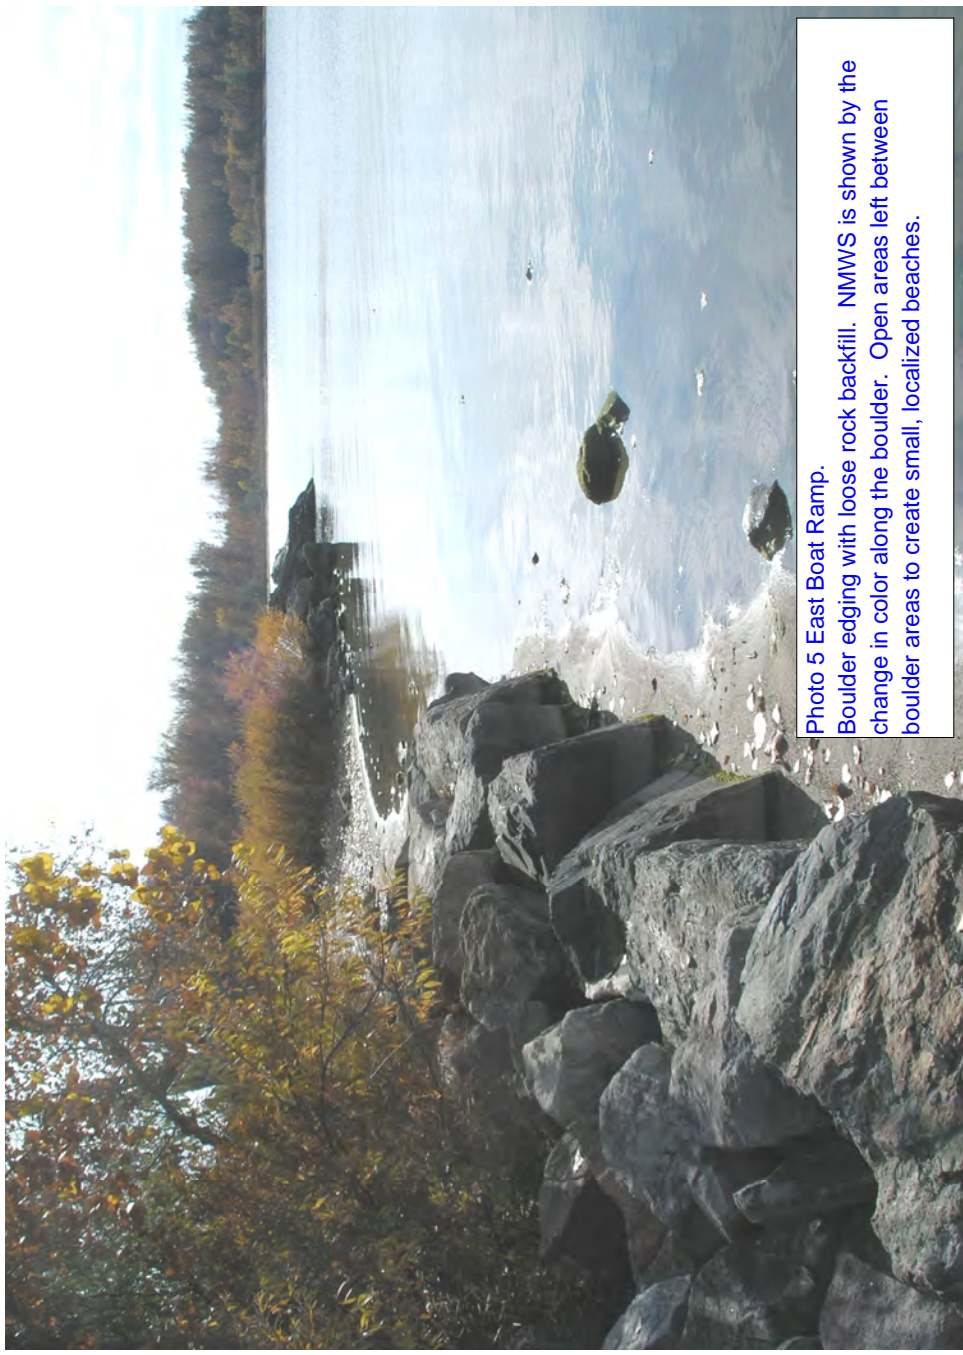
Photo 5 East Boat Ramp.  
Boulder edging with loose rock backfill. NMWS is shown by the change in color along the boulder. Open areas left between boulder areas to create small, localized beaches.

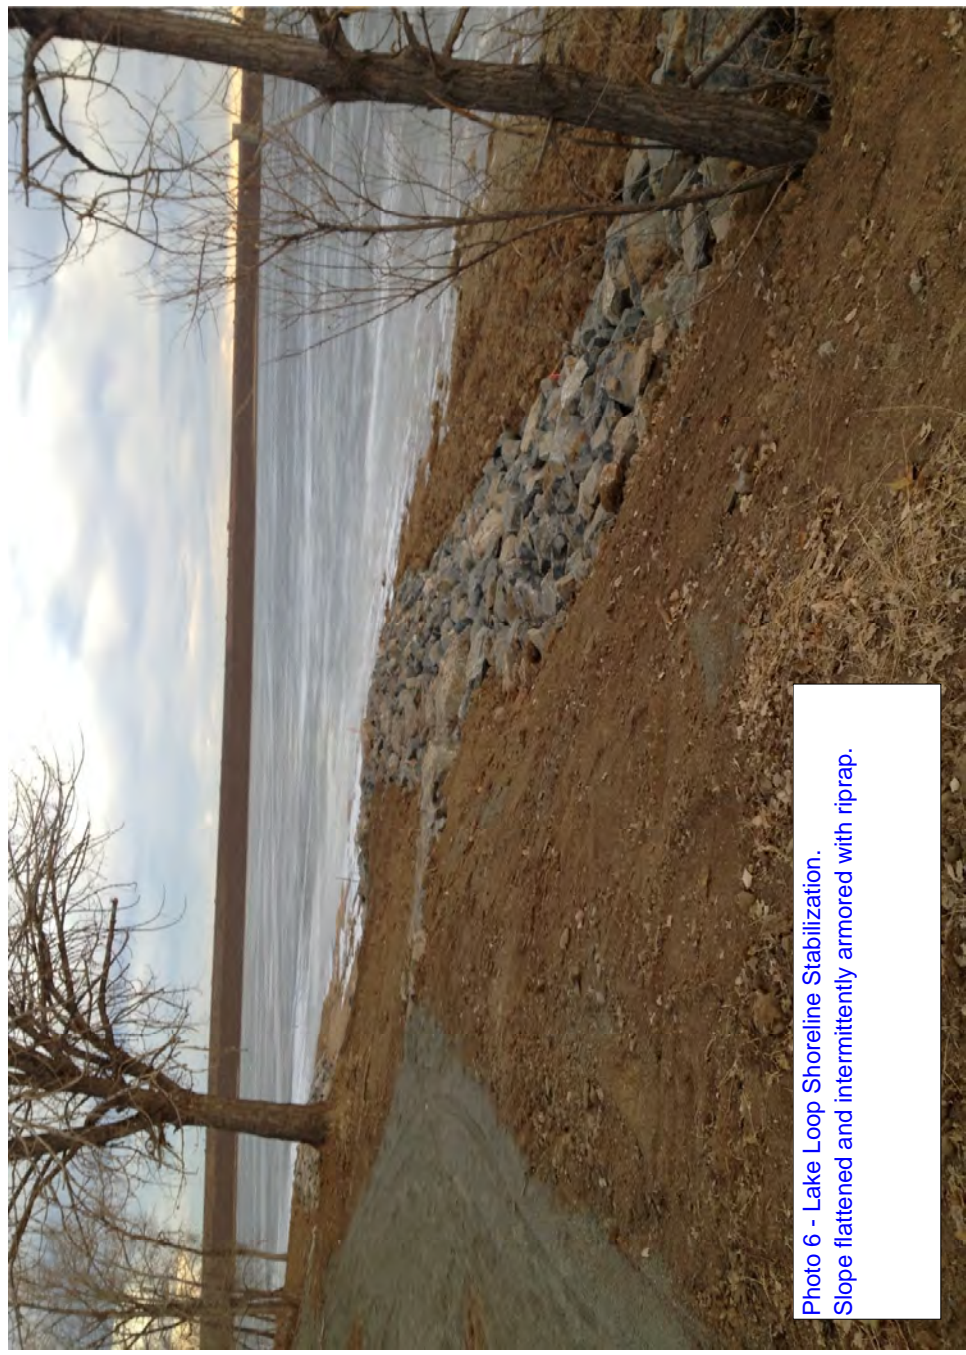
Photo 6 - Lake Loop Shoreline Stabilization.  
Slope flattened and intermittently armored with riprap.

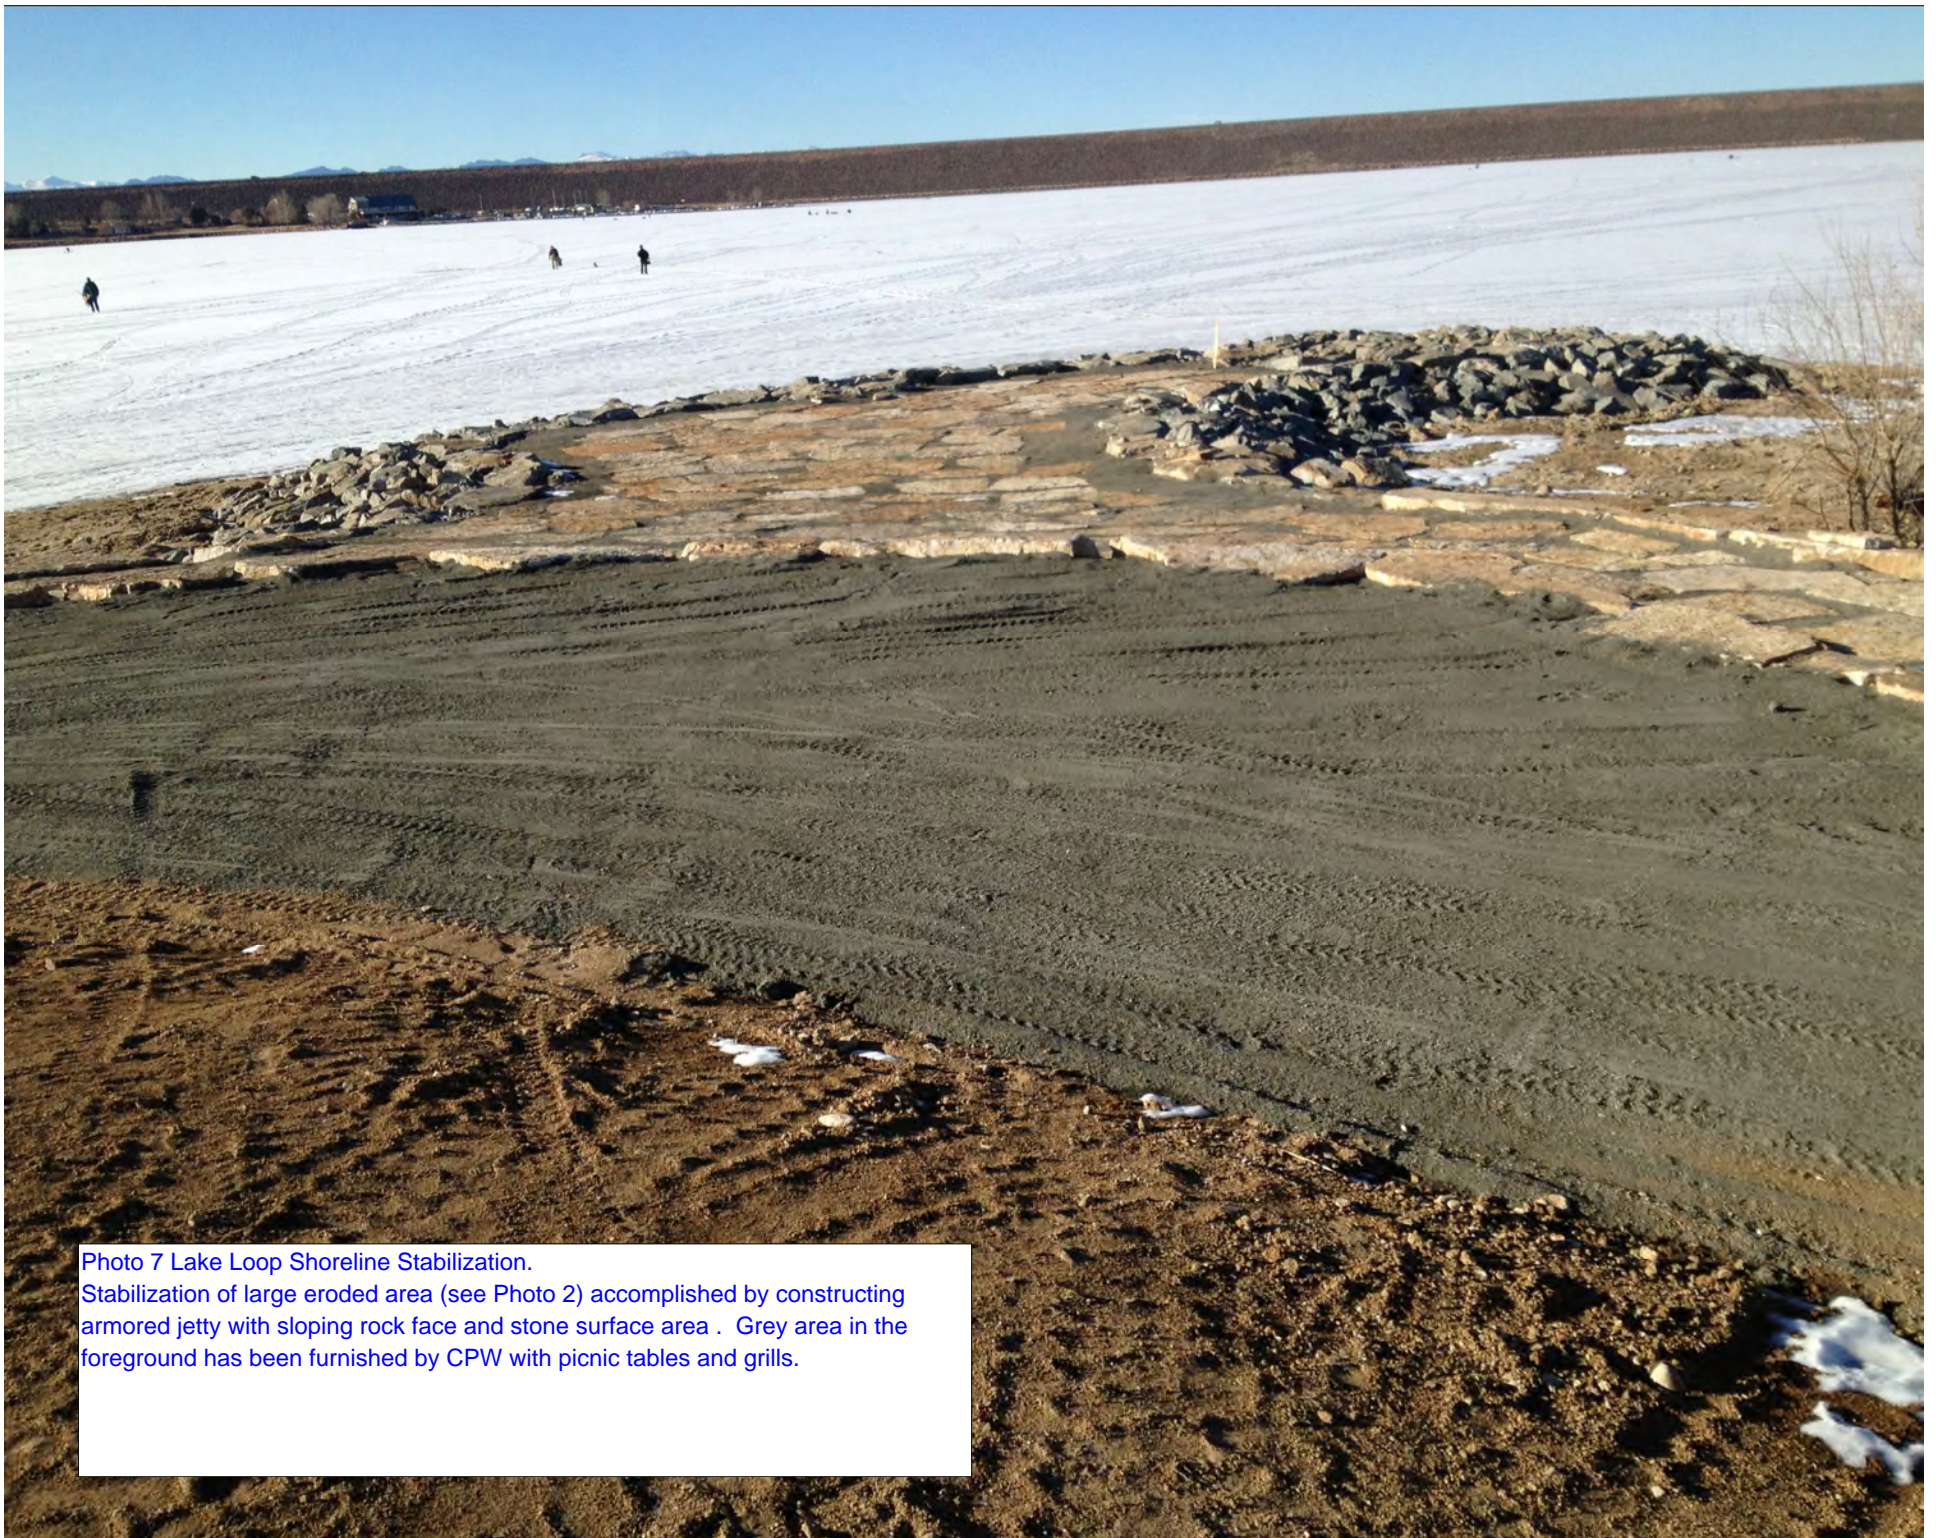
Photo 7 Lake Loop Shoreline Stabilization.  
Stabilization of large eroded area (see Photo 2) accomplished by constructing armored jetty with sloping rock face and stone surface area . Grey area in the foreground has been furnished by CPW with picnic tables and grills.

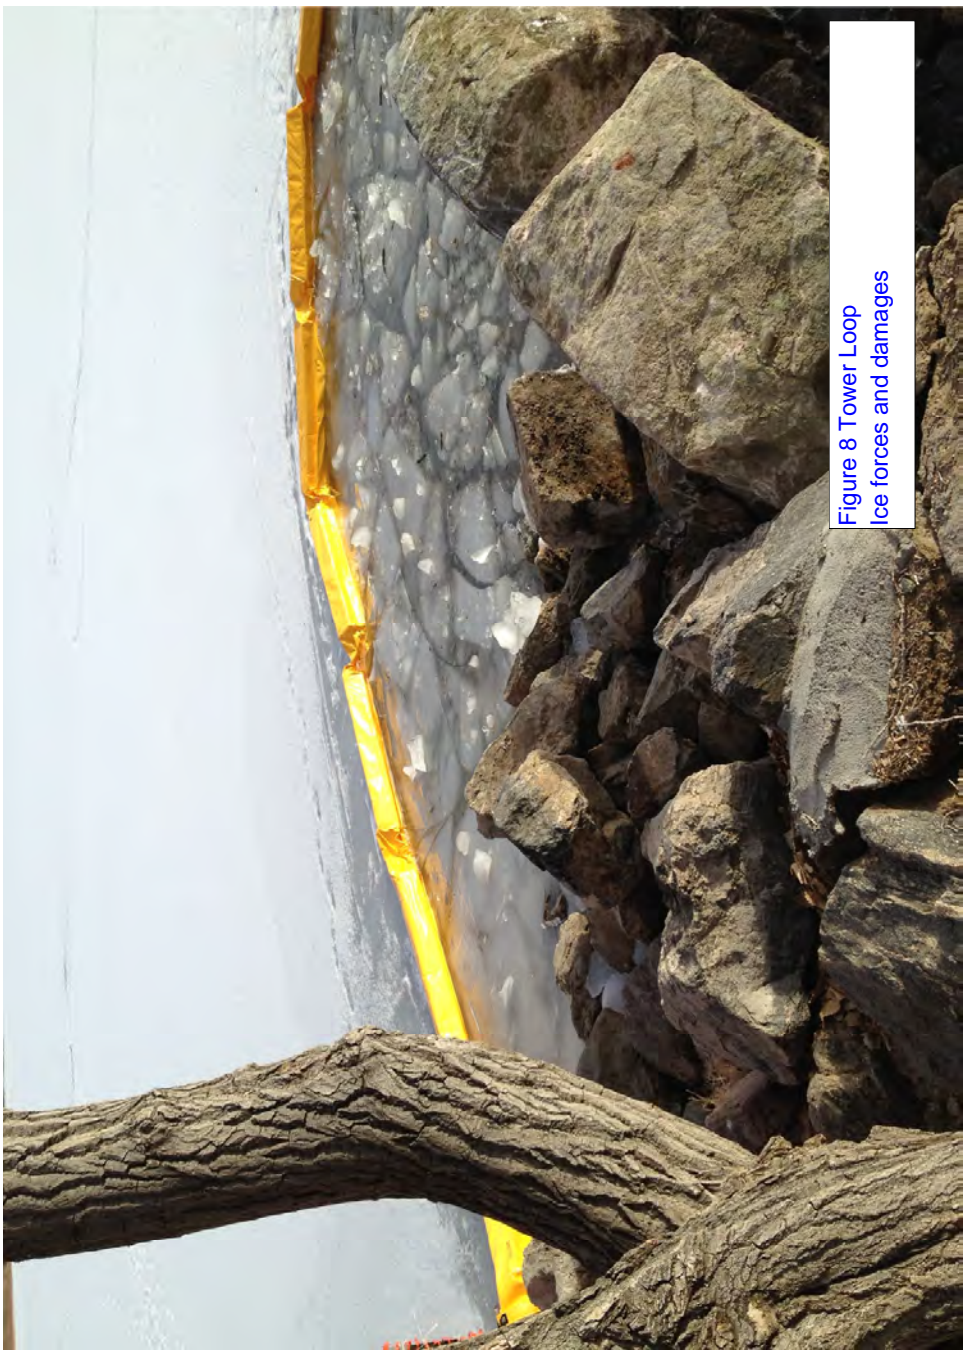
Figure 8 Tower Loop  
Ice forces and damages

The boulder sizes exceed rock sizes needed to protect the shoreline from wave erosion. However, it was observed during some winter and early spring periods that ice forces were able to move and displace some large boulders at the east shoreline projects and, for Tower Loop, resulted in failure of the boulder wall (see Photos 9 through 13). In other areas, the boulders were shifted around leaving gaps in the shoreline protection. Investigation into the causes identified two scenarios where ice forces were likely to cause damage to the shoreline:

- Long, cold winter periods that allowed thick continuous ice cover over the Reservoir which then expanded or shifted due to wind shear creating large horizontal forces at the shoreline.
- Melting of ice cover in the spring that begins along the shallow edge of the reservoir and leaves large, thicker, free floating sheets of ice in the main part of the reservoir. These sheets of ice are readily moved about the reservoir during high wind, spring storm events in almost any direction and impact shoreline facilities including the PRFs and the Marina docks<sup>1</sup>.
