## **CHERRY CREEK STREAM RECLAMATION AT 12-MILE PARK, PHASE I**

**To:** Chuck Reid, Manager, CCBWQA  
**CC:** Rick Goncalves, Chairman, TAC  
**From:** William P. Ruzzo, P.E.  
**Date:** January 28, 2013  
**Re:** Cherry Creek Stream Reclamation @ 12-Mile Park Phase I – Project Summary

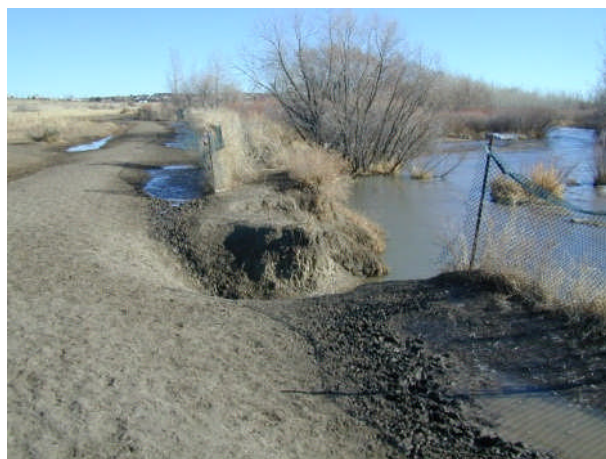
**Photo 1 - Cherry Creek 01-28-2008**

damage to bank vegetation and channel erosion were observed throughout the area where people, dog, and horse activity were concentrated (see Photo 1). The Authority evaluated the water quality impacts from these activities and decided to investigate the technical feasibility of stabilizing the channel banks. Funds for investigation were included in the 2008 capital improvement program (CIP).

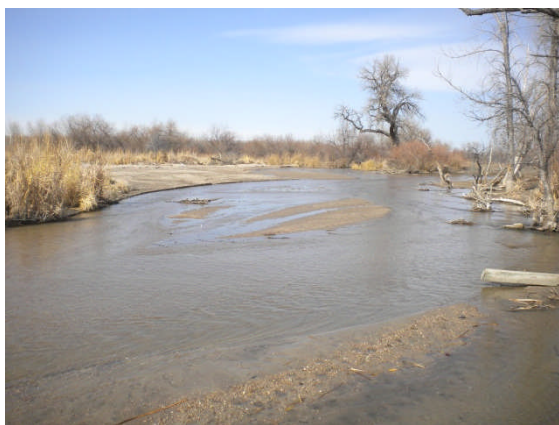
Photo 2 - Wetlands damage from breach

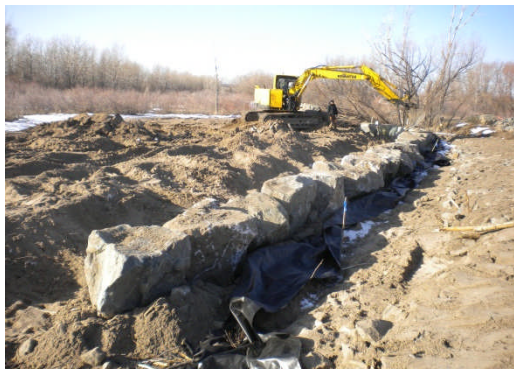
**Photo 3 - Boulder Toe Wall**

Repair to the breach along the right bank included a combination of a boulder toe wall (Photo 3) and sheet-pile cut-off wall along the upper bank (Photo 4).

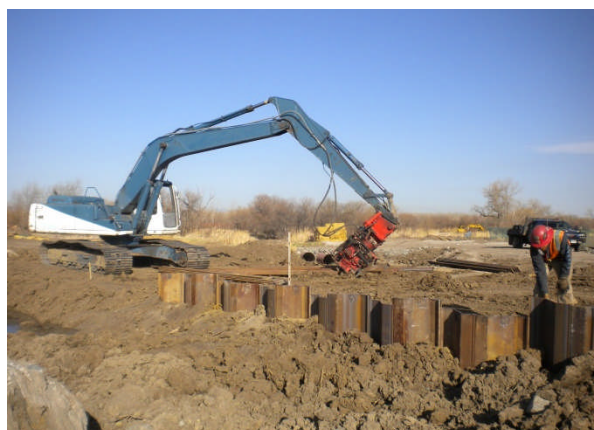
**Photo 4 - Sheet Pile Cut-Off Wall**

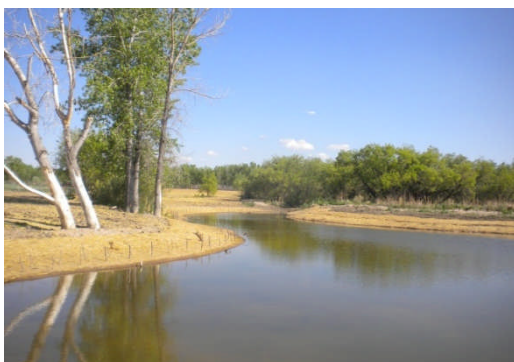
**Photo 5 - Restored Wetlands**

for use in the 12-Mile Park project, the Authority directed the contractor to haul sediment from the Cottonwood Wetlands project and place it at the 12-Mile Park project to reclaim the wetlands damaged during breach of the Cherry Creek channel. This exchange of material between projects reduced costs to import materials for the 12-Mile Park project and export materials from the Park to preserve flood storage volume<sup>2</sup>. Photo 5 shows the restored wetlands and Photo 6 shows the restored right bank of Cherry Creek that had breached.

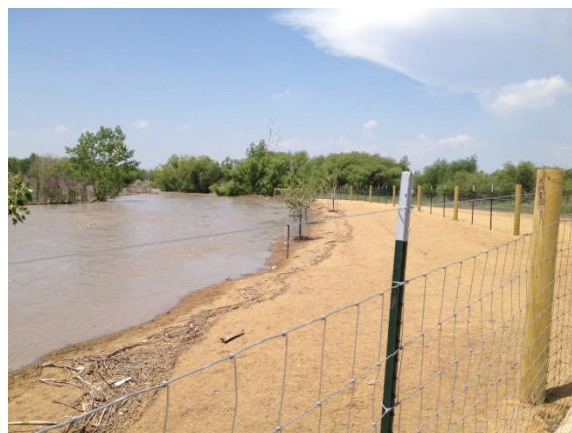
**Photo 6 - Restored Breach Area**

At the time of inspection (~ noon 6-7-12), the flows in Cherry Creek had begun to recede. Photo 6 above is looking downstream at the right bank where the creek previously was breached. The high flow debris-line is clearly visible just to the right of the water surface. The top of newly restored bank is along the wooden fence posts. This clearly shows that the flood did not breach the repaired bank at the breach area. Analysis by CH2M Hill of the debris line using HEC-RAS developed for the Project suggests that peak flow on June 6, 2012 reached values near 2,000-cfs.

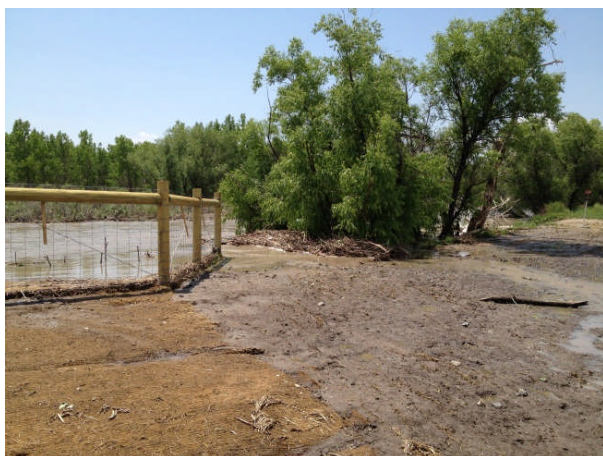
**Photo 7 - Bank Overflow Area**

Photo 7 shows the downstream end of the project where the grade was tied back into existing grade in front of the trees. The existing channel bank did overtop in this area, outside of the project limits, then flowed back into the project area and did result in some localized erosion. The area downstream of the breach (to the right of the photo) showed minor erosion and sedimentation and possibly some seeded areas were impacted.

Preliminary conclusion is that the project experienced minor local erosion damage and can be repaired during Phase II of the project at a minor cost. It is also my opinion that if the breach had not been repaired, the environmental damage in the breach area would have been extended wider and further downstream damaging
