# **CHERRY CREEK BASELINE CHANNEL MONITORING REPORT**

## **Reservoir to State Park Boundary**

November 2022

**Muller Engineering Company**  
777 South Wadsworth Boulevard  
Suite 4-100  
Lakewood, Colorado 80226  
303.988.4939

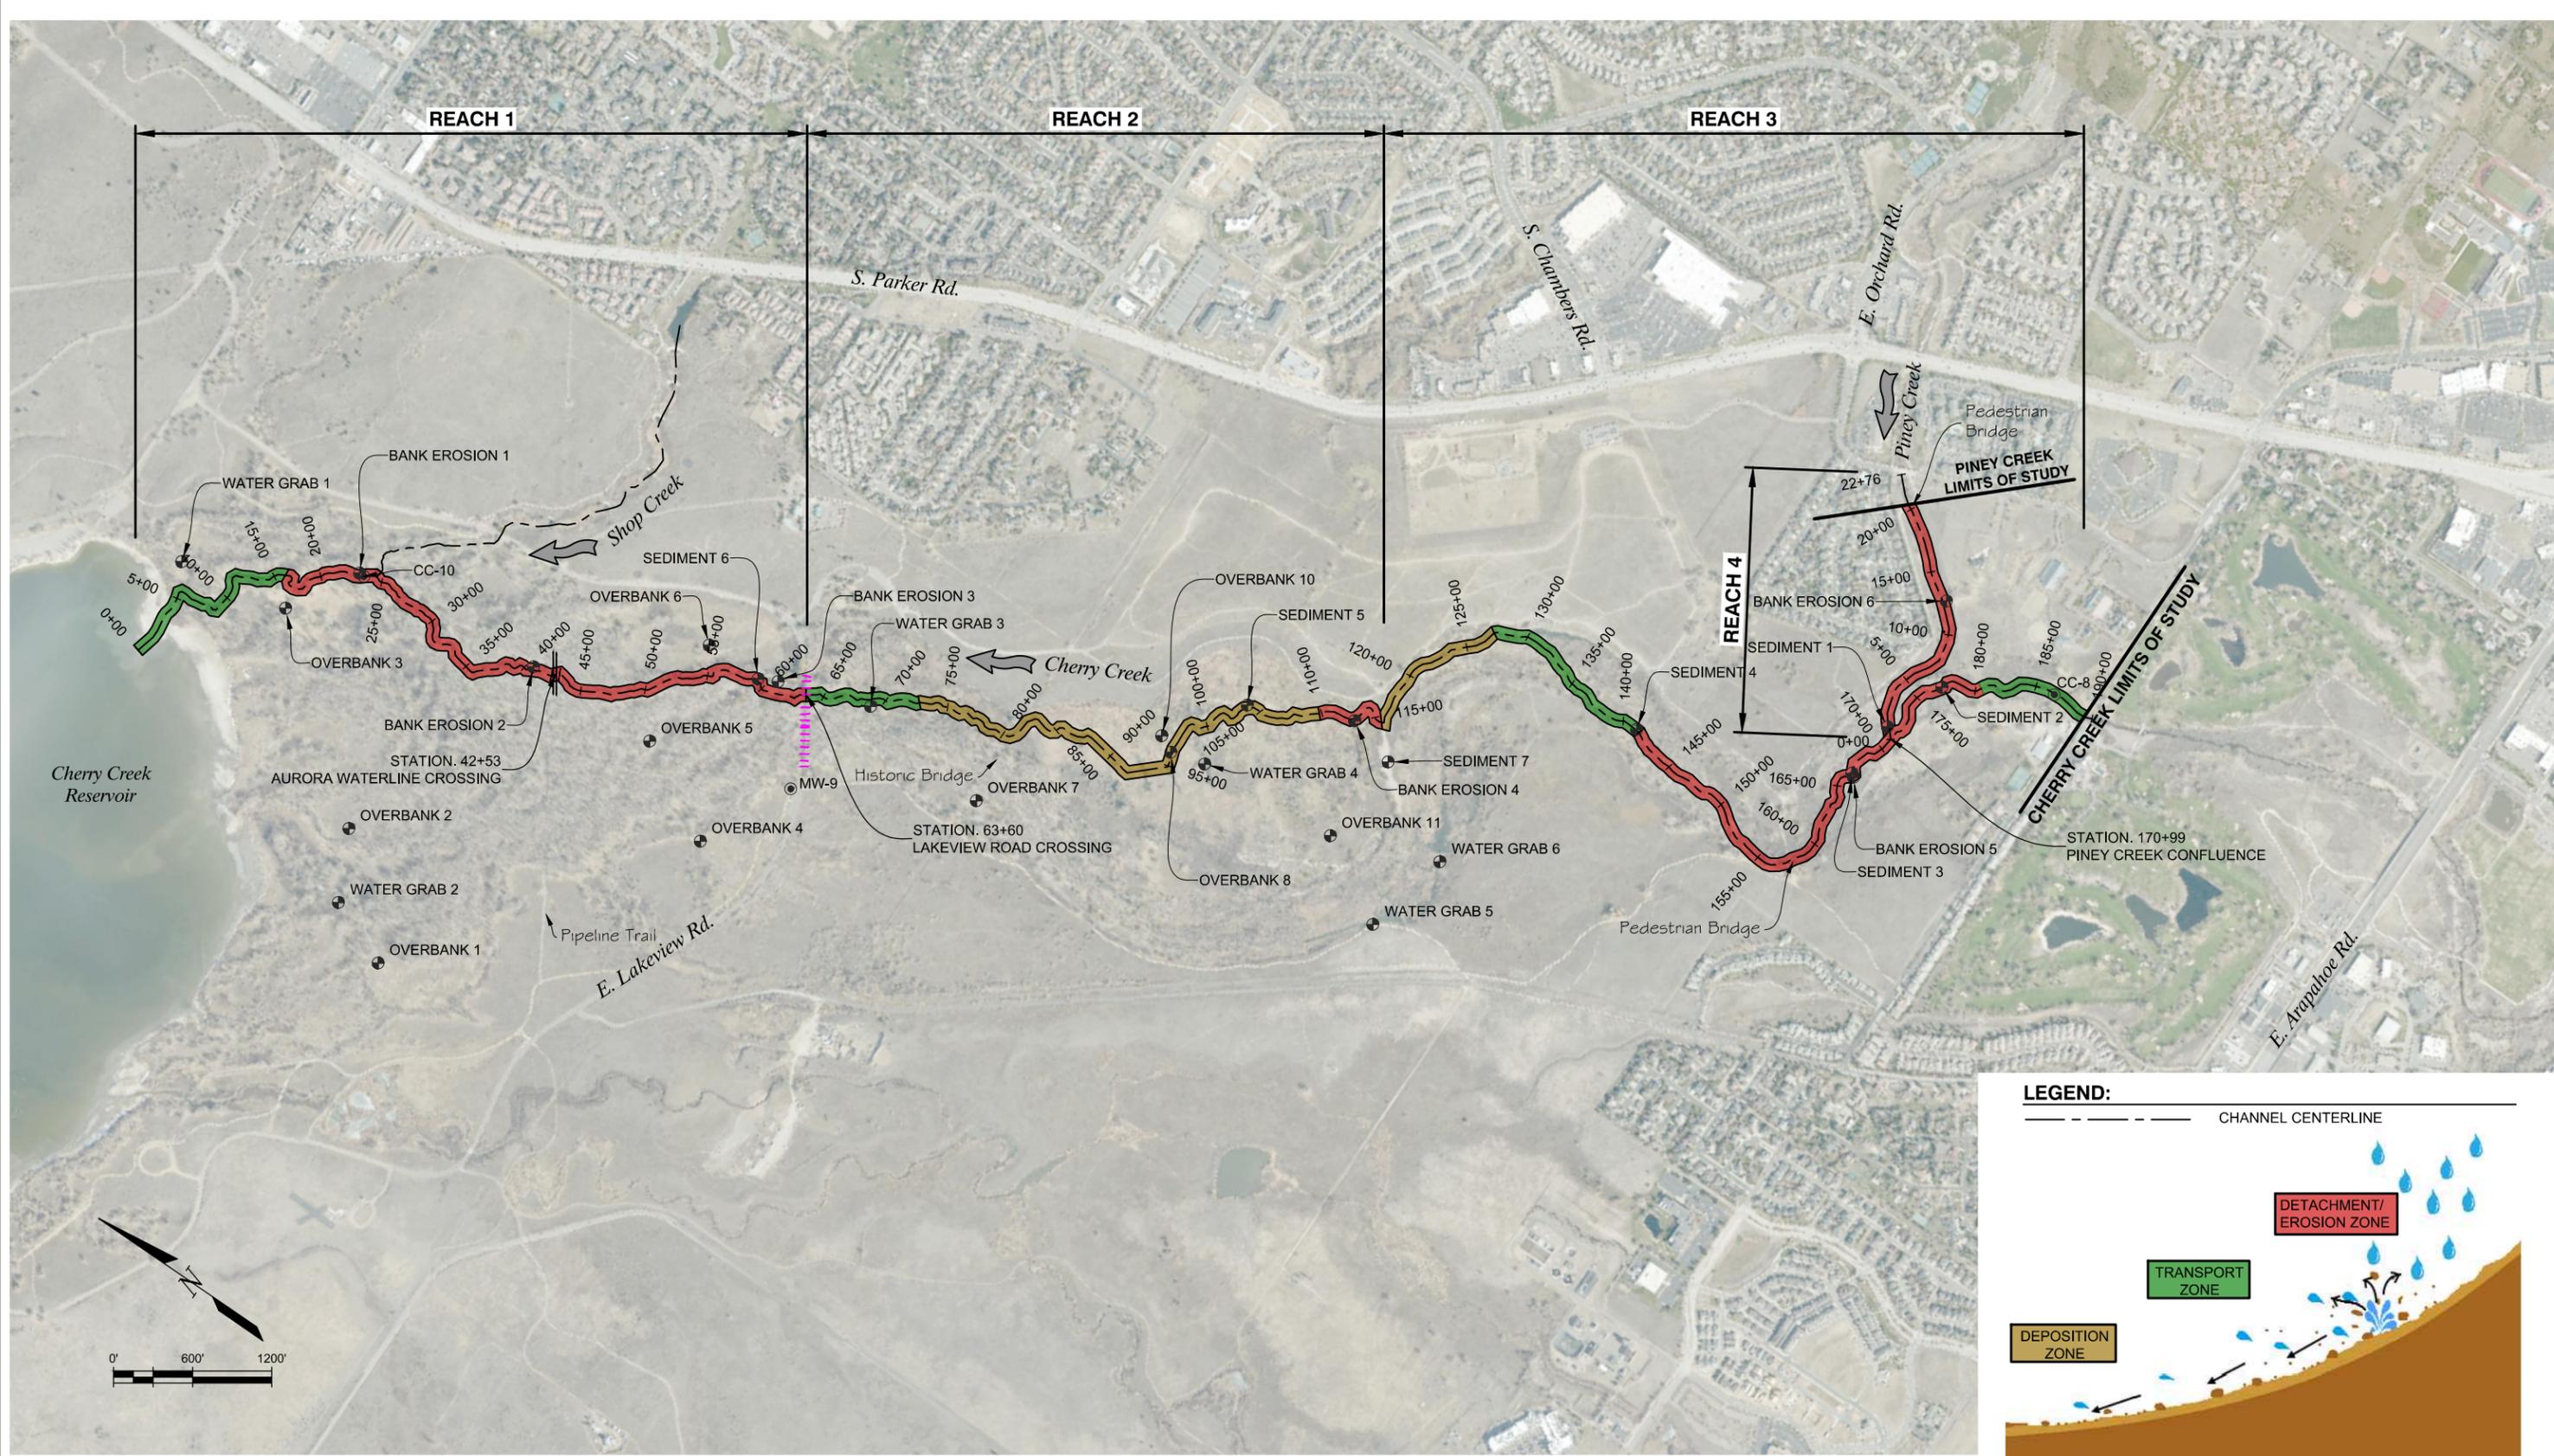
## CHERRY CREEK RESERVOIR TO 12 MILE GEOMORPHIC SUMMARY

The channel monitoring project reach has been divided into four separate sub-reaches based on similar geomorphic attributes which match the sub-reaches identified in the Cherry Creek Channel and Water Quality Assessment also completed in 2022. Reach 1 spans from the Reservoir to Lakeview Road and is characterized by channel downcutting with large areas of lateral stream bank erosion. Reach 2 spans from Lakeview Road to the 12-Mile Dog Off-Leash Area and is characterized by heavy sediment deposition through most of this reach. Reach 3 spans from the 12-Mile Dog Park to the assessment limits at the State Park boundary and is characterized by channel downcutting and lateral stream bank erosion. Reach 4, a reach of Piney Creek beginning at the confluence with Cherry Creek and extending upstream to an existing pedestrian crossing, was also included in the site reconnaissance, and is characterized by channel downcutting with extensive areas of lateral stream bank erosion. Figure 2 summarizes the geomorphic conditions and shows the limits of all four reaches.

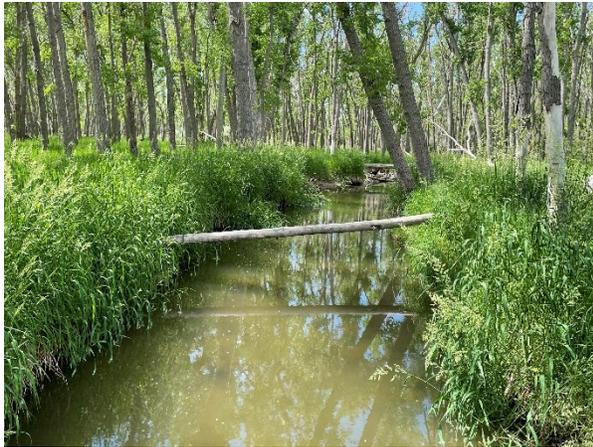
Photo 1: CC-8, BEHI - Low, NBS - Very Low (Sta. 43+00)

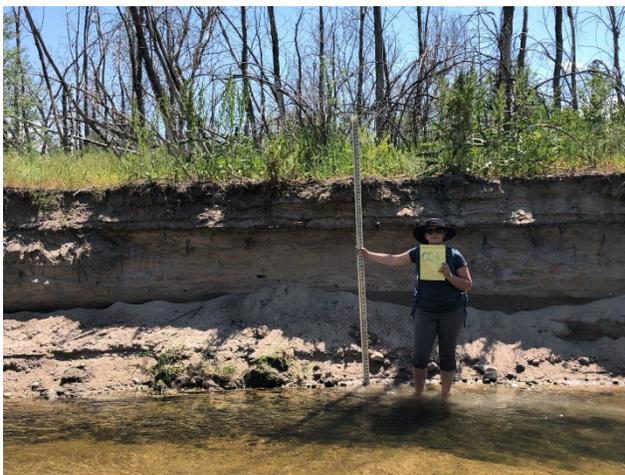
Photo 3: CC-1, BEHI - Very High, NBS - High (Sta. 177+00)
