RE: Corps File No. NWO-2010-02530-DEN
McMurdo Gulch Reclamation Project 2012 Annual Monitoring Report

**2012 ANNUAL MITIGATION MONITORING REPORT
MCMURDO GULCH RECLAMATION PROJECT
DOUGLAS COUNTY, COLORADO
CORPS FILE No. NWO-2010-02530-DEN**

ERO Project #4723

MARCH 12, 2013

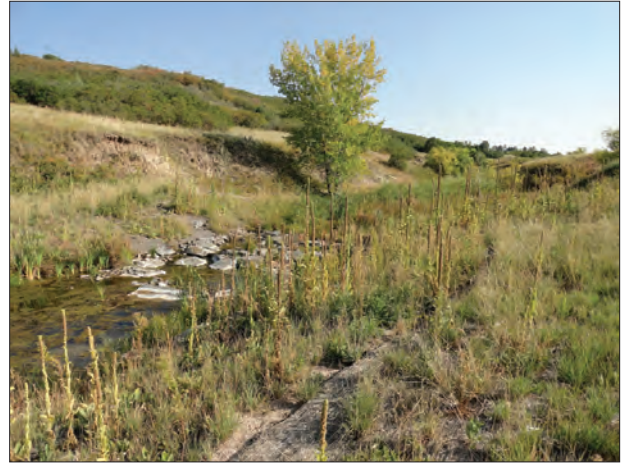
Photo 1b - View to the southeast of wetland vegetation establishing in the channel at Reach A-1.

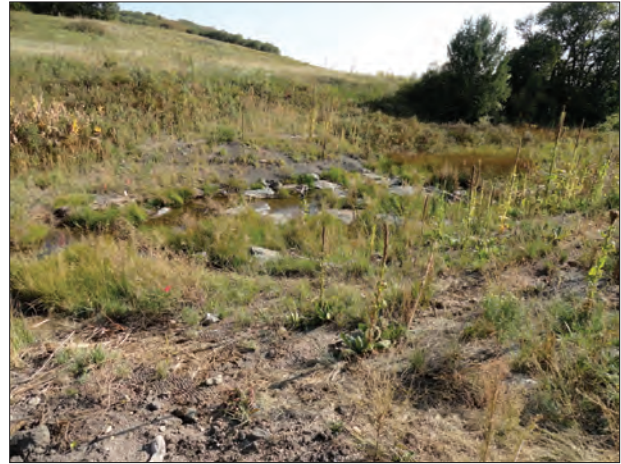
Photo 2b - View to the south of wetland vegetation establishing in the channel at Reach A-3.

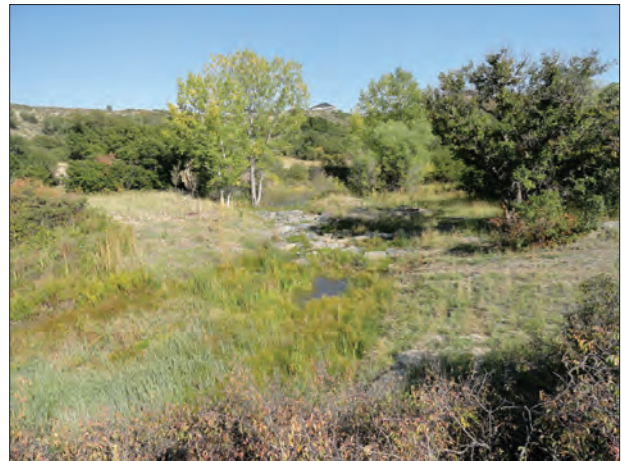
Photo 3b - View to the east of wetland vegetation establishing within Reach A-4.

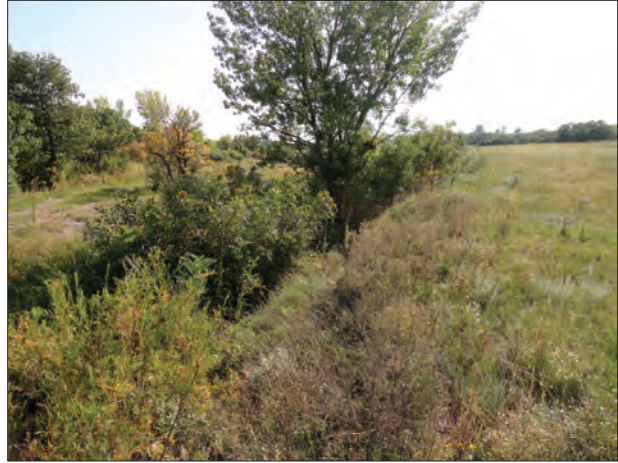
Photo 4b - View to the south of wetland vegetation and willows establishing at the downstream end of Reach A-6 following construction.

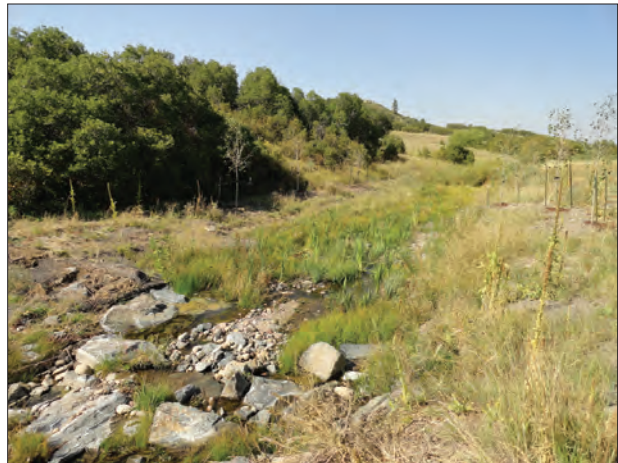
Photo 5b - View to the northwest of wetland vegetation establishing in the drop structure and channel bottom within the upstream portion of Reach B.

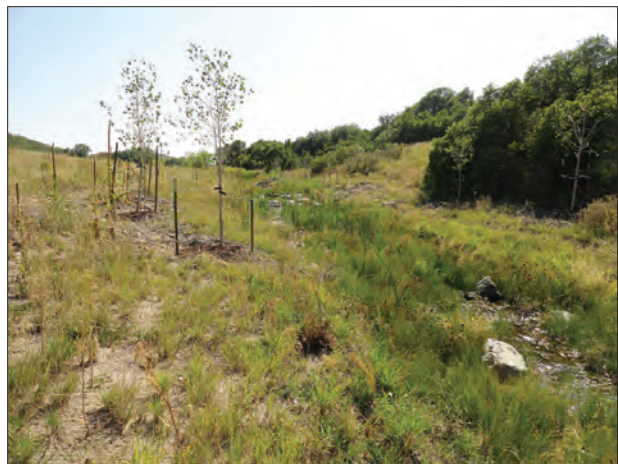
Photo 6b - View to the south of wetland vegetation establishing in the channel within the downstream portion of Reach B.

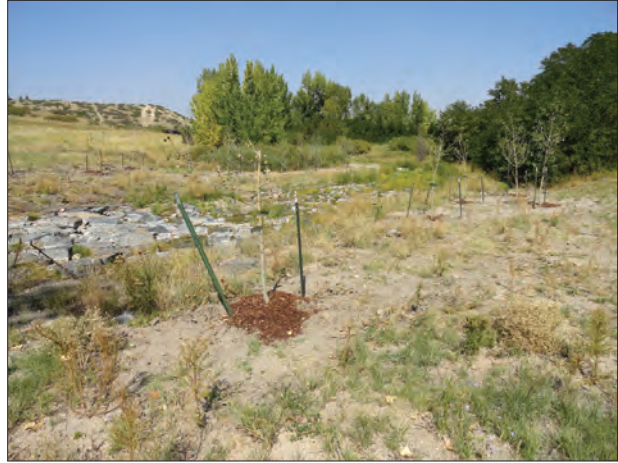
Photo 7b - View to the north of planted trees and wetland vegetation establishing in the channel within the upstream portion of Upper Reach C.

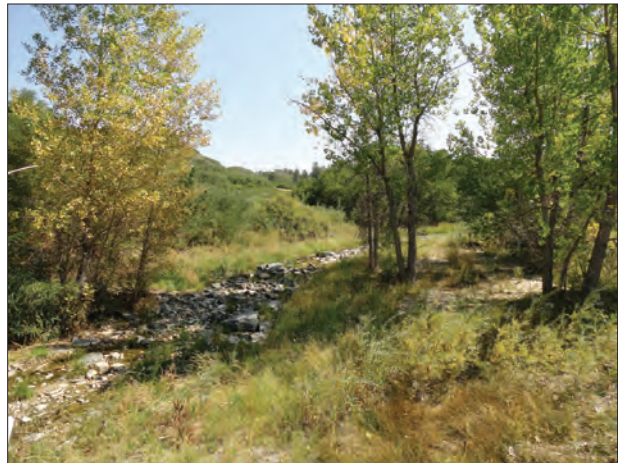
Photo 8b - View to the southeast of wetland vegetation establishing in the channel within the middle portion of Upper Reach C.

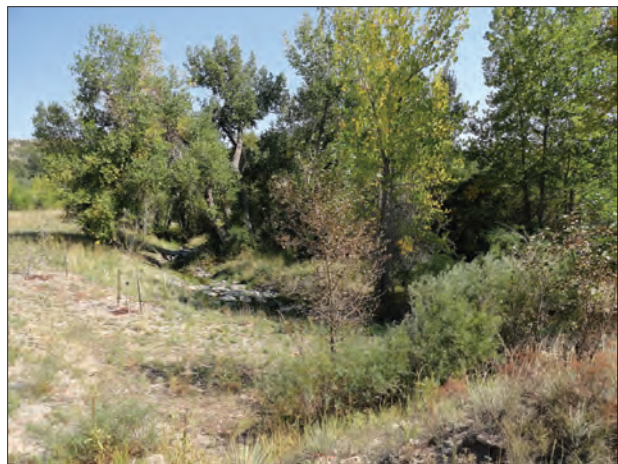
Photo 9b - View to the east of planted trees and wetland vegetation establishing in the channel within the middle portion of Upper Reach C.

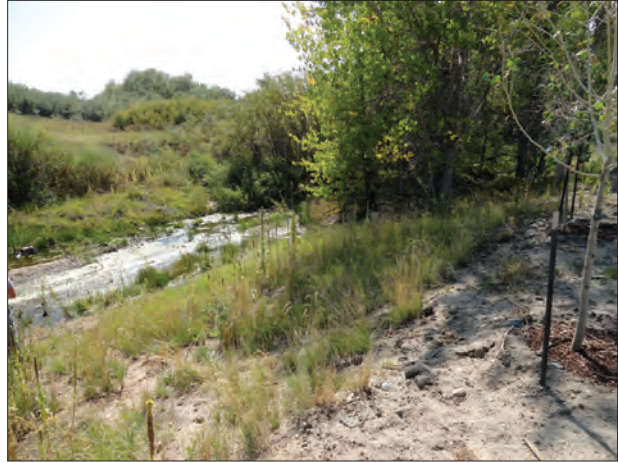
Photo 10b - View to the east of planted trees and wetland vegetation establishing in the channel at the downstream end of Upper Reach C.

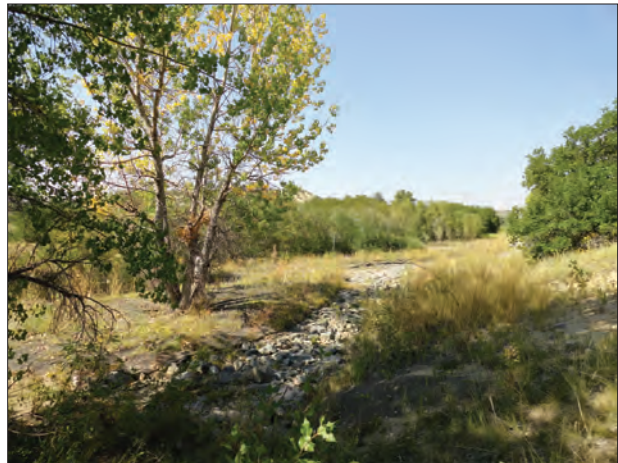
Photo 11b - View to the north of channel lining and vegetation along the channel banks at the upstream end of Reach C-lining.

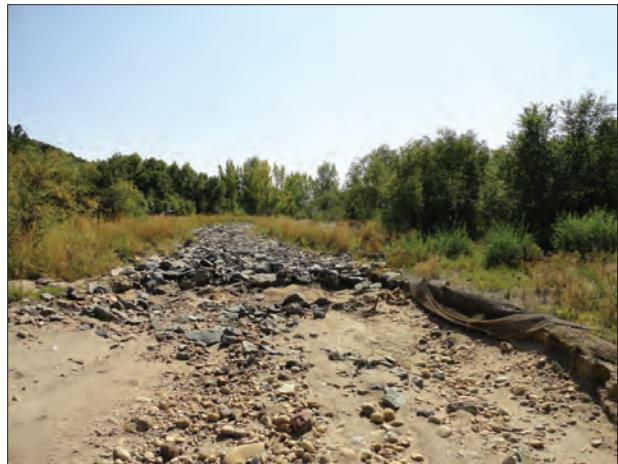
Evidence of high flows, including displaced void-filled rock and scour holes, were observed in Reach C-lining during the 2012 site visit. Prior to construction, no wetlands occurred in this reach; however, small pockets of wetland vegetation were observed during the 2012 site visit. The dominant species observed in the establishing wetlands was Baltic rush, redtop, and sandbar willow. During the 2012 site visit, sandbar willow clumps and black locust shrubs were resprouting in areas temporarily impacted during construction.

Photo 12b - View to the south of channel lining and displaced riprap at the downstream end of Reach C-lining.

Recommendations: ERO recommends planting additional sandbar willows and native trees to replace the ones impacted during the July 2012 storm event and to meet permit requirements, and repairing the channel banks within Reaches C, E, and I. ERO also recommends conducting weed control within the disturbed uplands to prevent the spread of noxious weeds. No other remedial measures are recommended at this time. The site will be monitored during the 2013 growing season.

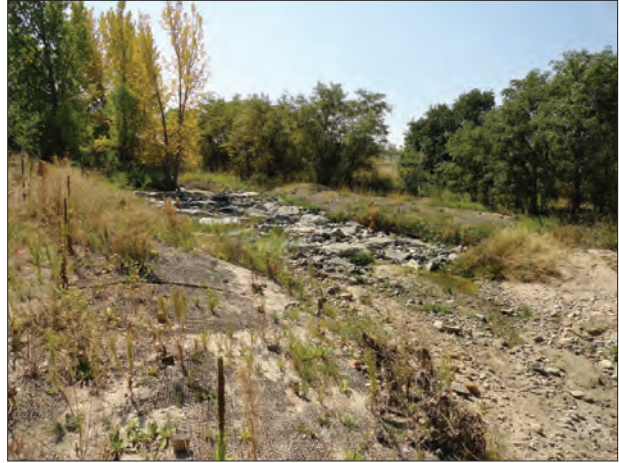
Photo 13b - View to the southwest of drop structure within the middle portion of Reach E.

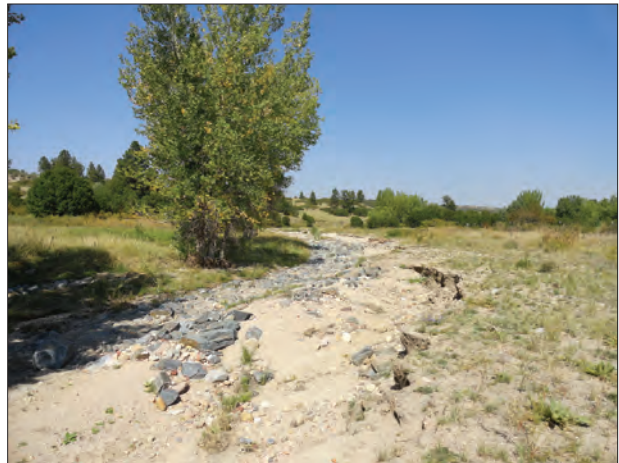
One riprap run down, two boulder cascade drop structures, and a section with void-filled rock channel lining were installed within Reach E (Figure 2d; Photos 13a through 15b). During the 2012 site visit, extensive bank and channel erosion was observed within Reach E and most of the planted sandbar willow stakes and coir blanket was either buried with sediment or washed away. Despite the damage caused by the storm event, wetlands were observed within the boulder cascade drop structures, in the channel bottom between the two structures, and in a 1- to 2-foot-wide fringe along the western bank of the void-filled rock channel lining section. The wetlands are approximately 55 percent vegetated and dominated by species similar to what was present prior to construction (Baltic rush, water speedwell, Torrey's rush, and redtop). Because of bank erosion, the uplands were only about 30 percent vegetated and were comprised mostly of sweet clover, common mullein, Canada thistle, and musk thistle.

Photo 14b - View to the northwest of bank erosion and displaced riprap within the middle portion of Reach E.

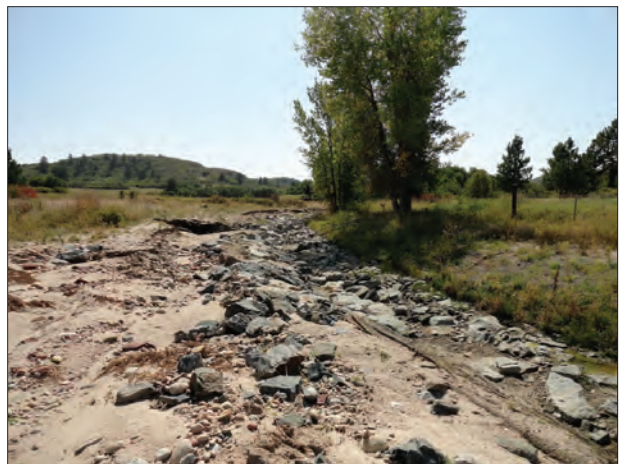
Photo 15b - View to the south of bank erosion and displaced riprap within the downstream portion of Reach E.

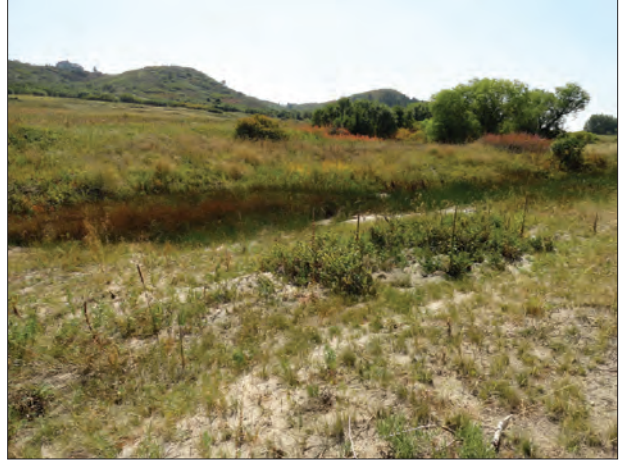
Photo 16b - View to the south of restored wetlands downstream of the rundown within Reach F.

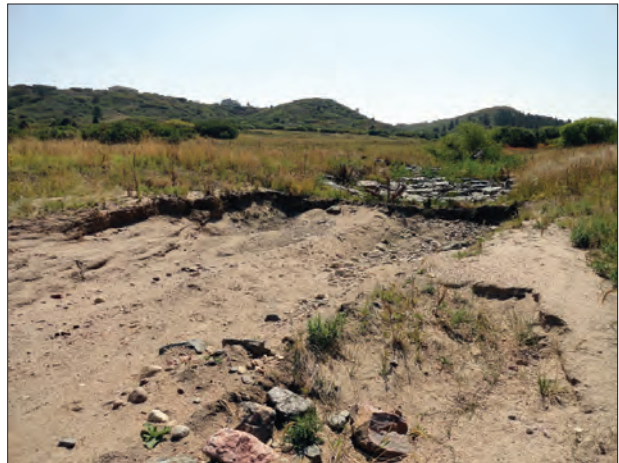
Photo 17b - View to the south of bank erosion and displaced riprap downstream of the drop structure at Reach F.

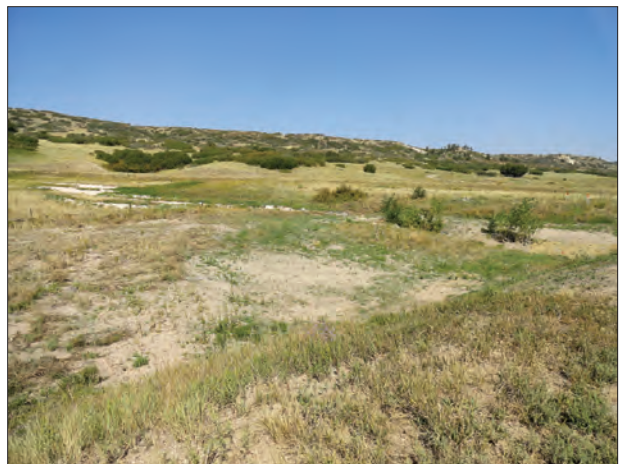
Improvements at Reach G included installing a riprap rundown upstream of the Castle Oaks Road bridge crossing (Figure 2f; Photos 18a and 18b). During the 2012 site visit, some minor channel erosion was observed in the project area due to the July 2012 storm event. No wetlands occurred in this reach prior to construction. The upland vegetation was dominated by similar species as the adjacent undisturbed areas including annual ragweed (*Ambrosia artemisiifolia*), sand dropseed (*Sporobolus cryptandrus*), sideoats grama, blue grama, Canada wildrye, switchgrass, and common sunflower (*Helianthus annuus*). The total cover was between 50 and 70 percent. Diffuse knapweed and musk

Photo 18b - View to the north of minor erosion and upland vegetation establishing in the channel at Reach G.

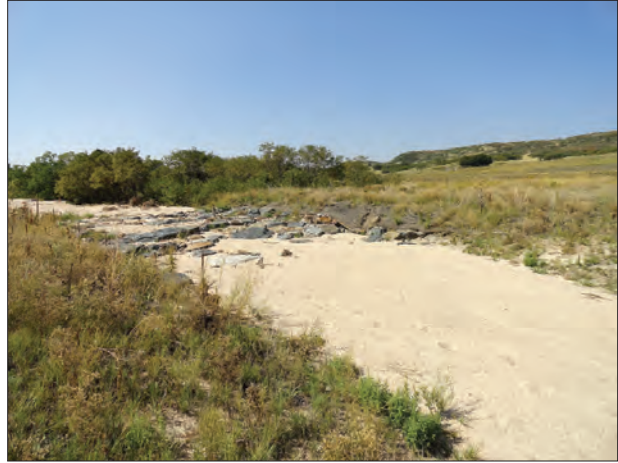
One boulder cascade drop structure was installed within Reach H (Figure 2g; Photos 19a and 19b). During the 2012 site visit, some minor channel erosion was observed downstream of the drop structure due to the July 2012 storm event. No wetlands occurred in this reach prior to construction. The uplands surrounding the drop structure were 60 percent vegetated with species similar to the adjacent undisturbed uplands. The dominant species included annual ragweed, sand dropseed, sideoats grama, blue grama, Canada wildrye, and switchgrass. Diffuse knapweed (List B) made up about 20 percent of the upland vegetative cover in Reach H. During the 2012 site visit, all of the black locust shrubs temporarily impacted during construction were resprouting in the project area.

Photo 19b - View to the southeast of vegetation establishing in the uplands and sediment deposition within the drop structure and channel bottom at Reach H.

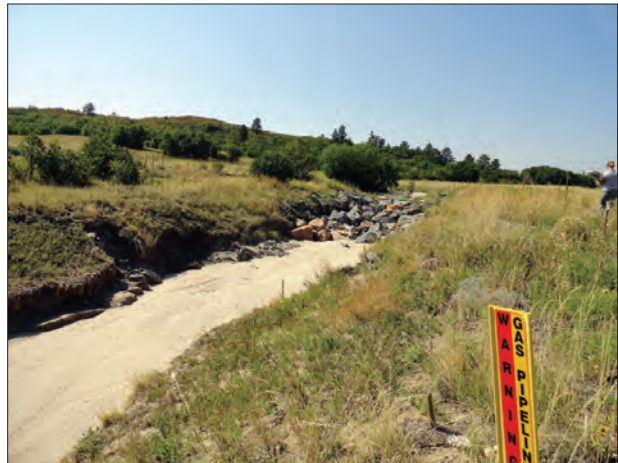
One boulder cascade drop structure was installed within Reach I (Figure 2h; Photos 20a and 20b). During the 2012 site visit, evidence of high flows from the large storm event in July 2012 were observed, including minor bank erosion downstream of the drop structure and displaced boulders within the drop structure. No wetlands occurred in this reach prior to construction and the vegetation reestablishing in the project area was similar to the preconstruction conditions. The upland vegetation cover was about 70 percent and was dominated by wild tarragon (*Oligosporus dracunculus*), common mullein, annual ragweed, and smooth brome. Diffuse knapweed, a List B species, was also observed in the disturbed uplands and made up about 10 percent of the total vegetation cover.

Photo 20b - View to the southeast of bank erosion and displaced boulders downstream of the drop structure at Reach I.
