Cherry Creek at 12-Mile Park – Phase 1

Performance after June 6, 2012 Storm Event

PREPARED BY: CH2M HILL

DATE: June 12, 2012

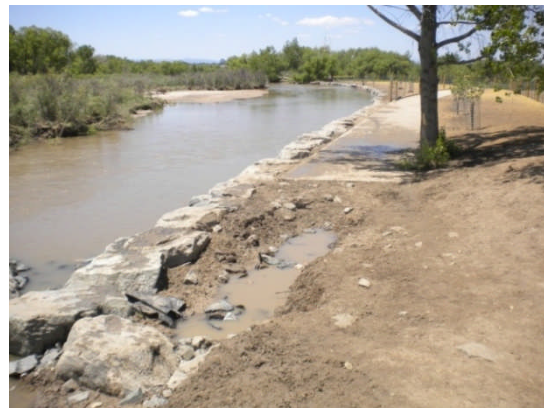
A scour hole developed immediately upstream of the sidewalk constructed as part of Phase 1. This scour hole is shown in the image to the right. The scour hole developed in the transition location between the Phase 1 construction and the Phase 2 construction (construction anticipated late fall to winter 2012) where no soil riprap or other protection was placed. The jetty, boulder wall, and concrete sidewalk were not damaged during the storm event.

Fill the scour hole with native material [WPR1]. This area will be hardened as part of the Phase 2 construction (likely a continuation of the concrete sidewalk). If there is another large storm event prior to hardening during Phase 2 construction it is possible that the scour hole will redevelop.

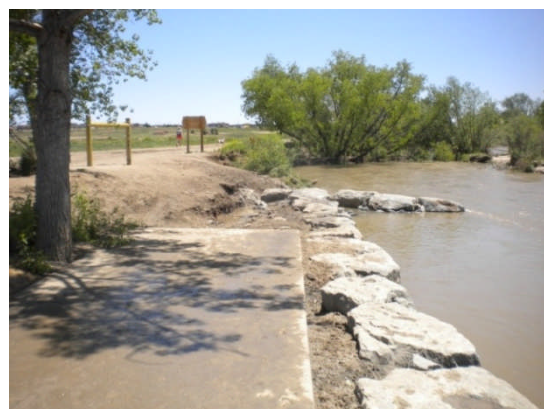
Adjacent to the concrete sidewalk, some of the crusher fines material was washed away during the storm event. This can be seen in the images to the right. The boulder wall and concrete sidewalk were not damaged when the crusher fines material washed away.

At this time, do not replace the crusher fines. The crusher fines or other material can be replaced as part of the Phase 2 construction.

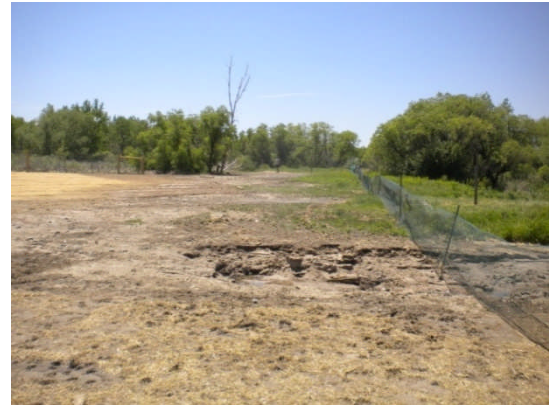
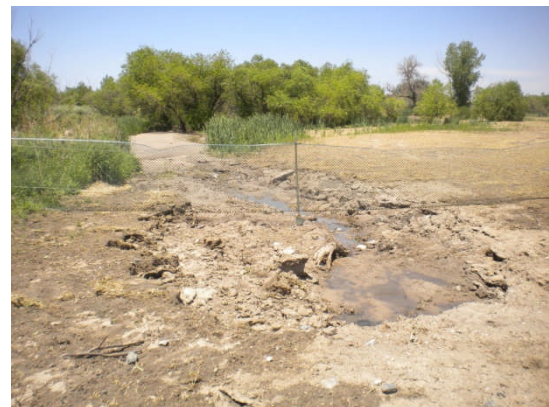
Erosion was observed along the breakout flow path where the Phase 1 construction grading tied into existing grade. The erosion is shown in the images to the right. It appears the water in Cherry Creek overtopped the north bank downstream of the limits of the Phase 1 construction flowing back towards the breakout flow path. The sediment from this erosion was deposited along the breakout flow path with some of the sediment reaching the upstream most portion of the open water restoration area.

The eroded area at the interface where the Phase 1 construction grading tied into the existing grade of the breakout flow path should be repaired to prevent [WPR2] further erosion and deposition of sediment in the open water restoration area. CH2M HILL recommends repairing this area as part of the construction for Phase 2.

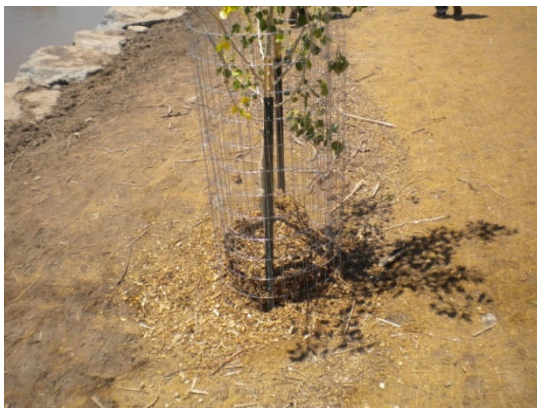
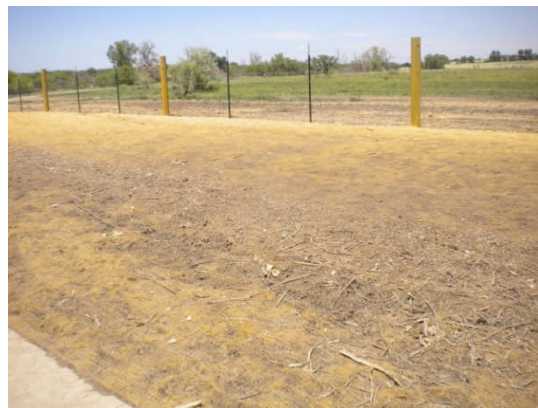
A high flow debris line was visible throughout the length of the Phase 1 construction area. The images below show the debris line. The debris line was surveyed on June 8, 2012 for both the Phase 1 and Phase 2 areas and will be used to determine the peak flows in Cherry Creek at the project area as a result of the storm.
