## Existing Conditions – Cherry Creek and Piney Creek

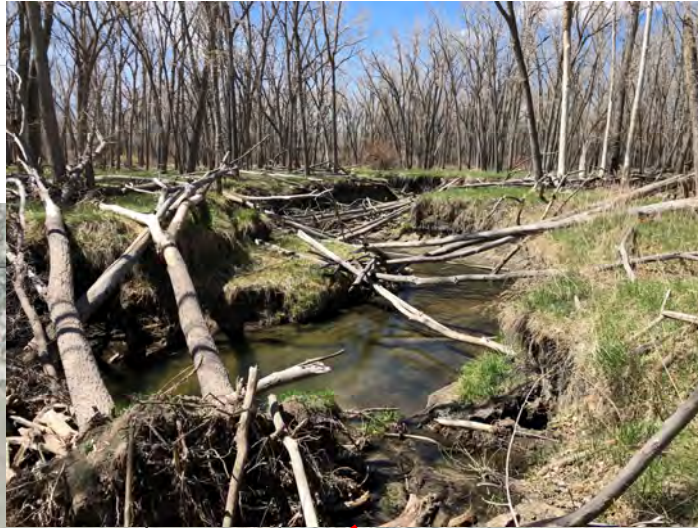
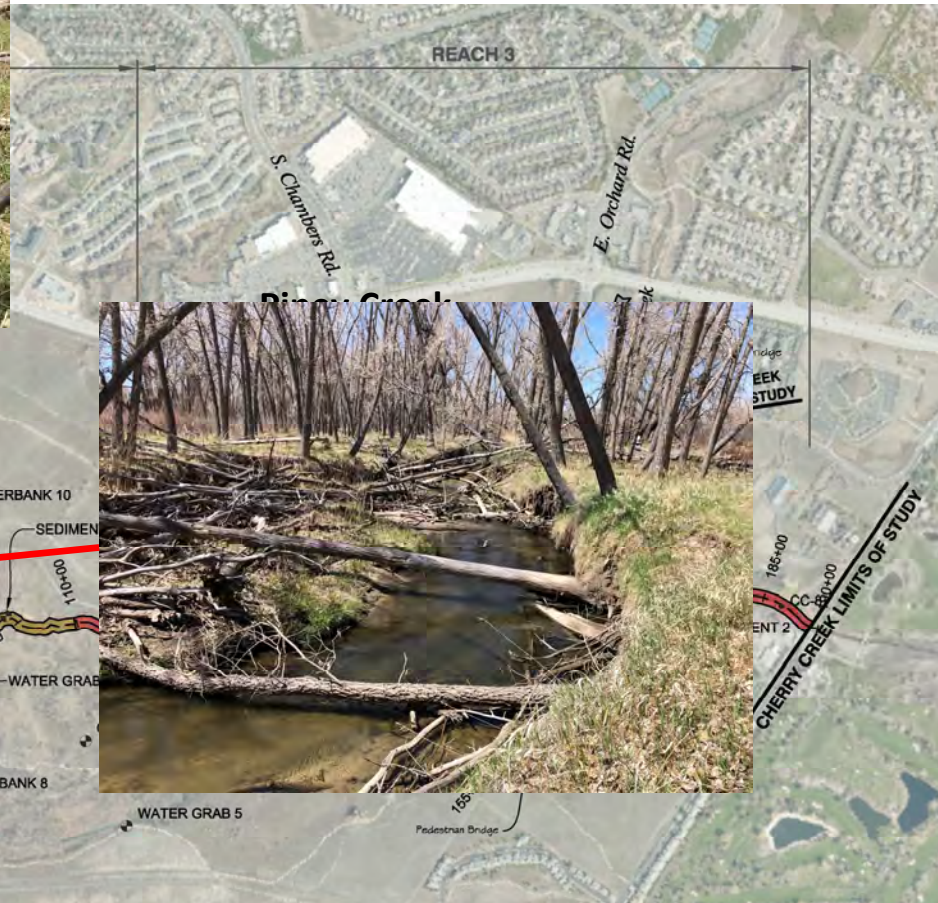
**CC-10 Flow Gage**

**182** Fallen trees in the channel  
**292** Live trees at risk within 5 feet of the channel

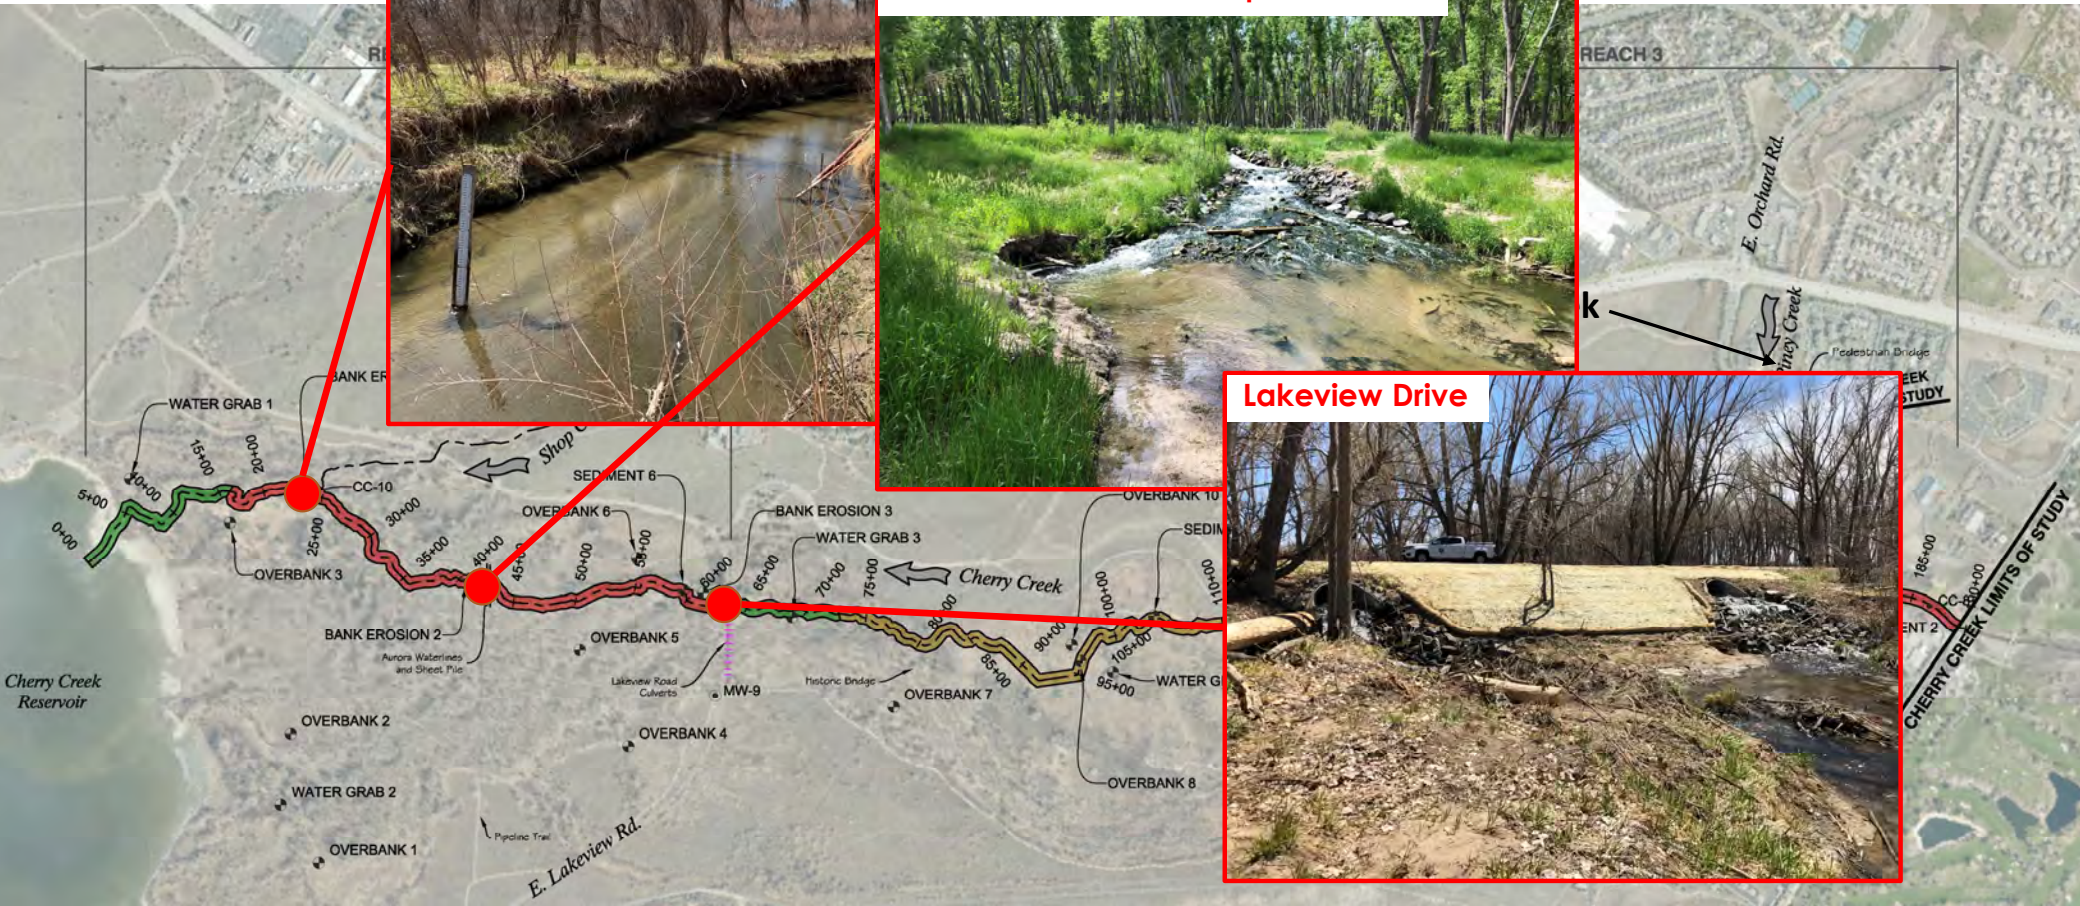
**Channel Degradation**

- Undermining of Pipeline Trail and Lakeview Drive
- Loss of PRF Function of Reach 2
- Increase of Sediment and Phosphorus to the Reservoir

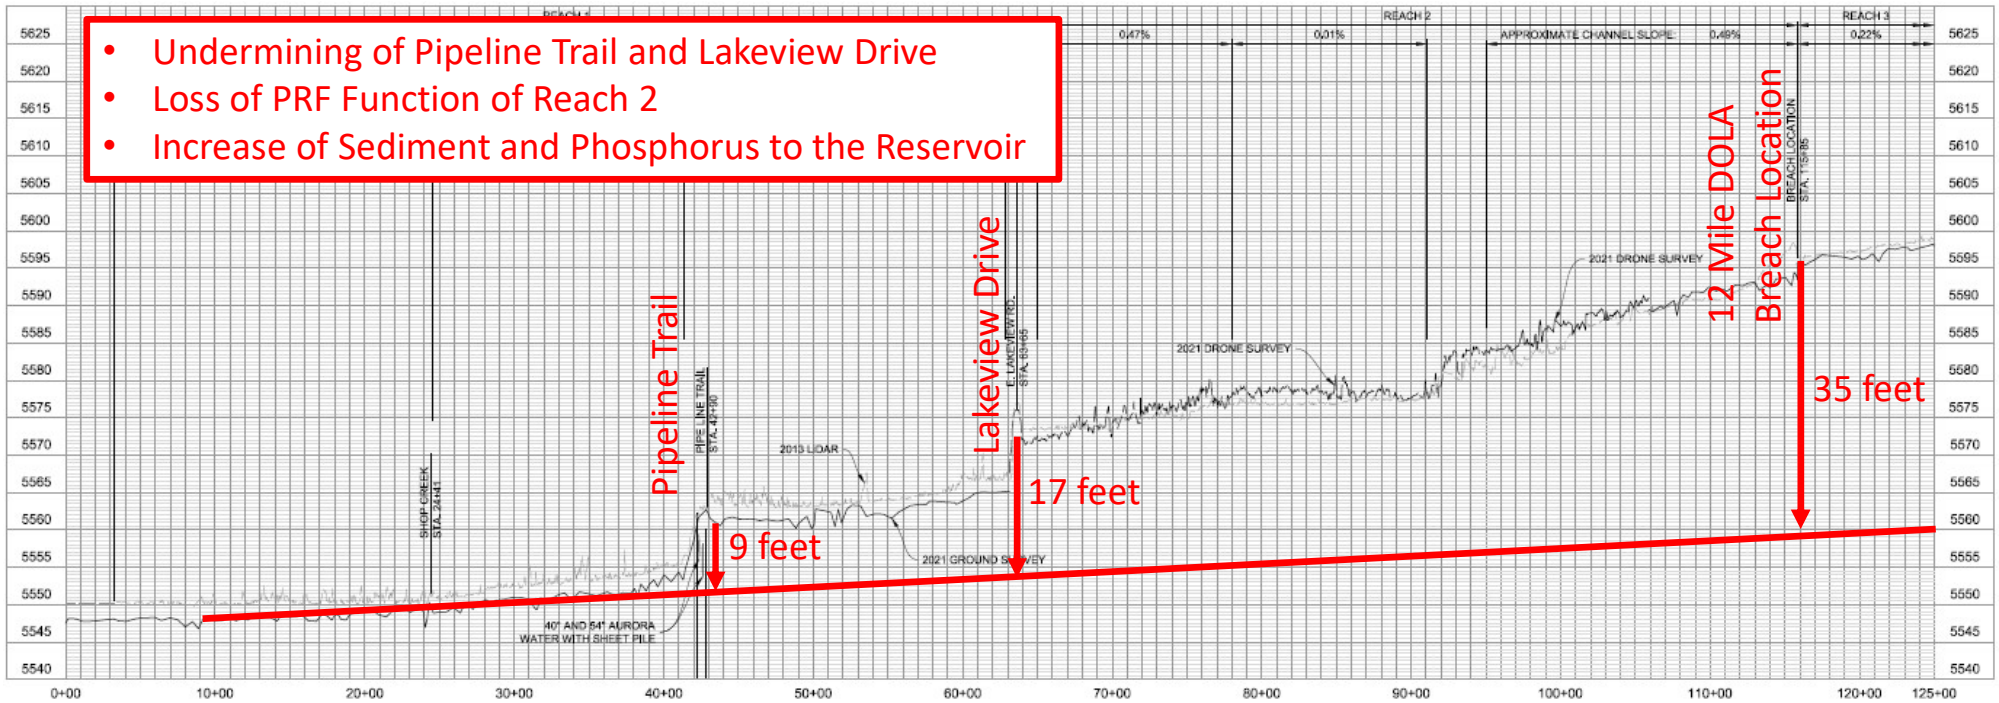
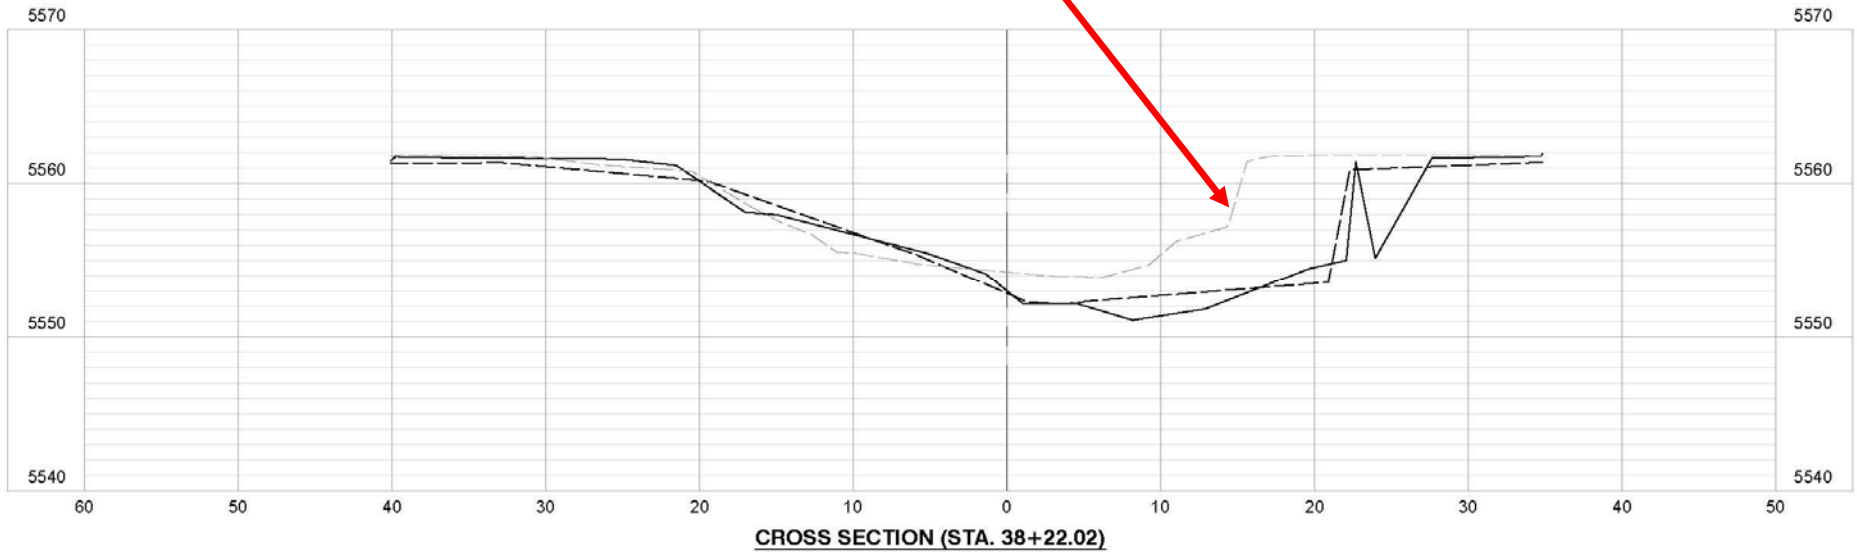
Reach 1 Monitoring Cross Section: Downstream of Pipeline Trail

**History of Widening:**

- Roughly 8' lateral migration since 2013

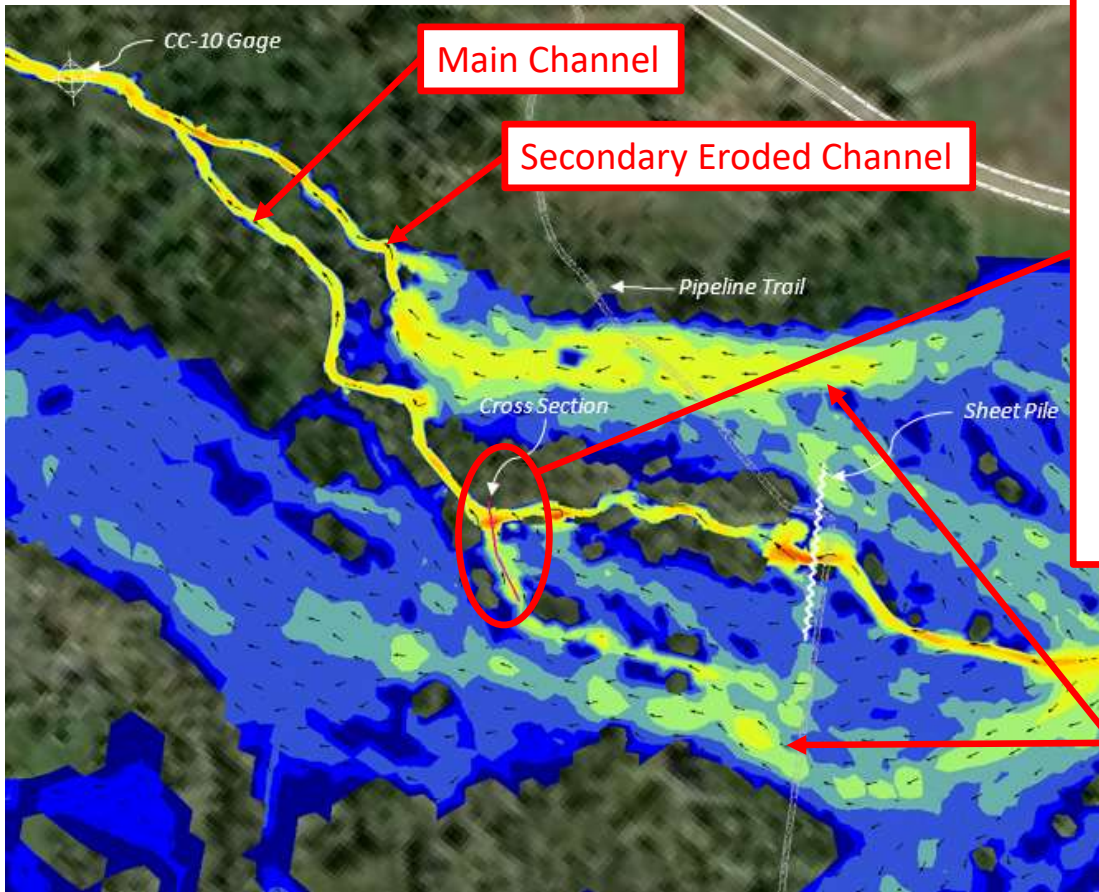
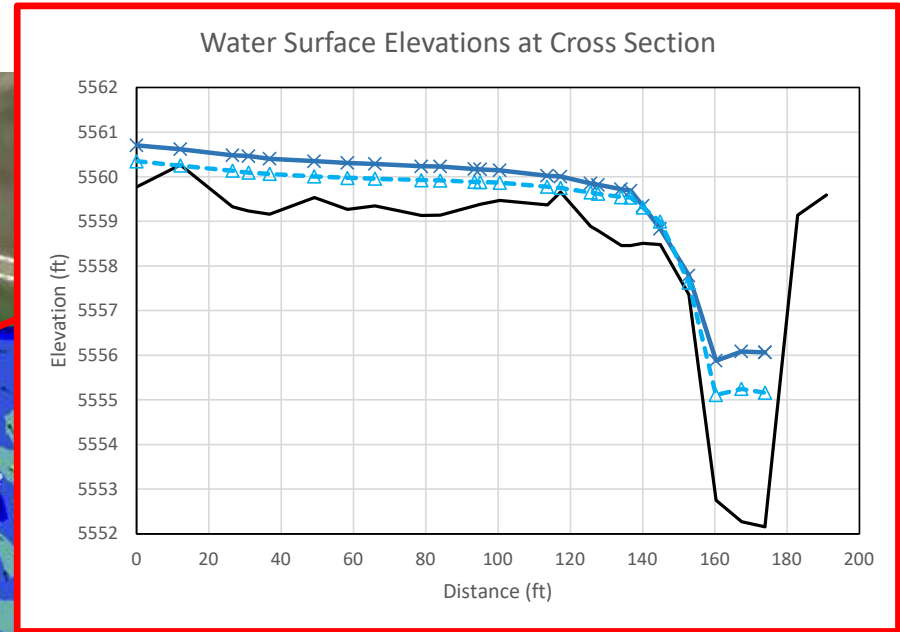
**Pipeline Trail and Aurora Water Lines:**

- Waterfalls occur where flood flows re-enter channel.
- Erosive velocities at re-entry points will lead to secondary channels that can travel outside of existing countermeasures.

- **Preserve PRF Function of Reach 2**
- **Reduce Risk of Degradation in Reach 2**
