**CHERRY CREEK RESERVOIR  
DESTRATIFICATION SYSTEM**

**OPERATION AND MAINTENANCE  
ANNUAL REPORT  
2025**

January 2026

# CHERRY CREEK BASIN WATER QUALITY AUTHORITY RESERVOIR DESTRATIFICATION SYSTEM OPERATION AND MAINTENANCE ANNUAL REPORT 2025

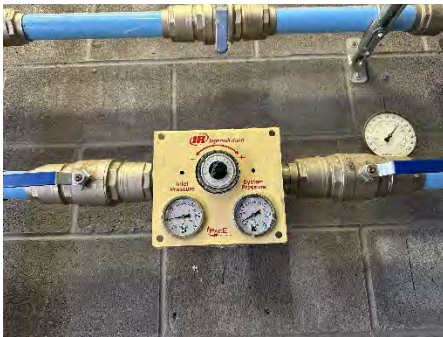
**Pressure ramping up to 40 psi**

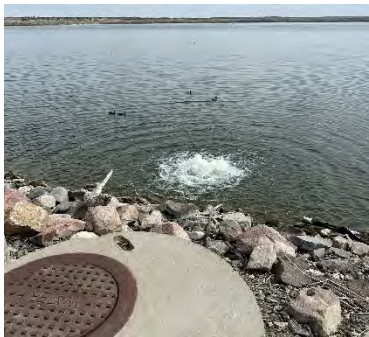
The mainline leak repair was located about 50 feet from the distribution manholes and was likely caused by chafing and wave action against the riprap on the face of the dam.

- I walked to the distribution manholes to check for correct pressures and any indications of any leaks out in the system.
- I did find a leak in the mainline about 50 feet from the distribution manholes.

**Leak detected near distribution manholes**

- Called Justin Foster to get him to come out and fix the leak.
- All pressures were normal at the compressor building and at the manholes.
- I toured the aerator field by boat with Erin Stewart and her companion to check for any broken aerators.

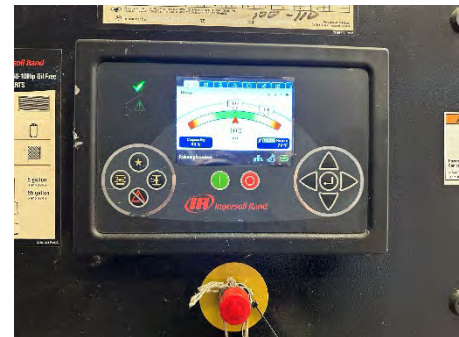
**Compressor running at normal operating pressure**

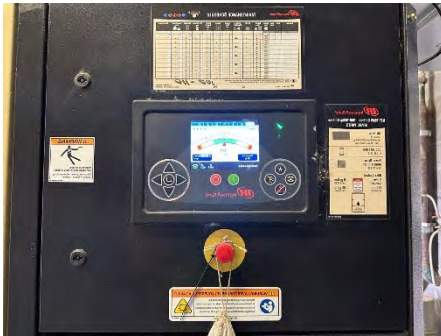
Compressor running normally at 100 psi

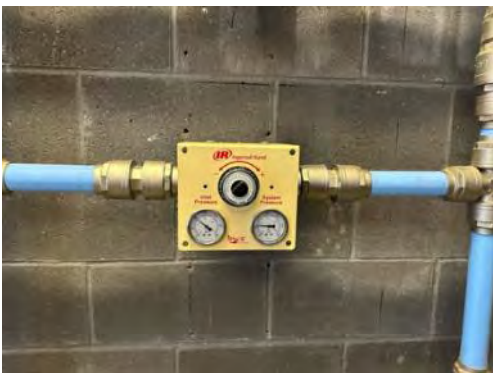
Compressor restarted and running at 55 psi

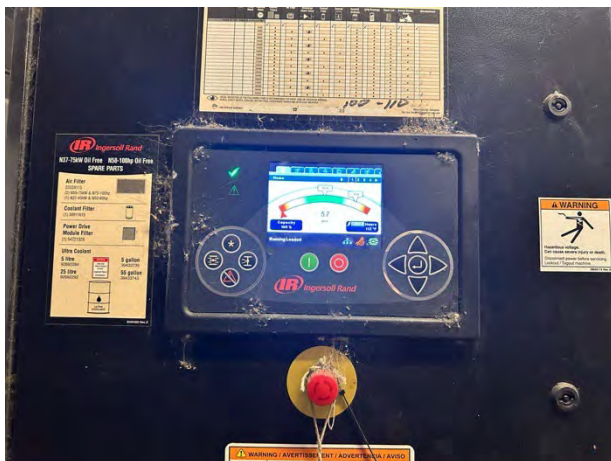
July 22-23- I was notified by Michelle Seubert that there were some aerators that were "virtual geysers", indicating a serious break. On checking the compressor status on-line, I noticed that the compressor was running at only at 57 psi, 57% of normal 100 psi, so I contacted Jeff Handley. He directed me to increase the back pressure on the system, which I did on-site, thereby reducing air flow until the pressure was at least 75 psi, 75% of normal. He said that running anything less than 75 psi would not be good for the compressor. Foster Dirt was notified and the aeration heads were fixed the next day, after which I had Justin Foster readjust the compressor back up to the normal 100 psi.

Compressor showing only 57 psi

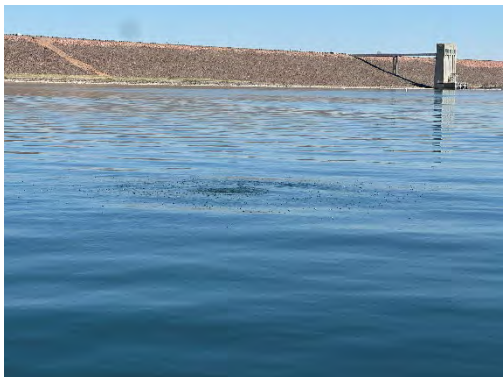
Normal aerator plume

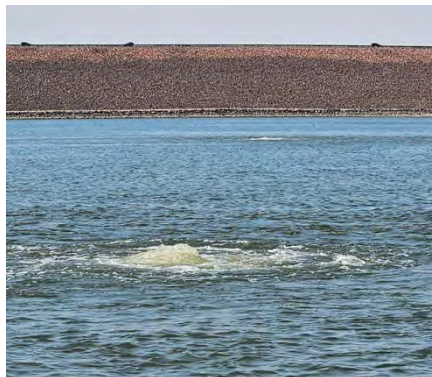
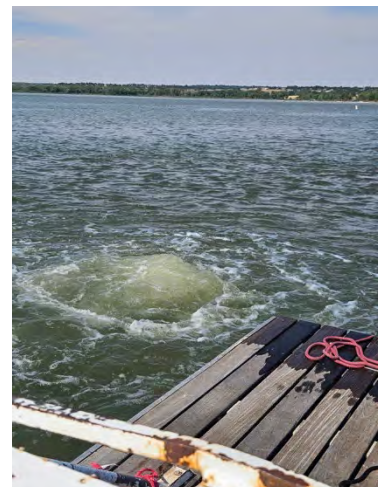
The 7 aeration head repairs needed were a result of ruptured short rubber aerator connection hoses. All but one of the ruptures occurred in the eastern more shallow areas of the reservoir, where a lot of boating occurs. It's likely that the violent, oscillating currents from boat wakes, especially wake-boarding boats, exacerbated by the abnormally low reservoir water levels in the 2025 summer, over-worked those connections resulting in failure and rupture. With low water levels expected again in 2026, a connection hose replacement program is recommended.

Examples of broken aerator heads

August 5-7- Notified by Erin of three broken aerator heads on August 5. Foster dirt repaired them the next day.

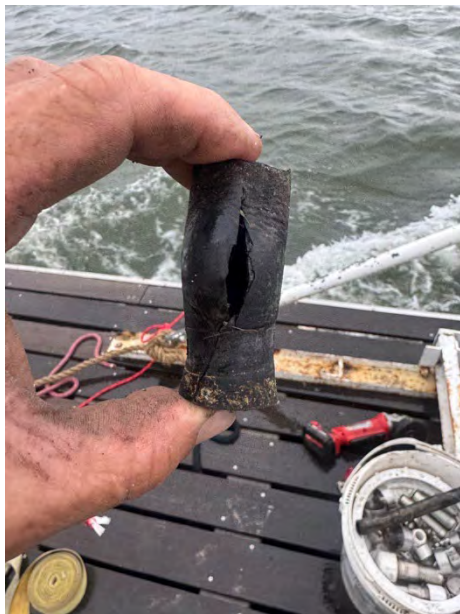
- Generally, lake bottom chemistry may be significantly different across the lake. Rubber components seem to deteriorate more rapidly in the 1000 feet near the dam, where a black, soft muddy bottom exists. Stainless steel parts deteriorate more in the cleaner bottom areas on the south and west portions of the basin.
- The heads and their stainless steel components generally showed about the same amount of corrosion as last year's inspection. Few pins and cams were replaced compared to many previous years.
- Hoses generally showed more deterioration than the past few years, especially the softer nylon reinforced riser hoses. A number of those showing fatigue or failure were replaced. In fact, all of the aerator heads that were repaired this year were due to ruptured rubber riser hoses.

An example of a ruptured aerator hose

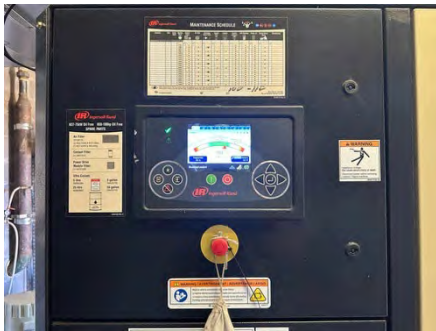
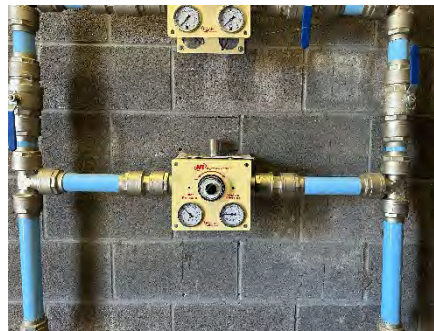
Photos showing compressor and system operating normally upon arrival on October 18, 2025

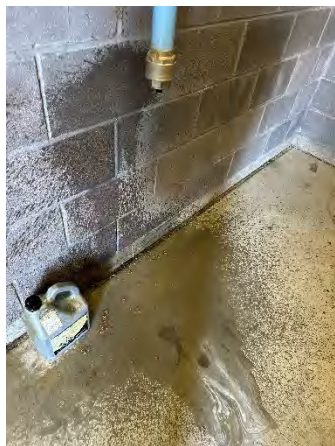
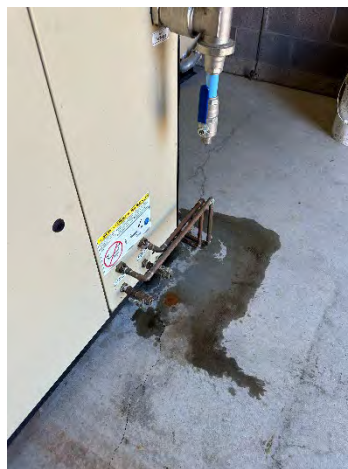
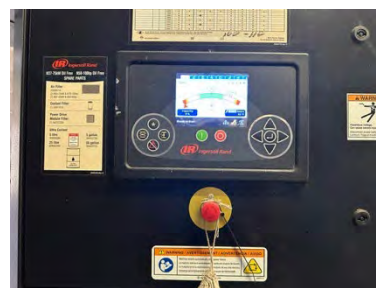
Photos showing accumulated water blown off and the compressor at "off" status

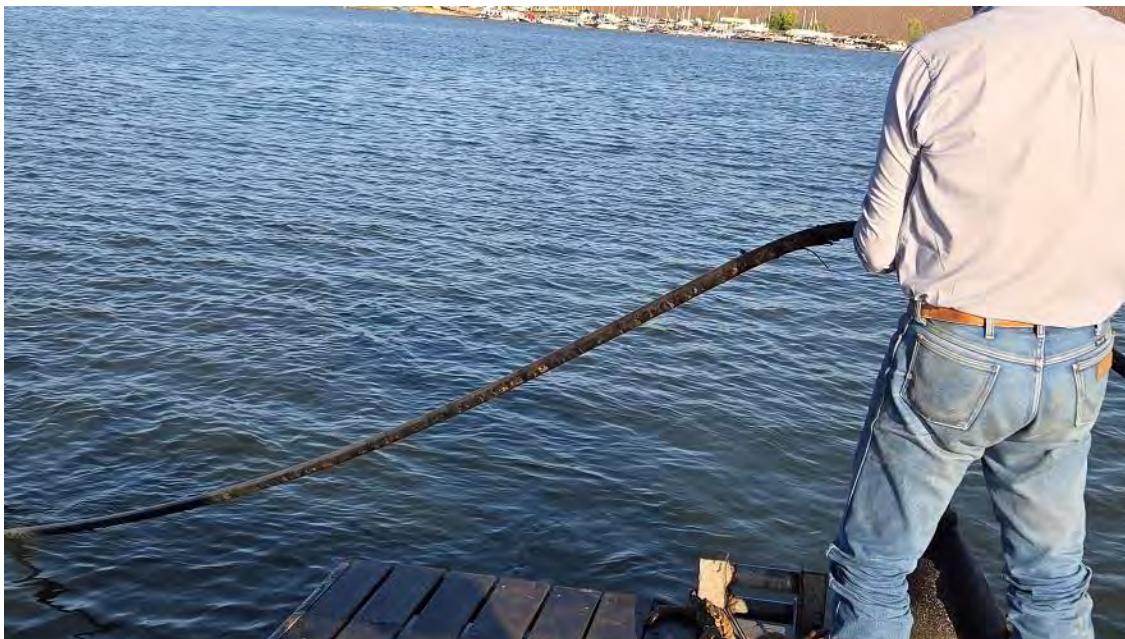
- This is mostly repetition of last year's report. Damage to the hydraulic lines that make up the aeration system is becoming apparent due to fatigue and aging of the system. This is becoming more and more evident. One area in particular, immediately west of head 105 was apparently raked by a boat anchor in a generally western direction, causing tears to the outer layer of rubber hose and rusting of the outer layer of steel reinforcement. The damaged area was about 45+ feet in length and 1 inch diameter.

- I suggest replacing this area of line prior to start up next year. It is also recommended to have about 200 feet of 1" diameter and 300 feet of 1 ¼" diameter hose available for general repairs next year..

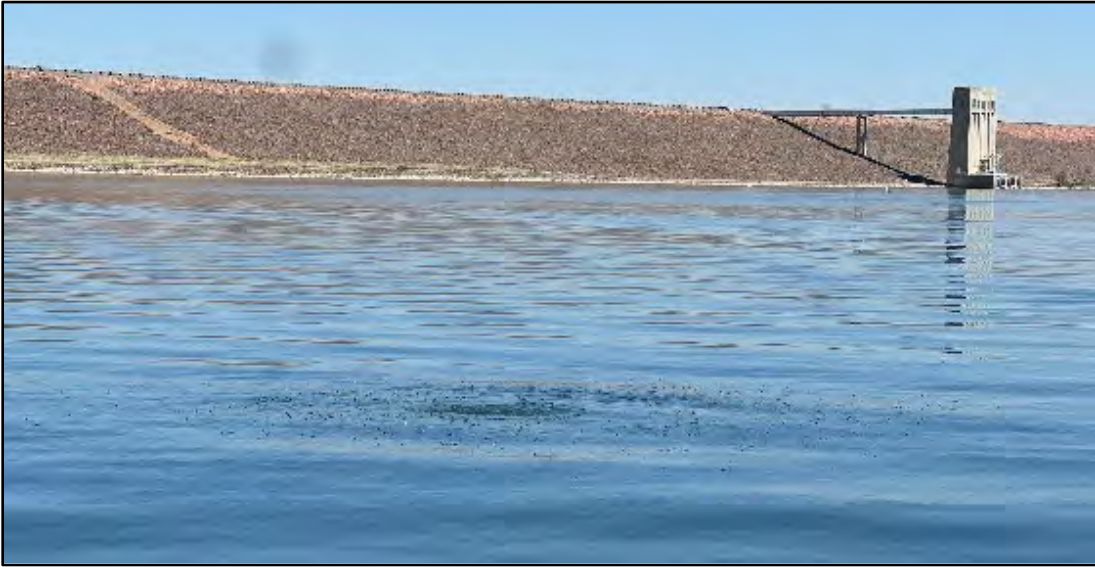
*Normal aeration plume appearing as bubbles distributed on the water surface.*

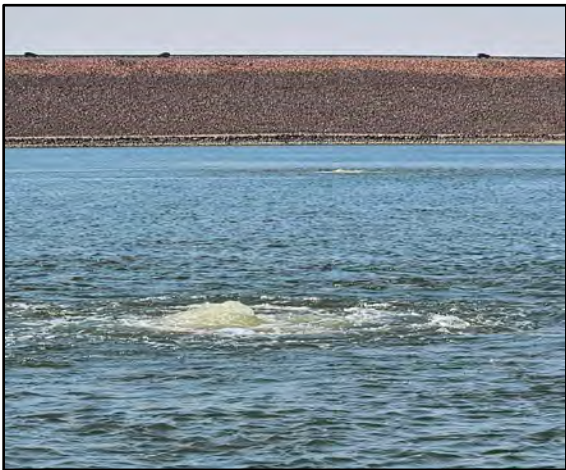
*Two broken aerator heads showing overly vigorous aeration plumes*

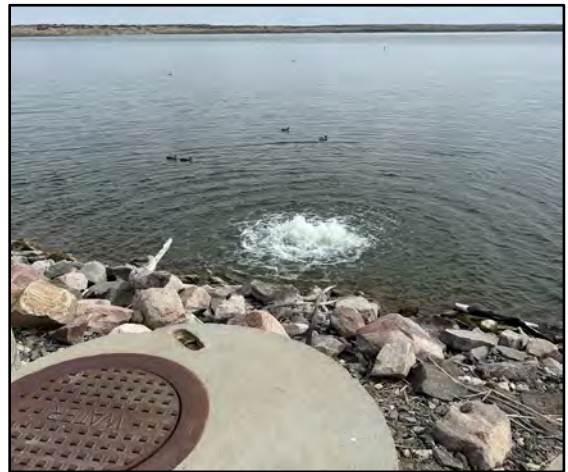
*Broken main air distribution line near the distribution manifold*
