**CHERRY CREEK RESERVOIR
DESTRATIFICATION SYSTEM**

**OPERATIONS AND MAINTENANCE
ANNUAL REPORT
2024**

**Prepared by:
Ricardo Goncalves, PE
January 2025**

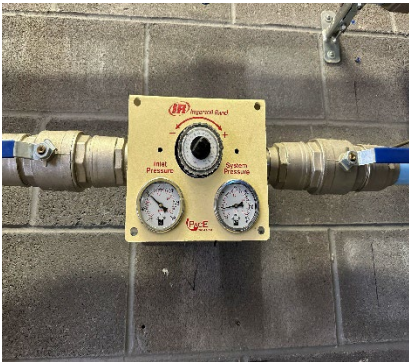
Starting pressure at 45 psi

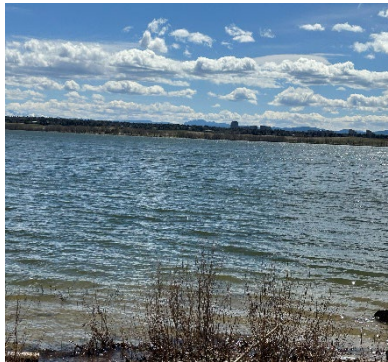
Normal aeration plumes

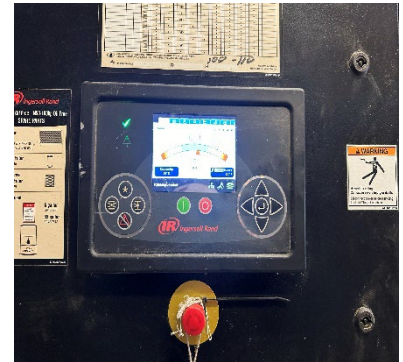
Normal compressor operating pressure

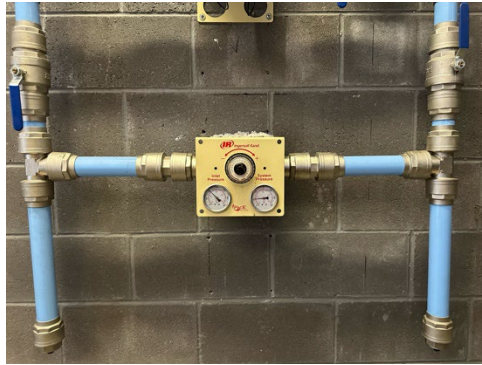
Final pressure at 55 psi

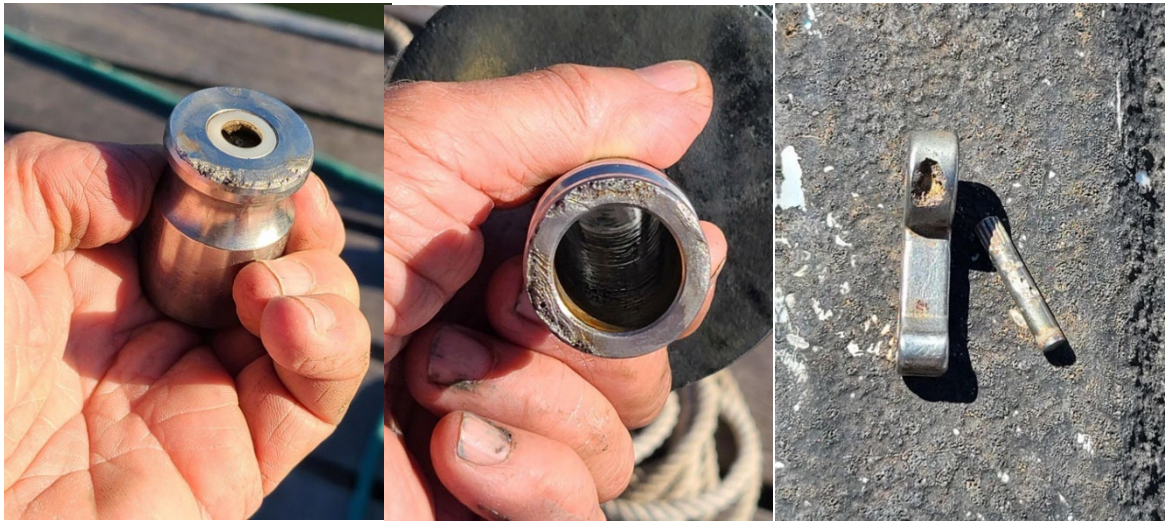
- The yearly inspection and maintenance of the aeration system was done and completed on September 17, 2024, by Foster, Dirt and Construction. Its full inspection report is contained in the Appendix of this report.
- Cleaning, disassembly, inspection and reassembly of all 115 aerator heads was done
- In general,
 - The heads in zones 2-5 showed less corrosion than any year, since the system was installed
 - Zone 1 required about the same or slightly more repairs to the system
 - Corrosion, probably due to electrolysis, is continuing to be noticeable in machined stainless-steel parts, a few to the point of requiring replacement to properly seal. (See photos below)

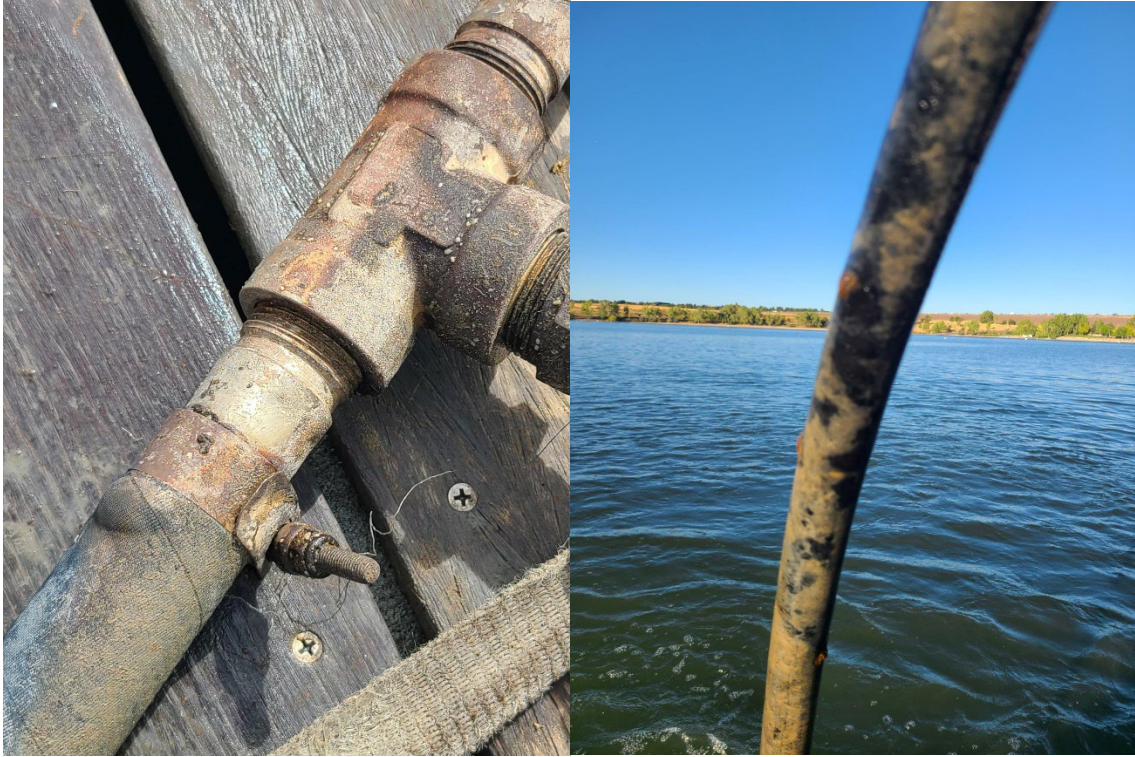
- Damage to the hydraulic lines that make up the aeration system is becoming apparent due to fatigue and aging of the system.
- One section of the hose, about 45 feet, has some boat anchor damage, with torn rubber and rusty steel reinforcing and should be replaced next year
- Hoses were showing some signs of aging, this being the first year of aging becoming evident, and we should be prepared to have spare hoses for replacements into the future.
- In general hoses have a useful life of about 20 years, depending on conditions and water quality.
- Consideration should be given to pulling up and inspecting the non-aeration head hose in the system within the next 5 years

| September 2024 repairs to Cherry Creek aereation system | | | | | | | | | | | | |
|---|---|---|---|---|---|---|---|---|---|--|---|--|
| 7 | 105 | x | clean | 0 | 1 | 0 | 0 | 0 | 38.374 | 51.877 | | Severe tears in outer hydraulic hose, likely by dragging boat anchor, 45 in ft +/- |

- It is recommended that the Authority replace 45 feet of air hose near aerator #105 in 2025.
- It is recommended that the Authority begin testing of the non-aeration head mainlines in 2026

- Parts required for continuing operation next year(s):
 - 25 cam pins
 - 50 cam levers
 - 20 plastic protective cones
 - 200 linear ft +/- hydraulic hose, each size 1" & 1 ¼", specs stamped on existing hose

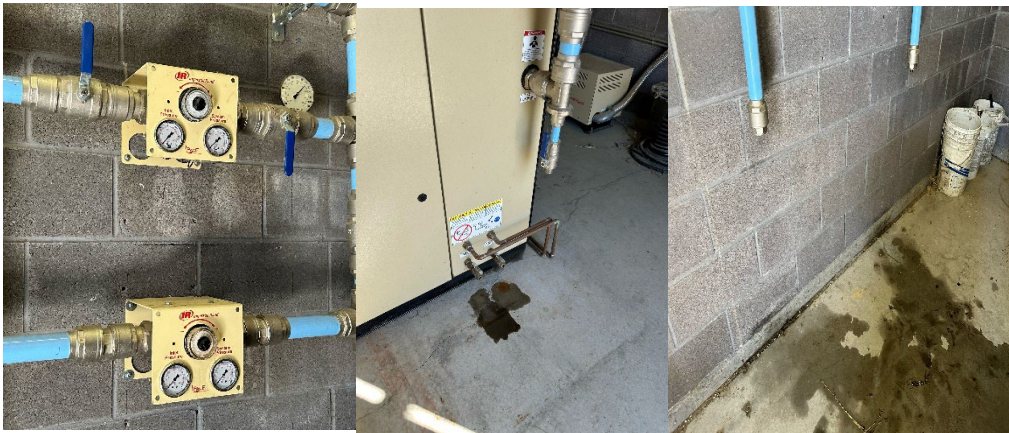
- It was noted that the lower air pressure regulating valve was malfunctioning, just prior to shutdown, and Jeff Handley indicated that IR would replace it at the February 2025 compressor maintenance trip.

There were no repairs to the system in 2024. In June, the compressor shut down for 24 hours due to an Xcel power problem, but there was no damage or repairs to the RDS system itself. At the system shutdown on October 3rd, it was determined that one of the Pressure Regulating Valves was malfunctioning, and Ingersoll Rand will be replacing it under warranty at no cost to the Authority in February 2025.

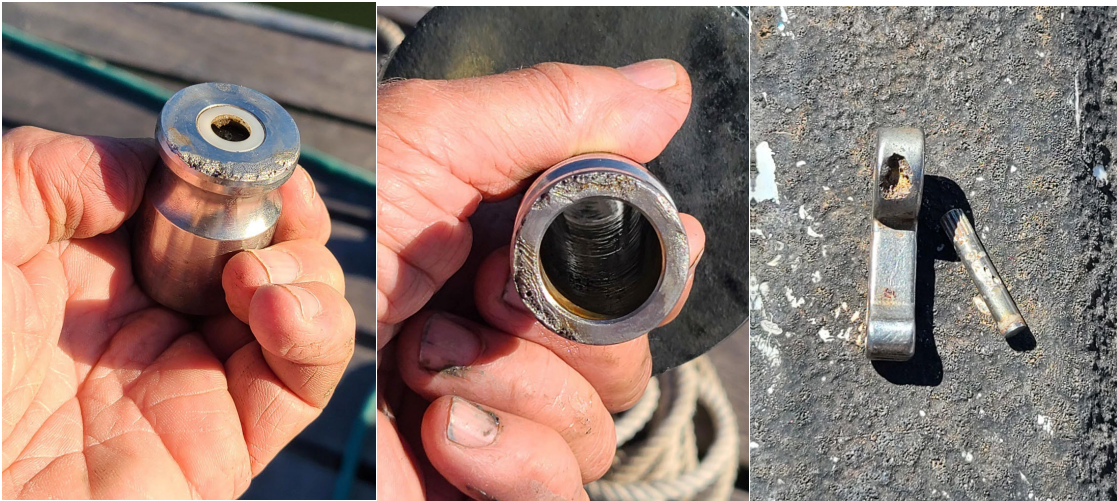
- The heads in zones 2-5 showed less corrosion than any year, since the system was installed
- Zone 1 required about the same or slightly more repairs to the system
- Corrosion, probably due to electrolysis, is continuing to be noticeable in machined stainless steel parts, a few to the point of requiring replacement to properly seal. (See photos below)

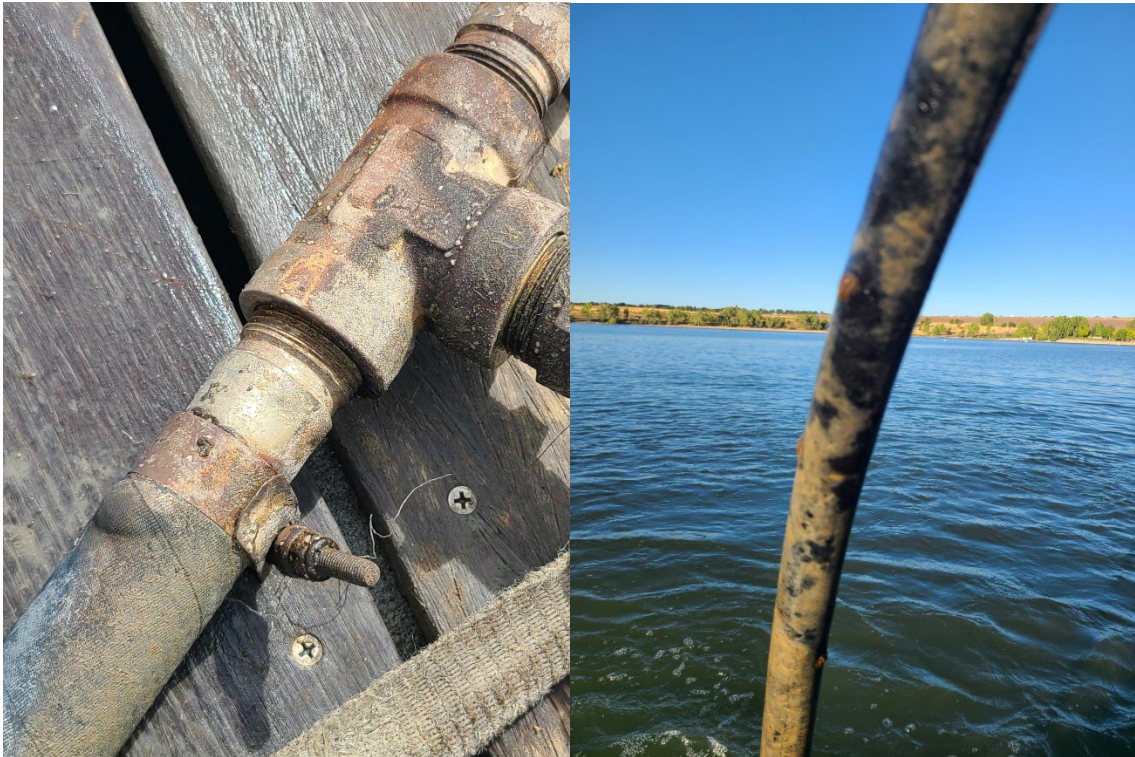
- Damage to the hydraulic lines that make up the aeration system is becoming apparent due to fatigue and aging of the system. One of the crew, Blair Wacha, has had extensive experience diving in Cherry Creek Reservoir and has done numerous repairs to hydraulic outlet gates throughout the state, says that hydraulic hoses used which are submerged in water, generally have a useful life of about 20 years, depending on conditions and water quality. Prior to failure, hoses will start to show bubbles, abrasions, or rust on the exterior of the hose. This is the first year for that to be evident. One area in particular, immediately west of head 105 was apparently raked by a boat anchor in a generally western direction, causing tears to the outer layer of rubber hose and rusting of the outer layer of steel reinforcement. The damaged area was about 45 feet in length. I suggest replacing this area of line prior to start up next year. It is also recommended to have about 200 feet of both 1" diameter and 1 ¼" diameter hose available for repairs next year. This size hose is likely not in stock in Denver, so time should be allowed to procure it. Our normal maintenance includes pulling the heads to the surface, gives the opportunity to view the hose condition in a very limited area. Consideration should be given to pulling up and inspecting all the hose condition in the entire system, which includes over 6 miles of hoses, within the next 5 years. These early signs of fatiguing, likely mean that boat anchor damage in the future is more likely, and failures more common in upcoming years.

Parts required for continuing operation next year(s):

- 25 cam pins, better off to get 200 to last for several years
- 50 cam levers
- Pin & cam samples left on shelves of compressor building for sizing
- 20 plastic protective cones
- 200 lin ft +/- hydraulic hose, each size 1" & 1 ¼", specs stamped on existing hose
