MOUNTAIN AND LAKE LOOP SHORELINE STABILIZATION

Cherry Creek Reservoir Shoreline Stabilization

Cherry Creek Basin Water Quality Authority

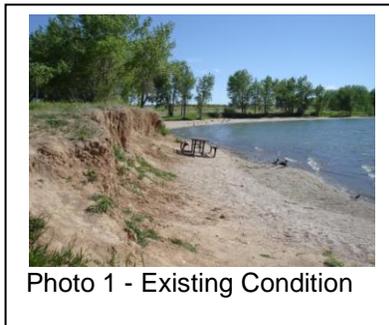
Photo 1 - Existing Condition

Wave action, wind, ice push and shoreline users have each contributed to erosion of the reservoir shoreline and major cut banks. This point along the shoreline is exposed to wind and wave actions during every season of the year. As the ice cover breaks up each spring, the north wind pushes ice to the south shore and in particular this point. Typical pre-project conditions are shown on Photos 1, 2 and 3.

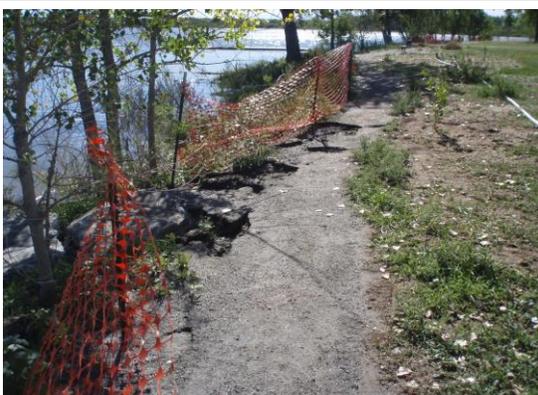
An on-site inspection followed on September 18th that found moderate erosion of the trails and graded areas above the upper limit for design (Elevation = 5552) based on the 2008 reservoir water level assessment findings . The boulders and armored structures were not impacted by the flood stage. Following that review, a restoration plan has been completed and construction is anticipated this fall / winter to restore the site to its post construction condition. Photos 8 and 9 show some of the typical damage from the storm.

Photo 8 - Trail Damage

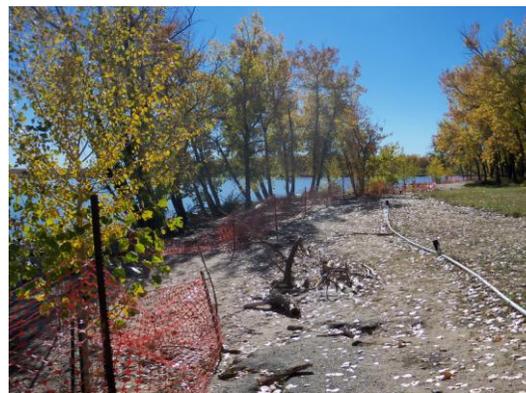
Photo 9 - Sand Deposition on Trail & Vegetation
