MEMORANDUM

JRS ENGINEERING CONSULTANT, LLC

TO: Chuck Reid, Manager - CCBWQA
CC: Rick Goncalves, Chairman, TAC
FROM: James R. "Jim" Swanson P.E.
DATE: December 27, 2013
SUBJECT: Effects of September 2013 Flood Event on PRF's in the Cherry Creek Basin

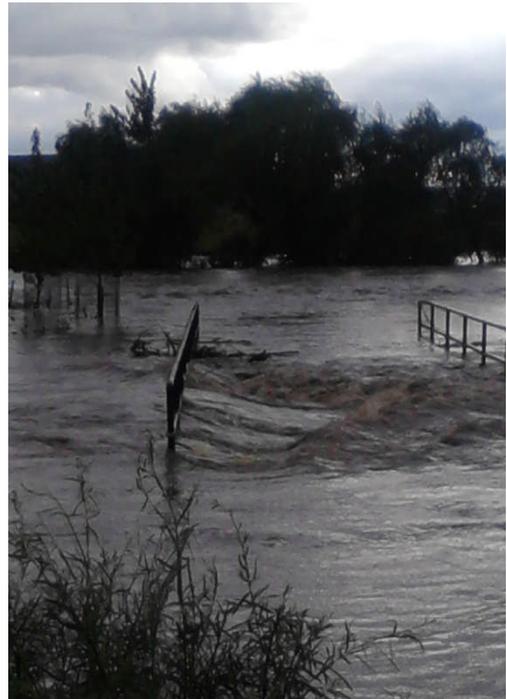
An on-site inspection of Eco Park captured the flooding in-progress at the pedestrian crossing near the downstream end of the project as shown in Photo 1. Photo 2 shows the post flooding condition of this crossing.

Photo 1 - Flooding @ Pedestrian Bridge

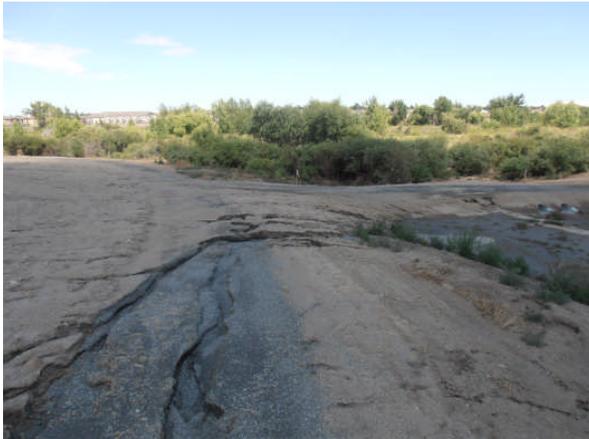
Photo 3 typifies the erosion damage to un-vegetated slopes and crusher fine trails. To date all eroded areas at Eco Park have been repaired. Seeding and mulching of all disturbed areas is complete.

Photo 3 - Typical Bank and Trail Erosion

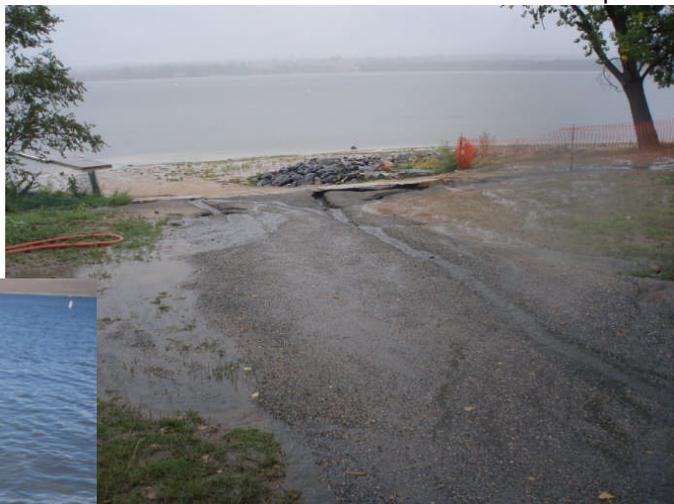
Photo 4 - Erosion from Local Rainfall

The Mountain / Lake Loop Shoreline Stabilization project sustained surface erosion on the graded side slopes where re-vegetation was not yet established and on the crusher fine trails. This type of damage was also observed on other facilities owned and operated by Parks.

The Authority has completed evaluation of all on-site erosion, prepared a restoration plan and negotiated a contract with the Mountain / Lake Loop Shoreline Stabilization project contractor to restore the site to its pre-flood condition. It is anticipated that the project will re-vegetate over the next few years and will then be armored for future high reservoir water events.

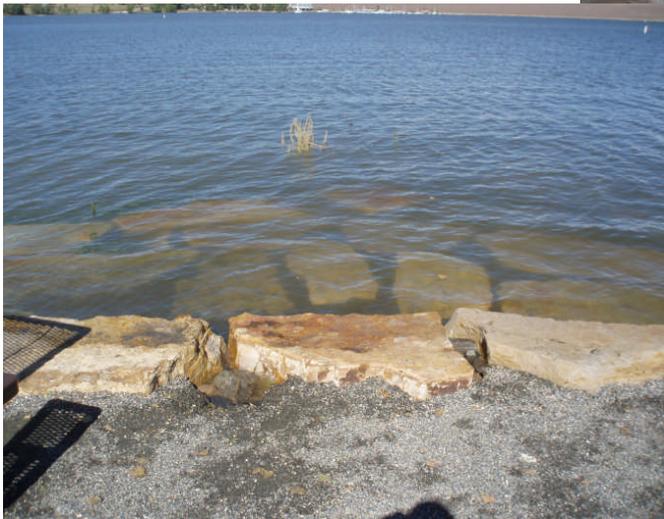
The day prior to the the September 14th storm event, the water surface elevation of Cherry Creek Reservoir was 3.6 feet below "recreation pool" (i.e.: Elevation 5550). The day after the storm event the water surface was almost seven feet higher, at an elevation of 3.2 feet above "recreation pool". Approximately one week prior to this storm event. Messrs Ruzzo and Swanson had performed the annual PRF inspection of the projects located within the Park. After the storm event, a follow-up inspection was performed.

Photo 5 - High Water at a Shoreline Structural Feature

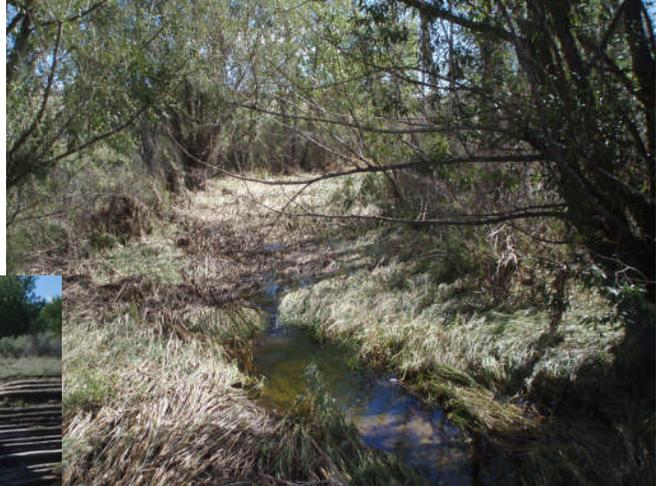
Shop Creek PRF includes five stilling basin ponds, each with a soil concrete rundown at the upper end of each basin and a reed filled creek channel. This PRF sustained virtually no damage. During the high flows the reeds within the channel laid over and allowed the flow to pass over the top, as shown in Photo 6. The Shop Creek basins, see Photo 7, provided energy dissipation for the storm flow.

Photo 6 - Shop Creek

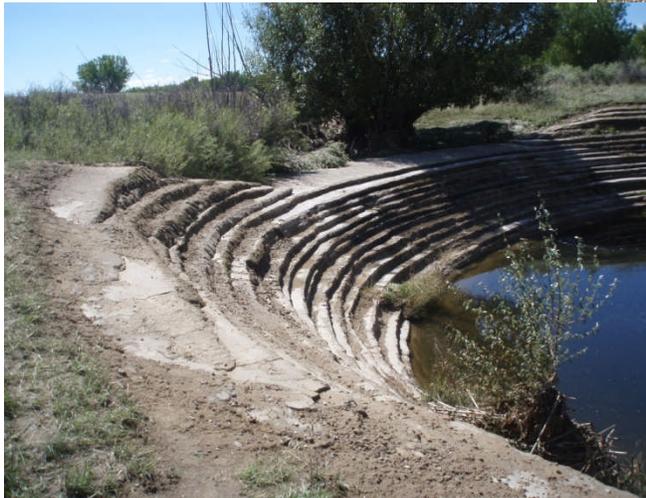
Photo 7 - Shop Creek Basin

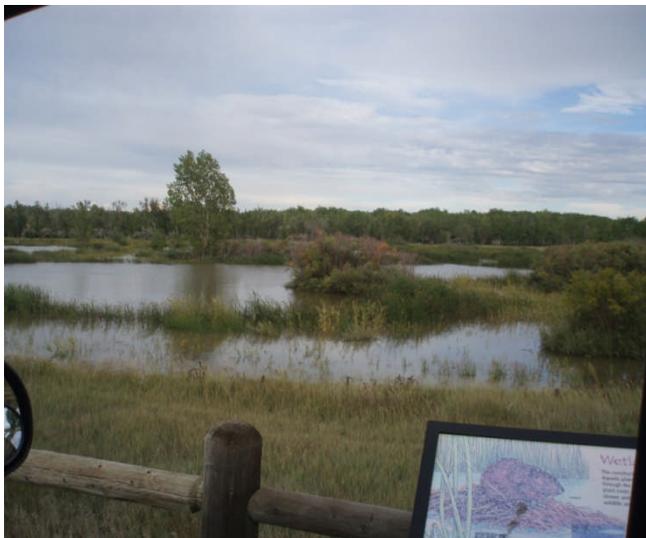
Cottonwood Creek / Wetlands performed as designed. No erosion was noted.

Photo 8 - Cottonwood Creek / Wetlands
