## CHERRY CREEK STREAM RECLAMATION AT PJCOS

# Memorandum

**Re:** Cherry Creek Stream Reclamation @ Parker Jordan Centennial Open Space – Project Report

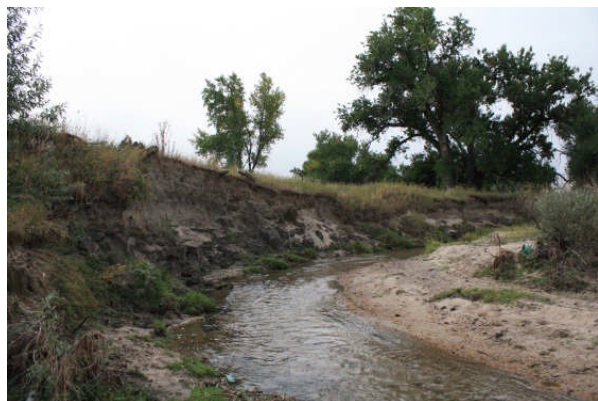
**Photo 1 - Pre-Project**

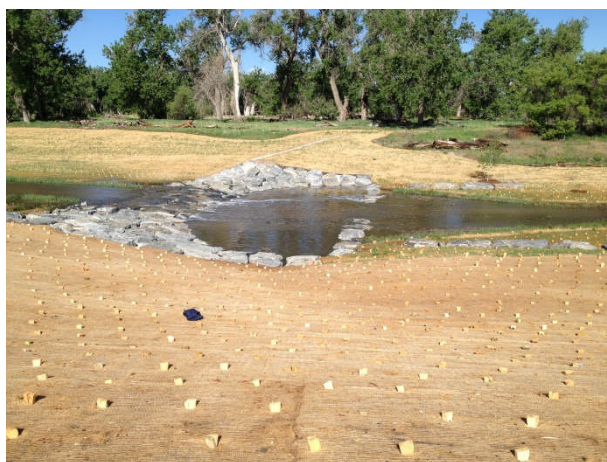
**Photo 2 - Post project drop structure**

Drop structures necessary to flatten and control longitudinal grade are grouted boulder drop types with sheet pile cut-off walls to protect the structure from damages during larger flood events. The

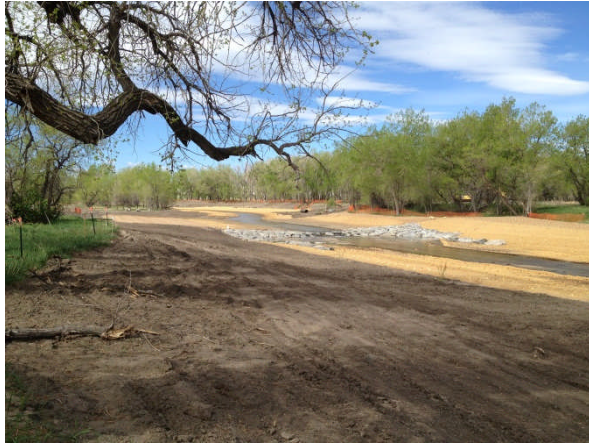
Photo 3 - Post project with side channel

In addition to the improvements along the main channel, an overflow channel was constructed along the inside of a bend of Cherry Creek to reduce the stream pressure along the banks of the main channel during frequent flooding events (e.g., 2-year events) and reconnect the water table with portions of the floodplain. The overflow channel is about 1,200 feet long and constructed along the remnants of a historical channel on the east side of Cherry Creek. A sloping grouted-boulder drop structure was constructed at the downstream end of the overflow channel to transition the elevation to match the elevation of the main channel.

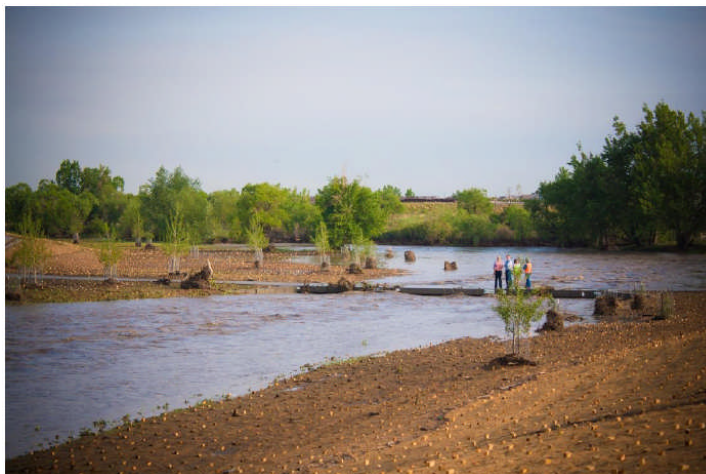
Photo 4 Post project flood June 6, 2012

at the time of the flood. Phase 1 had the most advanced stage of re-vegetation in the low flow terrace due to its completion occurring at the beginning of March. Phase 3 vegetation was installed only 2-3 weeks prior to the event; therefore, seedling germination and establishment was minimal.

*... stream reclamation project of Cherry Creek within PJCOS experienced an estimated 2-year storm event<sup>6</sup> on the evening of June 6<sup>th</sup> through the morning of June 7<sup>th</sup>. This storm occurred at a time when the project was vulnerable since vegetation was not fully established or in some cases minimal growth of vegetation occurred and portions of the project were not completed (i.e. erosion control blanket staked, vegetation installed). Although this storm even caused damages to the project, the integrity of the channel improvements functioned as intended in the design. Minor damages occurred to isolated areas of the structural components (drop structures, bendway weirs, grouted boulder edge walls). Minor to moderate damage occurred in vegetated areas and the general observation was that areas planted from February to mid-April functioned much better than portions more recently seeded and blanketed.*

Most stream reclamation projects are designed to minimize, not eliminate, flood damages during events up to and including the 1% chance (i.e.: 100-year event) and therefore some damages are expected. The projects are most vulnerable, however, during the period before adequate vegetation becomes established to protect the channel from erosion. The design includes measures, such as biologs, riprap, and blanket, to temporarily protect the more critical sections of the channel, such as the toe of slope and the main channel bank.
