# Cherry Creek at 12-Mile Park

## DRAFT FINAL Site Assessment Report

November 2010

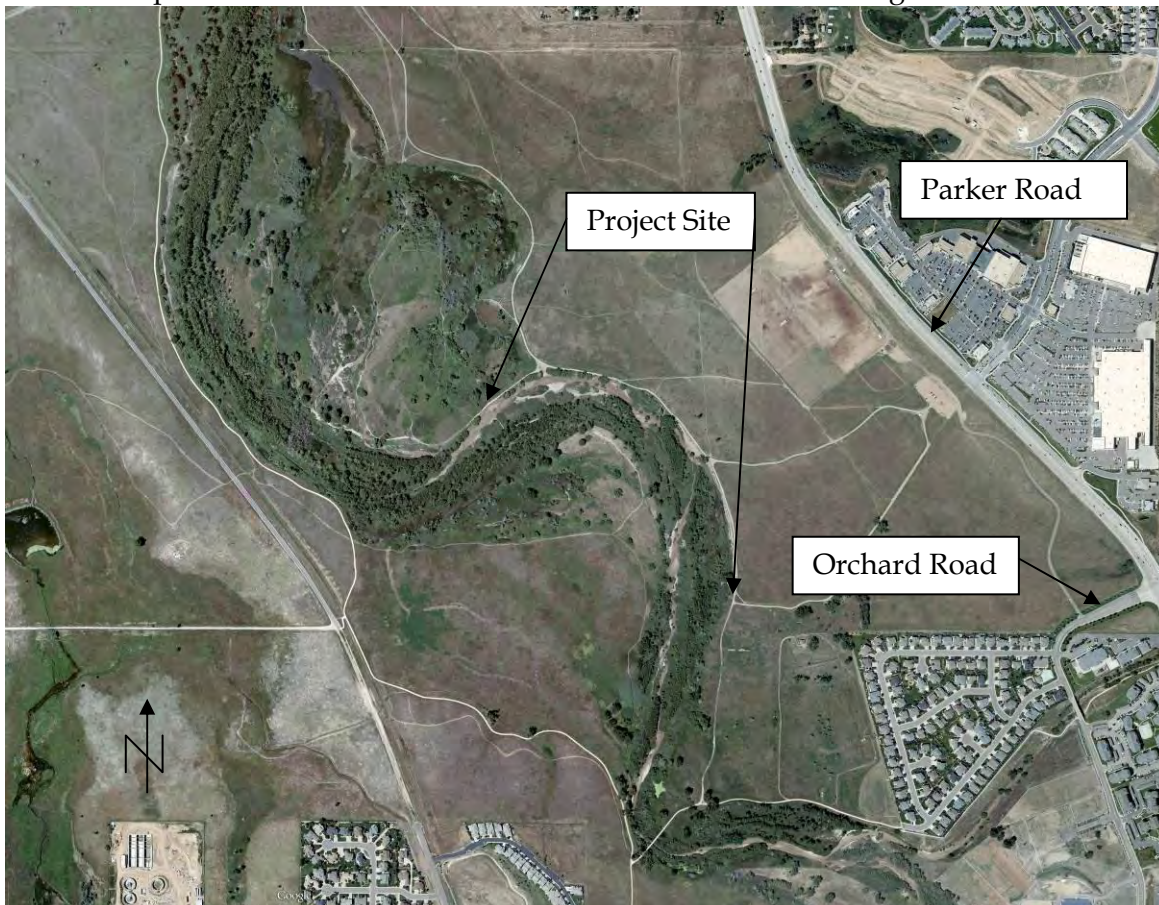
**EXHIBIT A**  
Project Location Map  
*Cherry Creek Stream Reclamation at 12-Mile Park Project*

The purpose of this Site Assessment Report (Report) is to document and present the stream and site conditions of Cherry Creek located at 12-Mile Park, at the upstream end of Cherry Creek State Park. Exhibit A shows the project area. The Site Assessment for Cherry Creek is part of a larger scope of work for the Cherry Creek Stream Reclamation at 12-Mile Park Project (Project), which is contracted between CH2M HILL and Cherry Creek Basin Water Quality Authority. The existing eastern or right bank of the channel has degraded in locations resulting in active erosion. The channel has also experienced a breakout or breach of the right bank of the low flow channel into the floodplain resulting in overbank erosion and additional environmental damage. This Project aims to develop a recommended plan to stabilize the eroded banks and restore the channel bed profile and channel to the historic alignment. Project objectives include:

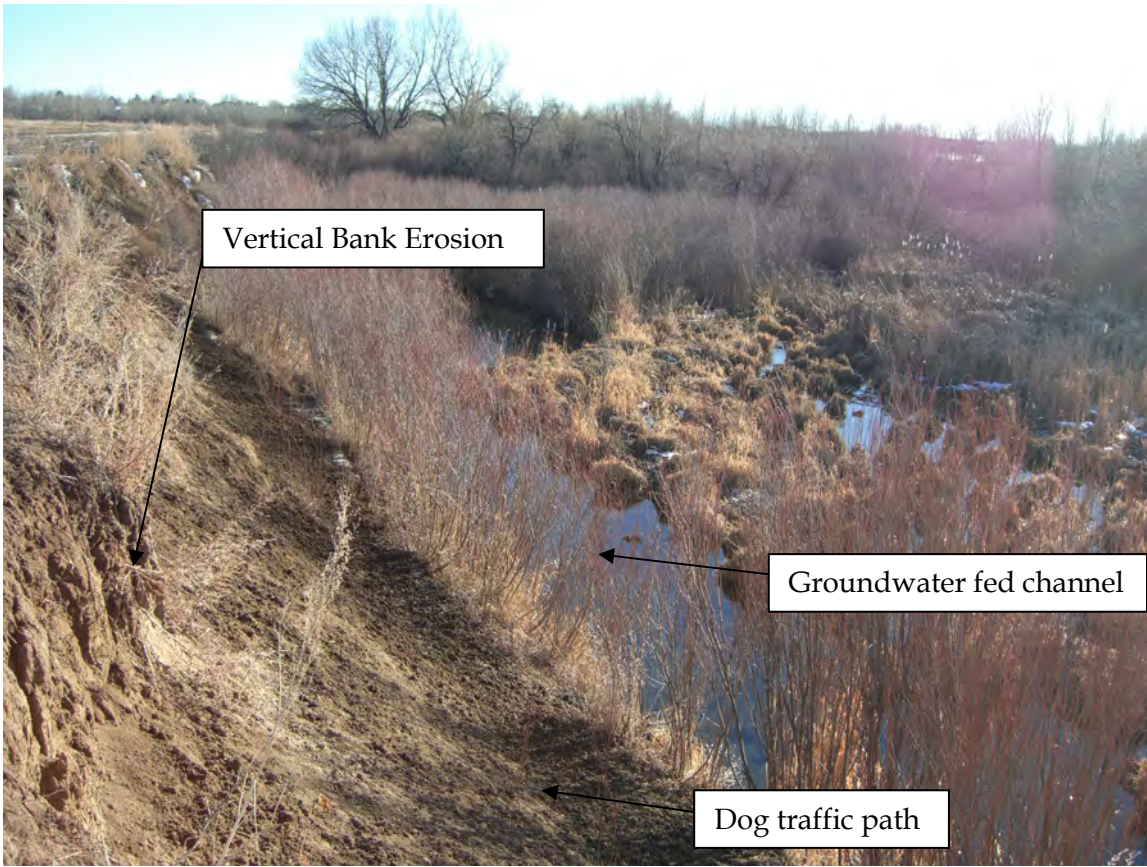
Cherry Creek through the upstream reach is located on the western side of the floodplain. On the eastern bank of the floodplain a groundwater fed secondary channel exists that has a lower channel invert than the main stem of Cherry Creek. The east bank of the floodplain is characterized by steep banks that are nearly vertical. The vegetation on the banks has been removed or damaged by park users, such as pedestrian and dog traffic. The loss of vegetation results in rapid erosion of the bank during minor storm events from surface runoff.

The eastern bank in Reach 1 is approximately 15 – 20 feet above the groundwater fed channel. To the west, the Cherry Creek channel is approximately two to three feet deep. The capacity of the low flow channel is such that flows from Cherry Creek infrequently leave the channel and flow toward the eastern bank. Due to the infrequent flows toward the east bank in this reach and the obvious eastern bank erosion, it is apparent the park use has caused the loss of vegetation and soil erosion on the eastern bank. Once the bank has been stabilized it is important to also manage the use of the bank to prevent this erosion from occurring again in the future. Photo 1 and Photo 2 depict the typical characteristics in the upstream reach.

Photo 1 - Reach 1, Looking Upstream

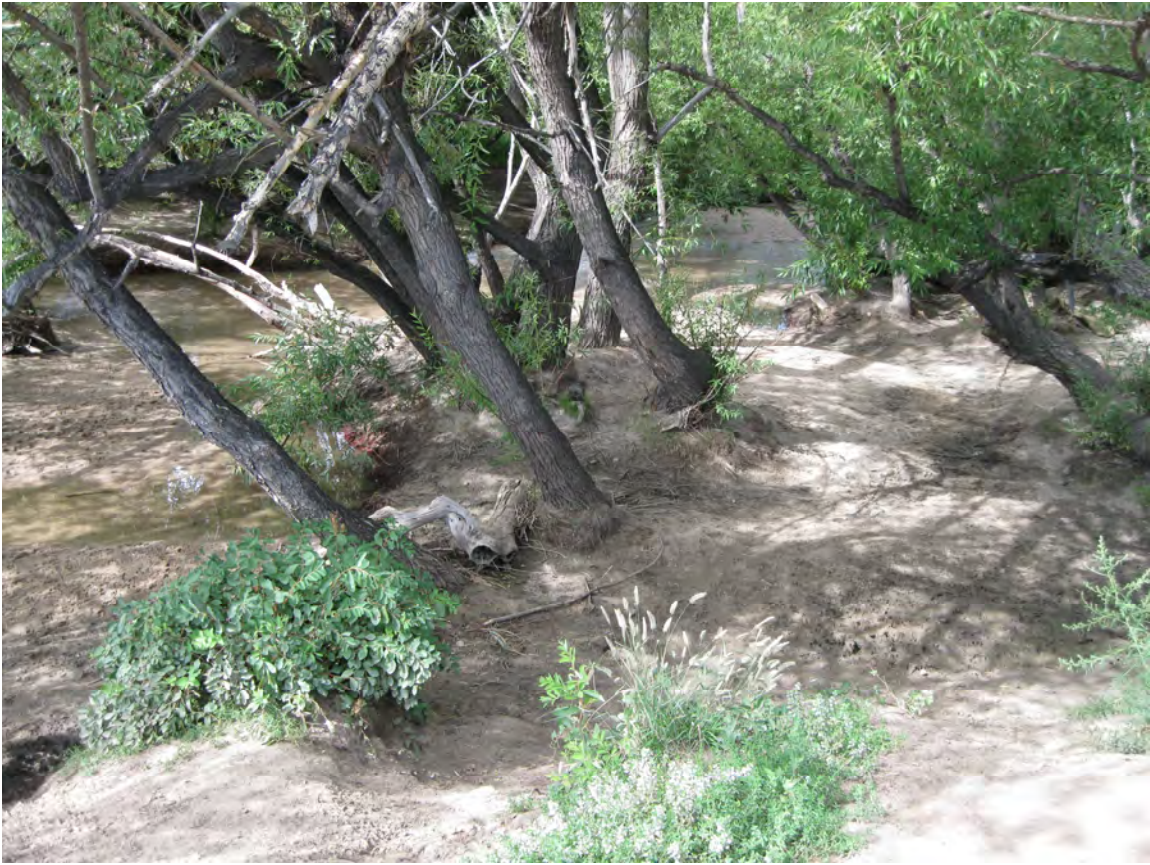
The eastern overbank in Reach 2 has lost a large amount of understory vegetation due to the user traffic in an effort to reach the water. The lower overbank and lack of adequate vegetation makes the area susceptible to erosion from higher flows in Cherry Creek. Restoration of the vegetative cover is recommended as well as management of access to the creek to prevent vegetation loss in the future. Photo 3 shows a typical overbank area in Reach 2.

*Photo 3 - Reach 2, Cherry Creek Treed Overbank*

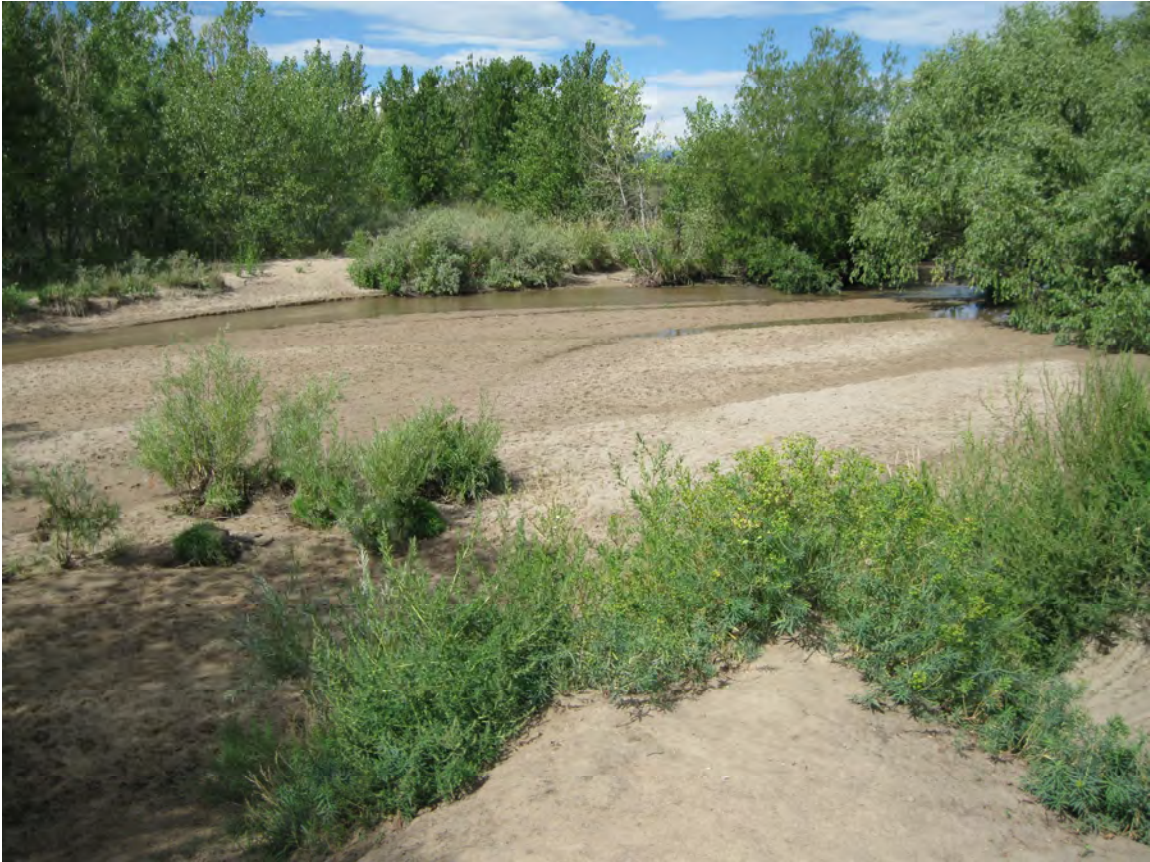
In areas of Reach 2 sandy overbanks are present that create soft access points to the water and are buffers between vegetated banks and the creek. These areas will naturally degrade and aggrade with the channel. Since vegetation is not likely to take root in these areas, these access points are attractive to maintain for future use. Photo 4 shows a typical sandy overbank area in Reach 2.

*Photo 4 - Reach 2, Sandy Overbank*

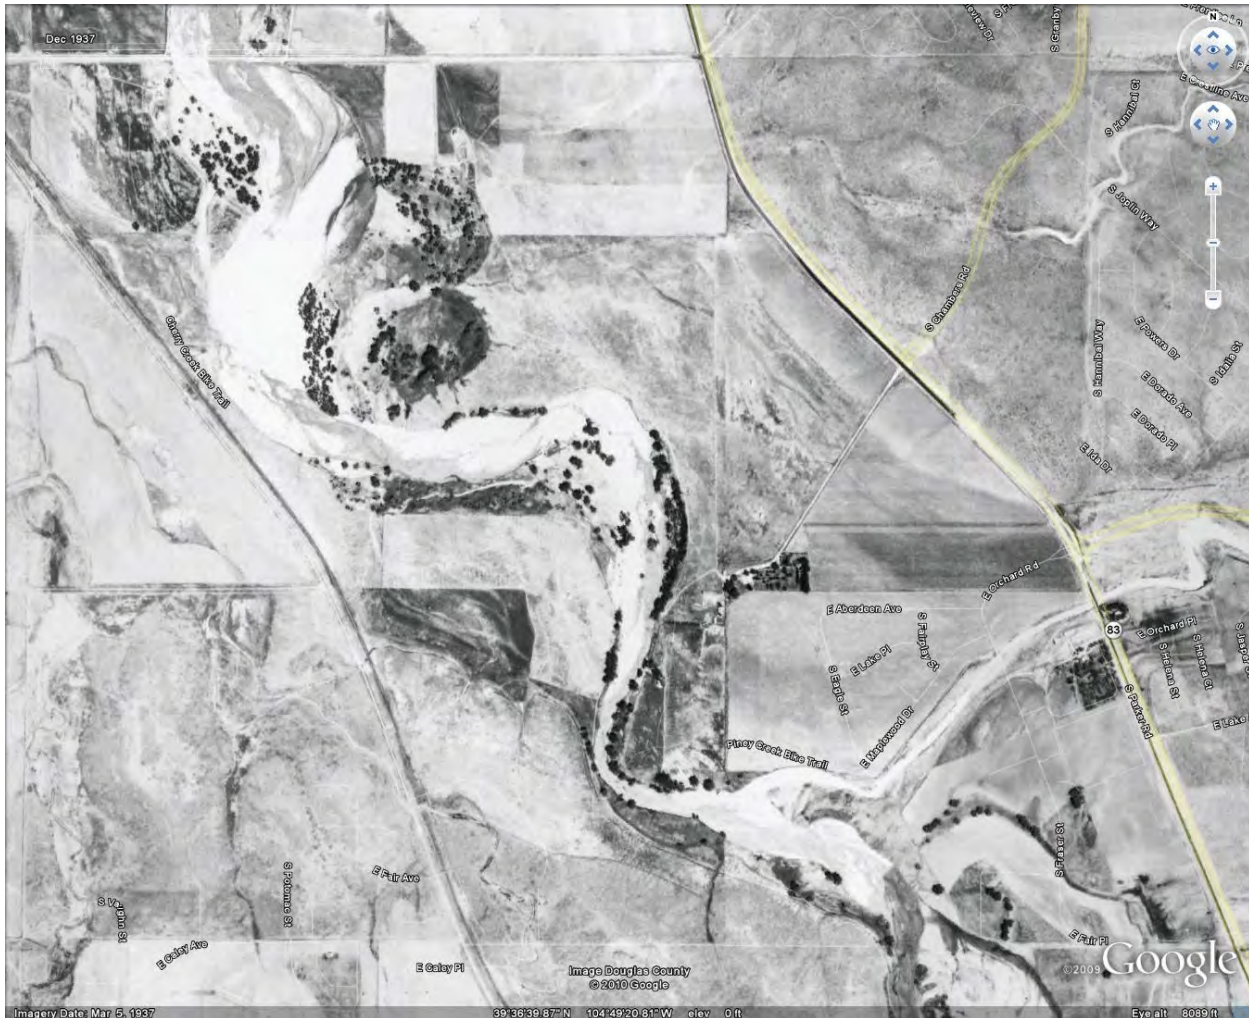
Photo 7 - Aerial Photo 1, December 1937

Based on the available historic aerial imagery, the existing channel appears to be very stable. The channel is not actively moving outside of the historic flow path over time. The most significant geomorphic event to occur in the channel corridor is the construction of the Reservoir resulting in an elevated water table. This has resulted in overbank ponds and groundwater fed secondary channels forming through the project area. This has also created a vibrant riparian habitat with multiple areas of wetland vegetation. Aerial images are provided below for the project area.

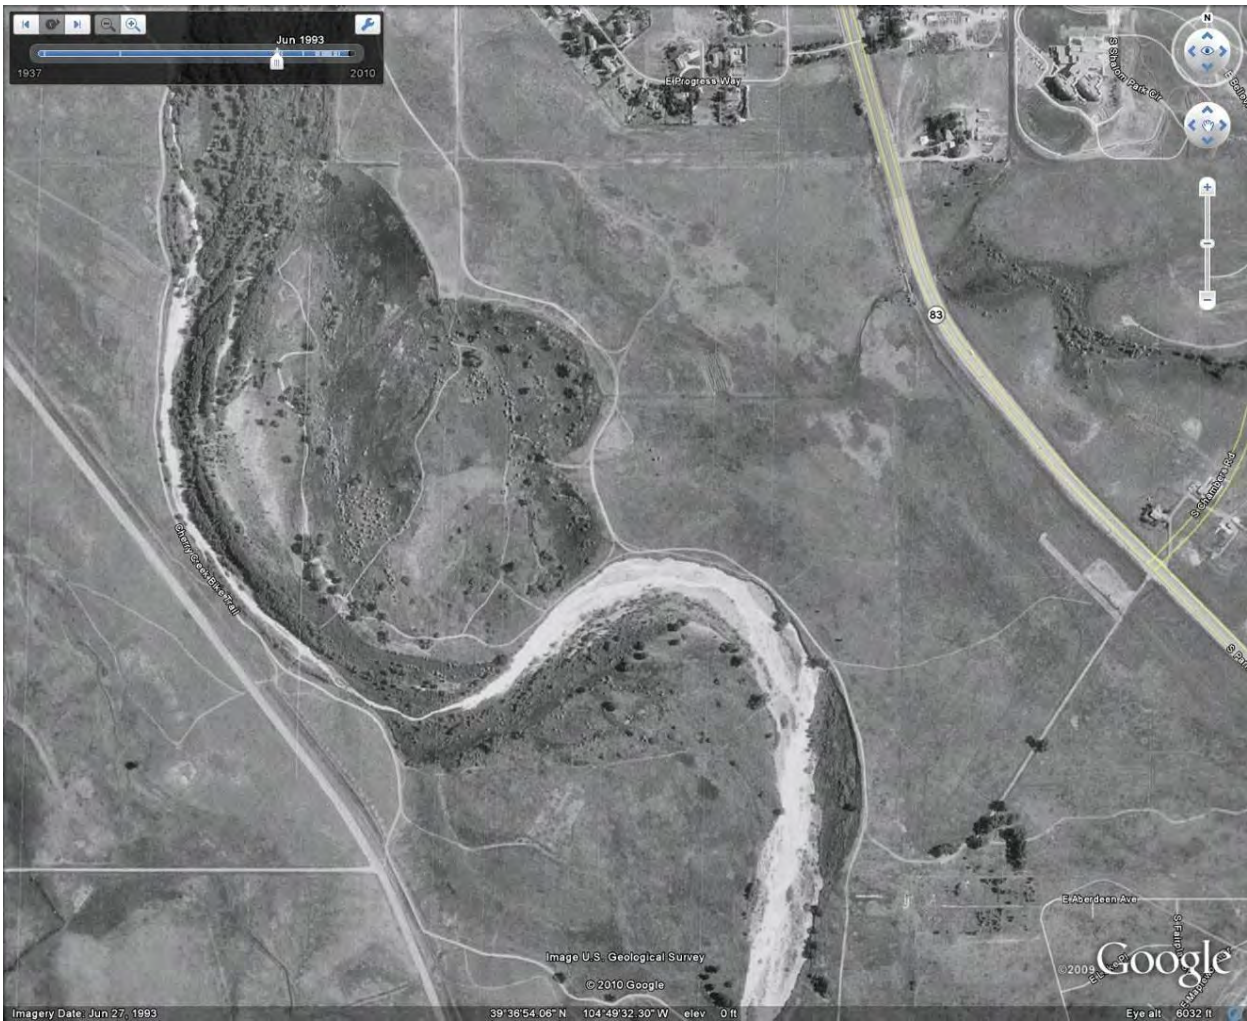
Photo 9 - Aerial Photo 3, June 1993

appear until the 1993 aerial photos. This suggests that this area is a result of elevated ground water caused by the reservoir.
