West Shoreline Erosion Control Management Plan

Cherry Creek State Park

URP 6653 – Natural Resource
Management & Planning

December 14, 2005

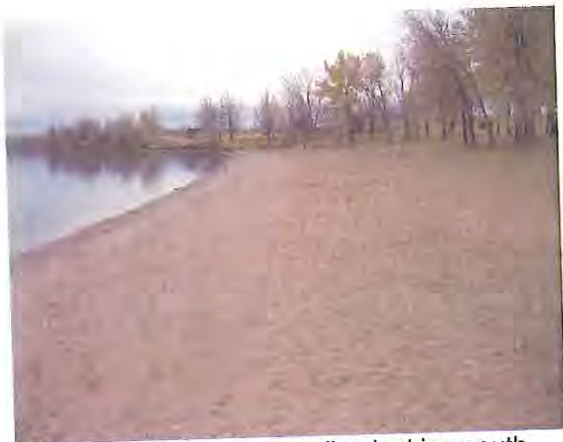
Figure 1: Beach and shoreline looking south.

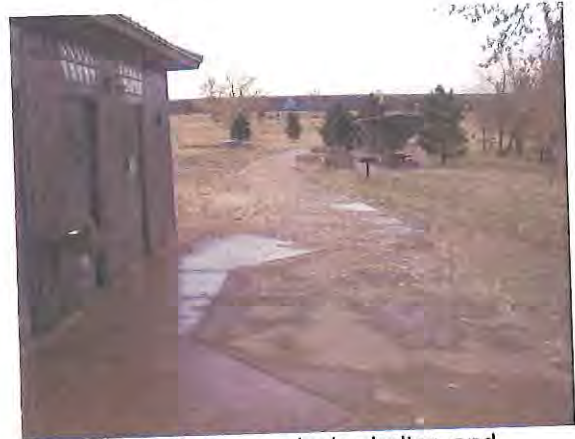
Figure 2: Bathrooms, picnic shelter, and concrete path.

West Lake View Road and a large parking area were later built to provide visitor access to the reservoir and restroom facilities were recently added between the beach and parking lot. The West Shade Shelters were constructed along the beach and shoreline. These 10 facilities are very popular during the summer months for use as picnic areas and as staging areas for other activities such as fishing and beach access. Finally, multiple concrete paths have been built that are part of the park's trail system and provide access to the shore, restrooms, shade shelters, and handicapped-accessible fishing areas (See Figure 2).

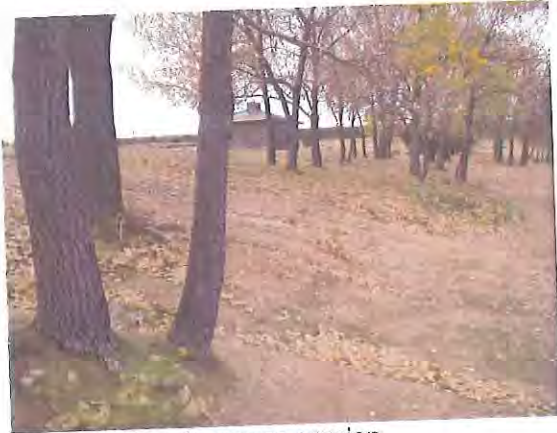
The grassy areas of the beach are adjacent to the sand and extend approximately 70 feet to the pedestrian path and are subject to significant erosion. Due to the steeper slopes that characterize the area, these areas are typically not used for recreation, but instead provide access between the beach and the permanent facilities to the west. While the steeper slopes do discourage recreational use, the slopes are generally not steep enough to inhibit pedestrian traffic. Additionally, most paths that have developed in the area are

perpendicular to the ground slope, further increasing the potential for erosion (See Figures 3 and 4).

Figure 3: Beach access erosion.

First, the eroded soil in the area should be replaced and the eroded banks should be reconstructed paying particular attention to the exposed tree roots and ruts. To further stabilize the soil, a geotextile grid should be placed in areas of steep slopes. The use of a retaining wall is not recommended for slope reduction due to the severe impact and high cost such a structure would have.

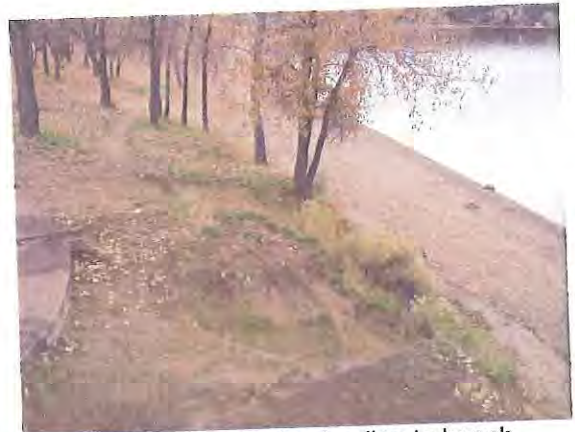
Figure 4: Severe erosion leading to beach.

The soil in this area of the beach is generally sandy and rocky. This soil type, combined with the high amount of pedestrian traffic, has inhibited the growth of grasses in the area. Without grass to protect against erosion, the steeper slopes in the area have been left vulnerable to erosion by storm runoff. As the runoff erodes the slopes, the resulting gullies attract more pedestrian traffic, again increasing the amount of erosion. It is the cumulative effects of runoff and pedestrian traffic that has led to the severe erosion problems in the area.

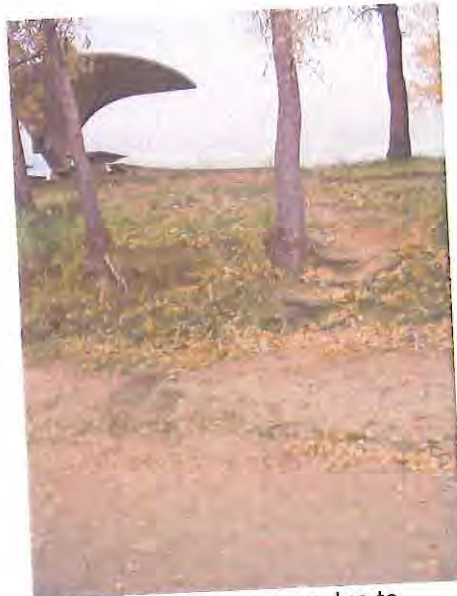
The third feature of the beach is a stand of trees that grows within the grassy area. The majority of the trees are cottonwood trees, which are commonly found along waterways and adjacent to lakes in the Colorado Front Range. The trees appear to be of similar size and age and have all developed erosion problems. In general, the erosion due to pedestrian and runoff traffic has begun to expose tree roots, threatening the health of the trees and the stability of

the slope. In areas of more severe slopes, the tree roots have been used as natural staircases for pedestrians to access the shore. Further erosion in these areas could eventually threaten the stability of the tree and pose a danger to park visitors (See Figure 5).

Figure 5: Root exposure due to pedestrian traffic.

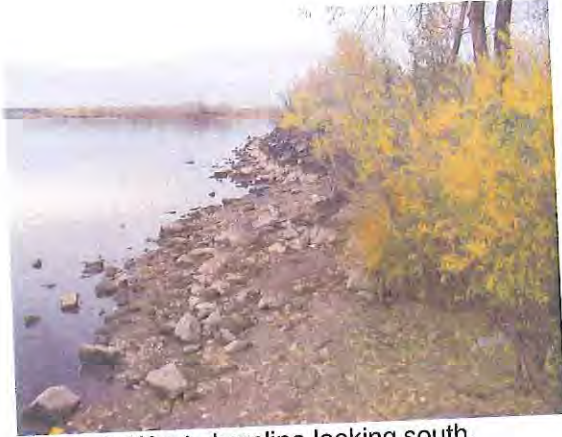
The shoreline is generally in good condition. The original reservoir design included riprap along the water edge that ranges from 6 to 18 inches in size. While the riprap has provided effective erosion protection along the shoreline, the

Park is concerned that the size of riprap is difficult to traverse and inhibits access to a significant portion of the shoreline (See Figures 6 and 7).

Figure 6: West shoreline looking south.

Finally, the improvement of shoreline accessibility would consist of two steps. First, the vegetative overgrowth that prevents even the most rugged visitor from walking along shore would need to be cut back or removed. Second, the riprap that currently inhibits walking along the shore would require maintenance. Options include removing and resetting the riprap, larger riprap could be used to replace the existing riprap, or gabions could be used to build a

wider, more accessible shoreline access route. Any of these options would provide a more even walking surface for visitors while maintaining the character of the shoreline.

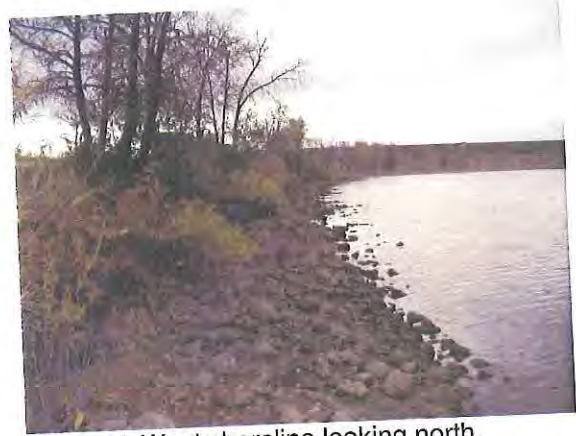
Figure 7: West shoreline looking north.

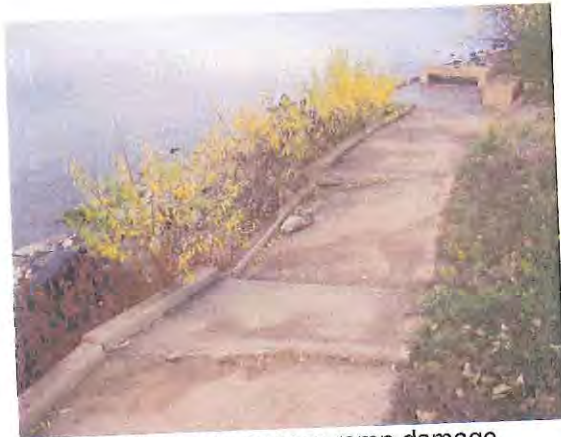
Adjacent to the riprap, the shoreline is relatively steep as compared to the beach area. Trees and bushes have been established on the slope as another source of erosion protection and several access routes have been constructed. Two wheelchair accessible concrete ramps provide access to platforms that can be used for fishing or relaxing near the reservoir. Both concrete paths have been severely eroded by runoff and wave action, in some areas causing the path to buckle and creating an unsafe condition (See Figure 8). Two concrete staircases are also in place to provide shoreline access from the parking lot and picnic shelters. The stairways are typically in good condition with minor erosion from runoff and pedestrian traffic along the edges (See Figure 9).

Figure 8: Concrete access ramp damage.

The concrete paths and stairways would require the greatest amount of repair. Because the access ramps have been eroded to the point of buckling and failure, the first step is to remove the damaged sections of concrete and replace them. When the paths are reconstructed, the foundation should be properly prepared to prevent future damage. In the areas where erosion is evident but the

Due to its immediate effect on visitor safety, the priority for shoreline restoration is the reconstruction of the damaged concrete paths. The panels that are replaced should be constructed on new foundations that are erosion resistant. The design should be approved by a licensed engineer prior to construction.

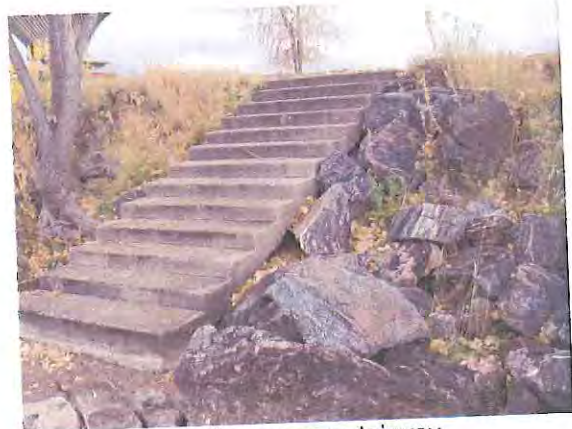
Figure 9: Shoreline access stairway.

paths or stairways have not been compromised, restoration is required. Soil should be placed beneath and along the sides of the concrete path and should be stabilized through the use of riprap or shrubs and/or trees.

The next area of improvement should be to replace soils that have been eroded from the remainder of the concrete paths, along the concrete stairways,

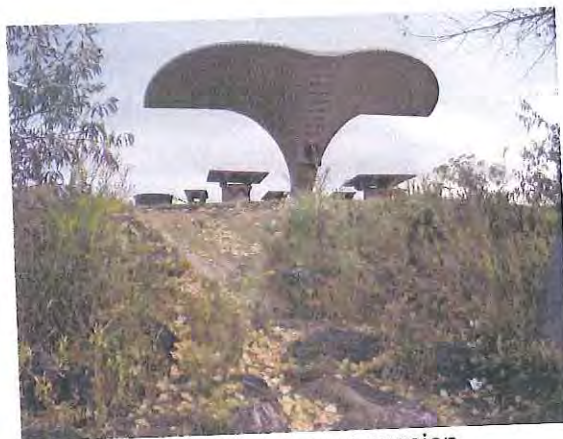
Lastly multiple footpaths have developed between the picnic shelters above the shore and the water's edge. The general pattern of pedestrian traffic and storm runoff applies in these areas as well. However, the steep banks have resulted in the use riprap and tree roots as stairs and in the erosion of the soil in the area (See Figure 10). The major concern to the Park is the potentially unsafe condition of loose rock, unstable trees, and the dangerous paths to shore.

Figure 10: Shoreline access erosion.

Typically, footpaths have been worn into the slope above the shoreline where no permanent path or access has been built. In these cases, the Park could best serve its visitors by replacing the paths that have developed with permanent paths. However, to retain the character of the shoreline and to maintain the quality of the visitor experience, the use of rock or wood to construct the paths would be the best solution (See Figure 15). Treated wood steps have been used in another area of the shoreline and appear to be a successful alternative to concrete. Alternatively, the use of rock might give visitors a more satisfying outdoor experience that could come with using a path that does not appear manmade.

Next, new pathways between each concrete picnic shelter and the shoreline should be constructed to provide a safe access route for visitors. Either rock or wood stairs would be acceptable alternatives that could withstand years of use.

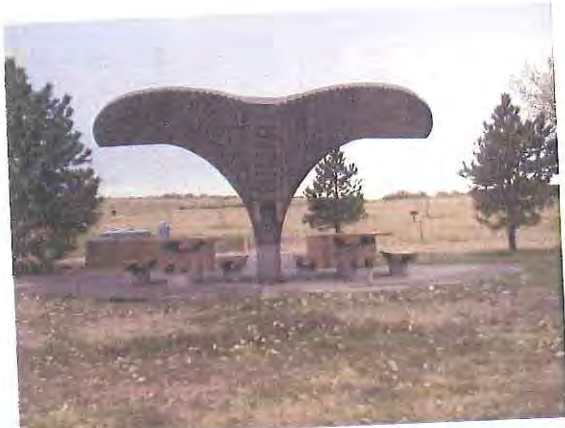
The concrete construction of the shelters has withstood the effects of weathering and use without much wear. The curved roof of each structure was an innovative and attractive design that was modeled to represent a bird's wings and directs rainfall to a downspout in the center of the shelter where it is released toward the shoreline (See Figure 11). The configuration requires minimal maintenance and could have an indefinite lifespan with proper care.

Figure 11: Typical picnic shelter.

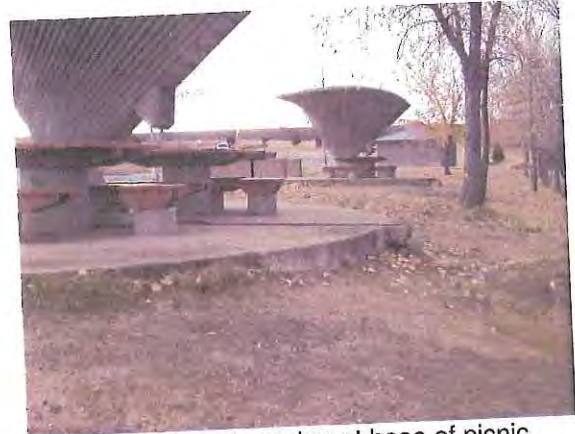
While the picnic shelters themselves do not exhibit signs of deterioration, the soil at the base of each shelter does. Around each shelter most vegetation has been worn away and the remaining soil has been eroded by foot traffic and storm runoff (See Figure 12). In most cases, the soil around the concrete pad for each shelter has been eroded to a depth up to one foot below the top of the concrete pad. Further erosion may expose the soil beneath the shelters, compromising the foundation and putting the future of the shelters at risk. In some cases the process has already begun, as evidenced at one shelter by the concrete rainspout having broken away from the concrete pad.

Figure 12: Typical erosion at base of picnic shelter.

As described earlier in the plan, the erosion of soil along the base of each picnic shelter is primarily due to excessive foot traffic. Therefore, after soil is added along the base of each shelter, pedestrian control measures would be required to maintain the integrity of the shelters.

First, new paths must be used to connect each shelter with its corresponding grill area and shoreline or beach access point. Second, the area immediately adjacent to the shelter base should be landscaped in a way that discourages visitors from gathering near the shelter base and causing the majority of erosion in the area. The use of materials such as shrubs or rock would serve the dual purpose of protecting the ground from erosion as well as encouraging visitors to use the paths.

The restoration around the structures and paths along the west shoreline is similar to that of the beach area. First, the eroded soil in the area should be replaced and each site graded to ensure proper drainage.

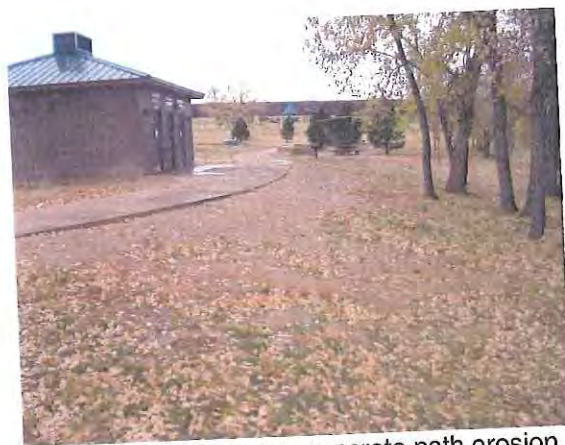
The bathroom facility was recently constructed above the beach area adjacent to the parking lot and includes a concrete path along the easterly side of the shelter. To date, the structure itself is showing no signs of erosion and the concrete paths adjacent to the building are showing only slight amounts of erosion (See Figure 13). However, the areas of soil adjacent to the structure and path have not developed significant amounts of vegetative growth. This fact, coupled with the high level of pedestrian activity in the area and the steeper ground slope to the east suggest that an erosion problem could develop if not properly managed.

Figure 13: Bathrooms, concrete path erosion, and lack of vegetative cover looking north.

The erosion along path edges is not as severe as the erosion near the picnic shelters, although the remediation methods would likely be similar. The first step is to replace the soil that has eroded away. To protect this soil, the ground should be planted with grasses or other groundcover vegetation common to the surrounding areas. Using shrubs or other landscaping along the edges of the path would provide additional pedestrian control, however, in most instances, once the groundcover along the concrete paths is established and the path system is developed to provide access to the beach, the area should not be subject to large amounts of pedestrian traffic and the additional measures should not be necessary.
