PROJECT COMPLETION REPORTS
POLLUTANT REDUCTION FACILITIES (PRF)

The following reports summarize the various capital projects completed with Authority funds as of April 2014.

To: Chuck Reid, Manager, CCBWQA
Cc: Rick Goncalves, Chairman TAC
From: William P. Ruzzo, P.E.
Date: December 27, 2012
Re: Cottonwood Wetlands PRF Rehabilitation – Project Summary

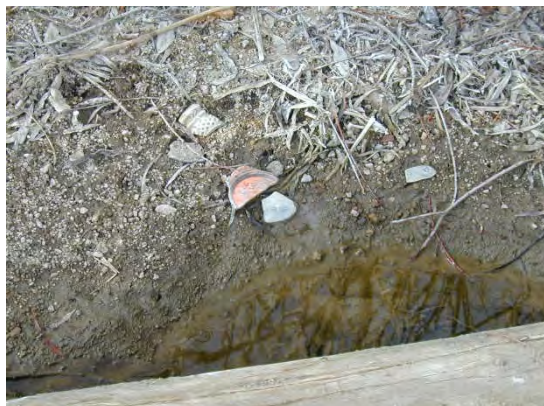
Figure 2 - Clay Pigeon Debris

During design of the rehabilitation project, clay pigeons were found at the site in early 2009. Some types of clay pigeons are classified as a solid waste since they contain polynuclear-aromatic hydrocarbons (PAH). In discussions with the Colorado Department of Public Health and Environment (CDPHE) it was determined that only material containing clay pigeons disturbed

during construction must be removed and disposed in a qualified landfill. It is not necessary to remove clay pigeons from the entire project site, if they are left undisturbed. Therefore, the Authority redesigned the Cottonwood Wetlands PRF to minimize excavation in areas of the project where clay pigeons were known to exist in order to reduce cost of offsite, landfill disposal.

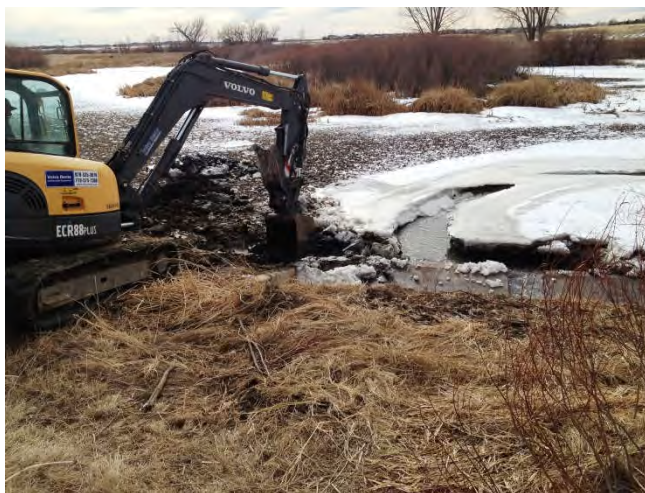
Figure 4 - Beginning excavation

To facilitate sediment removal, the pond was drained starting October 7, 2011 which revealed that the pond had experienced greater sedimentation than previously estimated and would require more excavation and sediment removal. During construction of the Project, the Authority also had another project⁶ under construction within Cherry Creek State Park by 53-Corporation, which needed earth materials. After determining the suitability of the sediment for use in the 12-Mile Park project, the Authority directed the contractor to haul sediment from the Cottonwood Wetlands project and place it at the 12-Mile Park project to reclaim the wetlands damaged during breach of the Cherry Creek channel. This exchange of material between projects reduced costs to import materials for the two projects and export materials from the Park to preserve flood storage volume⁷.

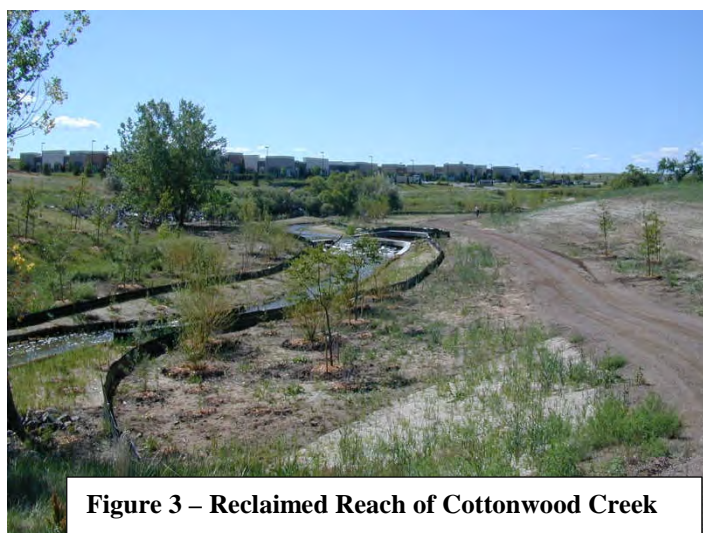
Figure 3 – Reclaimed Reach of Cottonwood Creek

Reclamation of the reach of Cottonwood Creek between Easter Avenue and Briarwood will reduce channel bed/bank erosion and pollutant loads to Cherry Creek Reservoir.

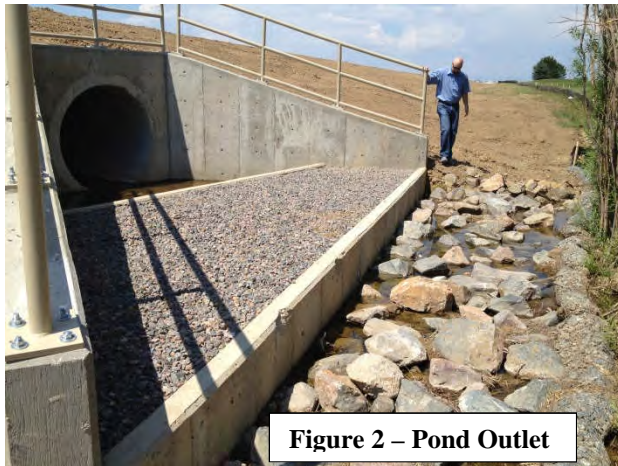
Figure 2 – Pond Outlet

Figure 2 shows the pond outlet which was modified to include a rock filter. Water quality sampling and testing by Arapahoe County has identified the natural presence of rust colored bacteria in the storm drainage system at Easter Avenue which includes runoff from Centennial Airport. Research by the Authority suggested that naturally occurring bacteria can reduce glycol concentrations and that

other airports have incorporated similar treatment for deicing runoff. Authority recommended modifications to the Airport pond incorporates small, angular rock in the swale and at the outlet to simulate a “trickling filter” common in wastewater treatment.

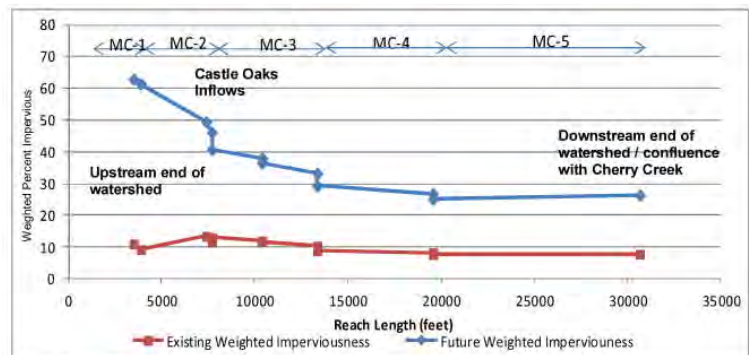
Figure 2. Cumulative imperviousness draining into McMurdo Gulch for existing and future development conditions.

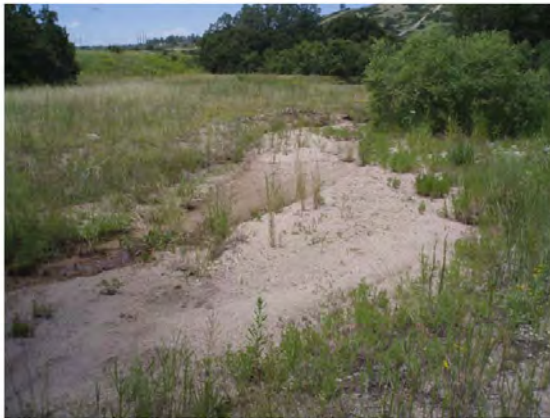
In all three reaches there is evidence of active erosion (see Picture 12 below). The impacts of this erosion were most evident in the lower reaches. Part of this is due to the change in soil characteristics and vegetative cover, which are comprised mainly of sand and cobbles that are more susceptible to erosive forces. Also, in many areas along the channel, erosion has been caused by off-road vehicles crossing and running down the center of the channel.

Picture 12: Station 208+00 looking d/s
Typical Channel, Sandy Channel and overbanks

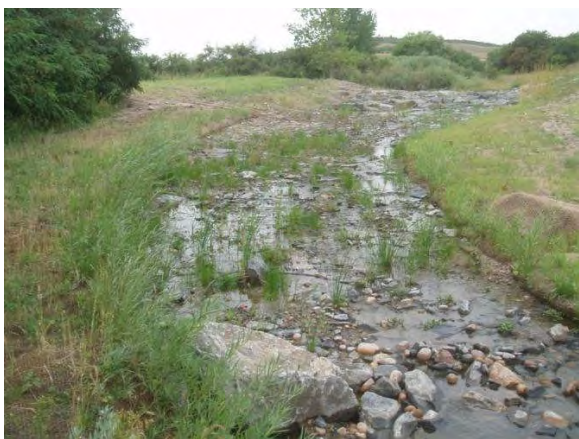
A unique approach to grade control structures, called boulder cascades, were designed to mimic a natural boulder channel characteristic of streams observed in the Rocky Mountains. The structures are comprised of a combination of loose boulders and void-filled riprap. The boulder cascades range from 1 to 4 feet in drop height and the bottom width varies from 10-feet to 35-feet. The structures contain a 6% longitudinal slope down the face of the structures and extend 2.5-feet up each channel bank at a 4:1 side slope. The side slopes are buried with topsoil and covered with erosion control blanket.

The drop dimensions are not intended to provide a specific capacity, but instead are intended to work with the geometry of the existing channel and surrounding areas. In areas where a series of

boulder cascades are to be constructed in close proximity to one another, a stable longitudinal slope of 0.6% was used between structures. The photo (MEC 2011) at the left shows a completed structure with wetland vegetation growing before the project was completed.

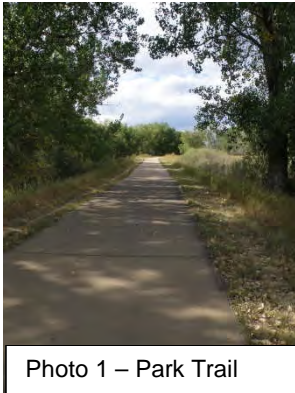
Photo 1 – Park Trail

The Quincy Drainage Detention (Project) is located in the east part of Cherry Creek State Park (see Figure 1) and consists of a small earth embankment that doubles as a paved park trail (Photo 1) with a pipe outlet and trash rack (Photo 2). The Project, which drains approximately 527 acres¹, was constructed in 1995 at a capital cost of \$219,000. To create the detention area, the park trail was relocated to the west around the Cottonwood grove and elevated [WPR1] to create an embankment².

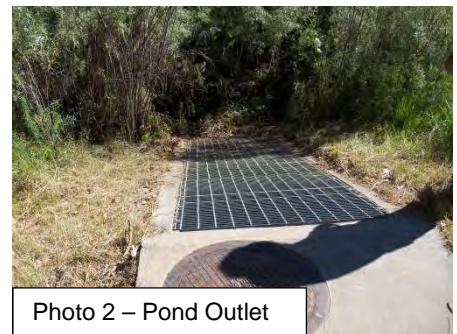
Photo 2 – Pond Outlet

Quincy Drainage Detention temporarily detains stormwater which allows for particulate matter (i.e.: pollutants) to settle out in the storage area, which is also a Cottonwood grove. In addition, because the native soils in the detention area are relatively pervious, the Project rarely experiences a discharge through the outlet because the storm runoff infiltrates into the alluvium, providing even greater water quality benefits.

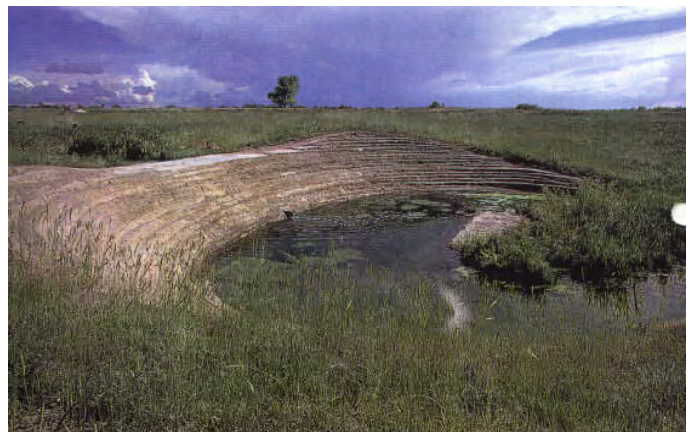
Regular sampling occurs upstream, downstream of retention pond and downstream of wetlands. In addition to phosphorus (total and dissolved), samples analyzed for nitrates, nitrites, nitrogen, copper, iron, manganese, zinc, alkalinity, chemical oxygen demand, and total suspended solids. Long term performance for phosphorus is shown in the chart below. Sampling upstream and within the wetlands was discontinued in 2000.

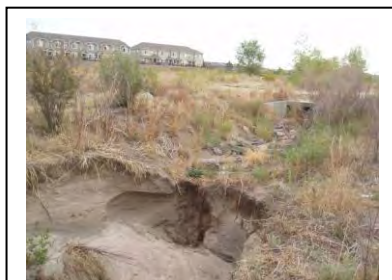
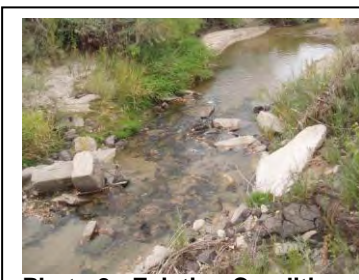
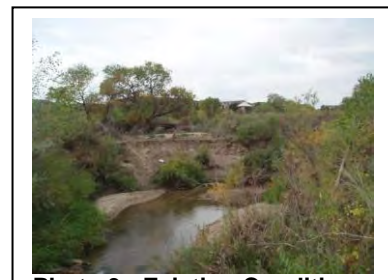
Urbanization and the resulting increase in the rate, frequency, duration and magnitude of stormwater runoff accelerated degradation of the streambed and banks. Typical pre-project conditions are shown on Photos 1, 2 and 3 documenting that Cherry Creek has degraded up to 10-feet within the streambed.

Photo 1 - Existing Condition

Photo 2 - Existing Condition

Photo 3 - Existing Condition

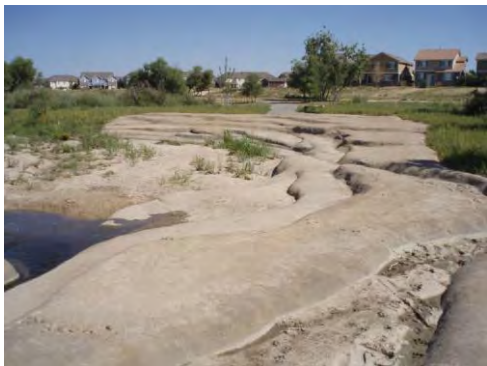
Photo 4 - Sculpted Concrete Drop

Hand sculpted concrete drop structures, as shown on Photo 4, are incorporated into the project to flatten and control the longitudinal grade, with sheet pile cut-off walls to protect the structure from damages during the larger flood events. Riffle-pool structures, constructed entirely of rock, were constructed in the channel to aide in conveyance of the mean flood event in the narrower channel. Larger floods in these areas then spread over the broader floodplain. This design approach lowers the runoff velocities allowing for more filtration and infiltration.

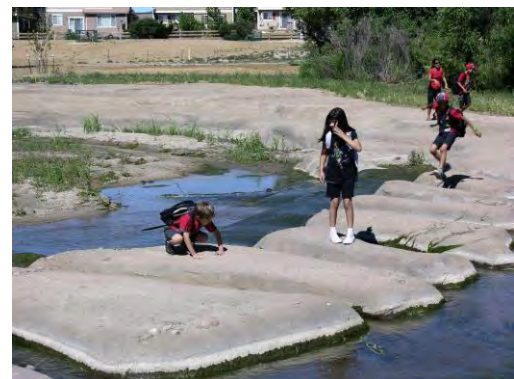
Photo 5 - Sculpted Drop Creek Crossing

The lateral drop weir and the sculpted concrete splitter drop each divert stream flows into a secondary channel section as the water level in Cherry Creek rises to the diversion invert elevation. This design feature allows for the stream flow to widen out into two channels and further reduce velocities. The secondary channels are beneficial for reconnection of the water table with portions of the floodplain. Six different types of bioengineered bank protection details were installed along the realigned/reshaped channel through the project. The bank protection types were unique for

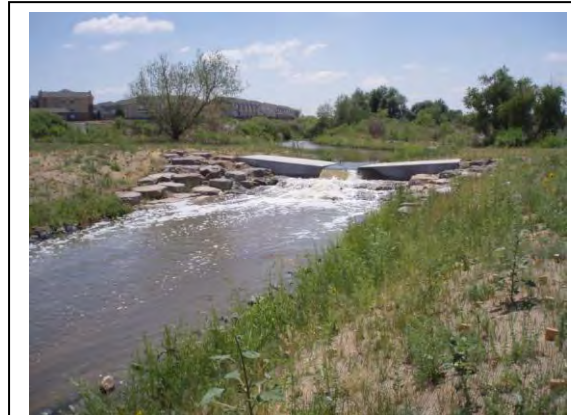
Photo 6 - New Monitoring/Sampling Station

A flow monitoring and sampling station was installed near the lower end of the project to provide a data collection point for the Authority as shown on Photo 6. This data collection point is one of a series used by the Authority along Cherry Creek to monitor nutrient loading and stream flows within the Cherry Creek Basin.

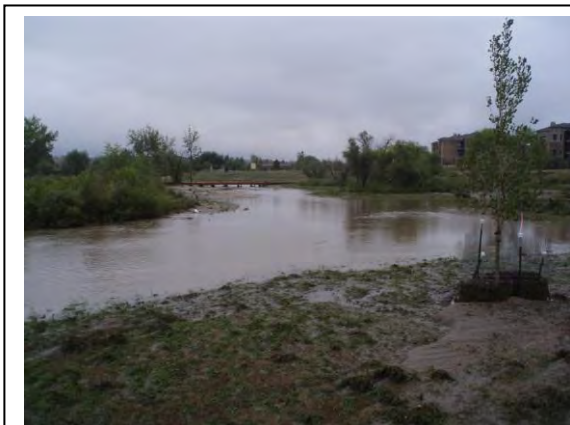
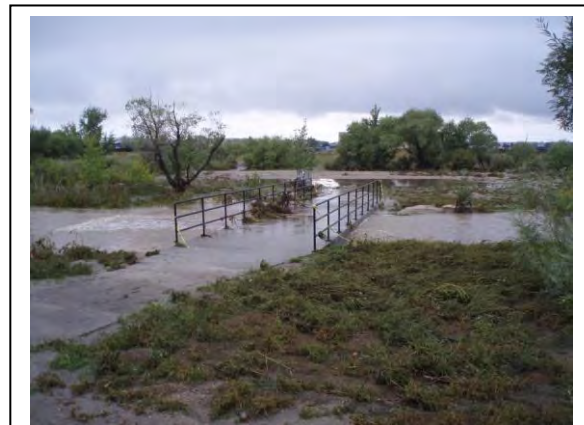
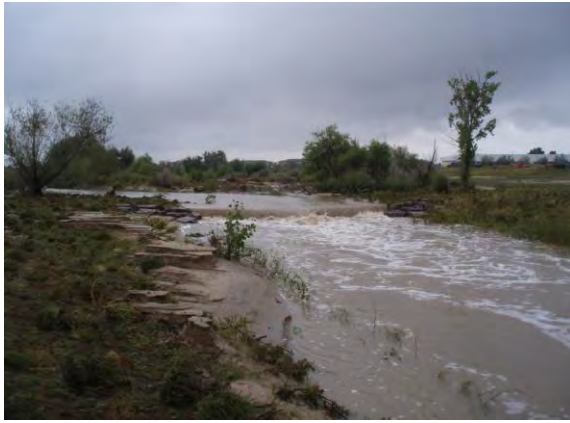
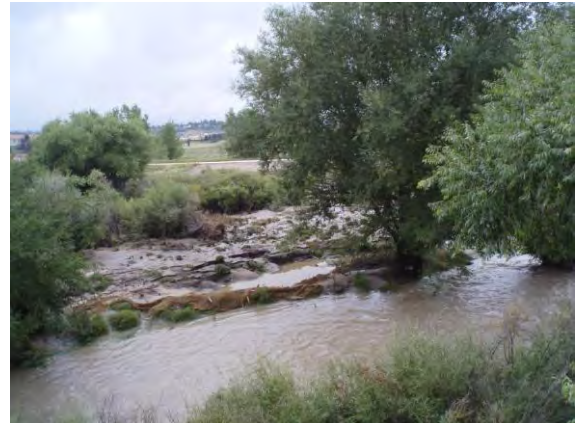
An on-site inspection followed that found that all major structures designed and installed to control the minor and significant storm runoff events each functioned as expected. None were damaged or adversely impacted. The upper banks where the revegetation work had not re-established itself yet, received the majority of the damage. Seeded areas had eroded, upper bank material was displaced and low areas filled in. Crusher fine trails were washed out in specific locations where runoff was concentrated. The project team quickly assessed the damage and the project consultant prepared an overall restoration plan. Restoration work began promptly to repair areas impacted by the flooding. It was anticipated that the flood damages would have been minimal if the project vegetation had a season or two to establish itself. This is confirmed following a brief site visit to the Parker Jordan Centennial Open Space project immediately upstream of Eco Park. It is strong testimony that bioengineering design works for stream reclamation after the vegetation is established.

Photos 8, 9, 10 and 11 show some of the typical damage from the storm.

Photo 8 - Flooding Damage

Photo 9 - Flooding at a Trail Crossing

Photo 10 - Flooding Damage

Photo 11 - Flooding Damage

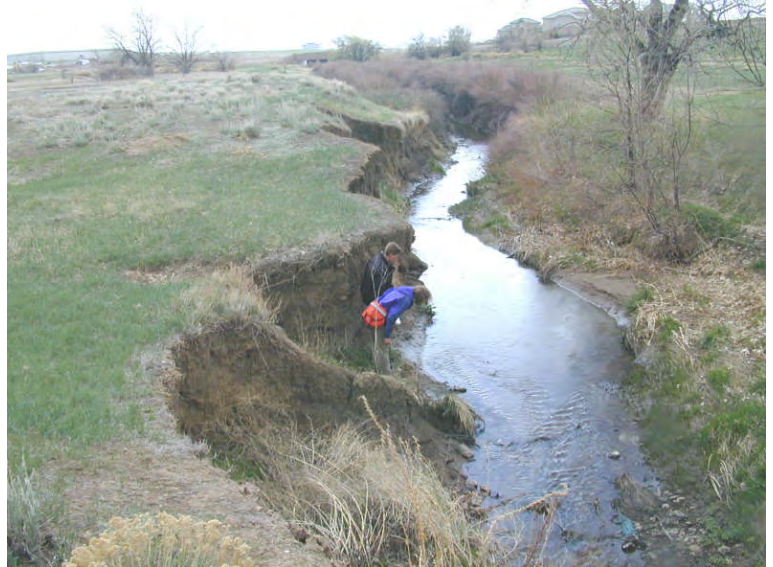
Urbanization of the Cottonwood Creek watershed (8.5 square miles) greatly increased during 1980's and continues today. Urbanization increases the rate, frequency, duration and magnitude of storm runoff, all of which increases erosion of the streambed and banks. This erosion is evident in the adjacent photo, which shows that the Creek had degraded up to 10-feet within Cherry Creek State Park. These soils, along with other associated pollutants, particularly phosphorus, are being carried into the Reservoir, degrading its quality. Soils were also being carried into the Park from upstream development and ending up in the Reservoir.

Cottonwood Creek through Cherry Creek State Park has a history of flood events that have severely eroded the channel bed and banks and confined it to a narrow section beginning at Peoria Street (see photo above). Flooding has been reported in the past at the intersection of Peoria Street and Bellevue Avenue, and within the shooting range, most recently in August 2004. Previous farming activities have apparently relocated the lower portion of the channel up on a ridge through the shooting center, rather than in the valley, which has altered the flood plain.

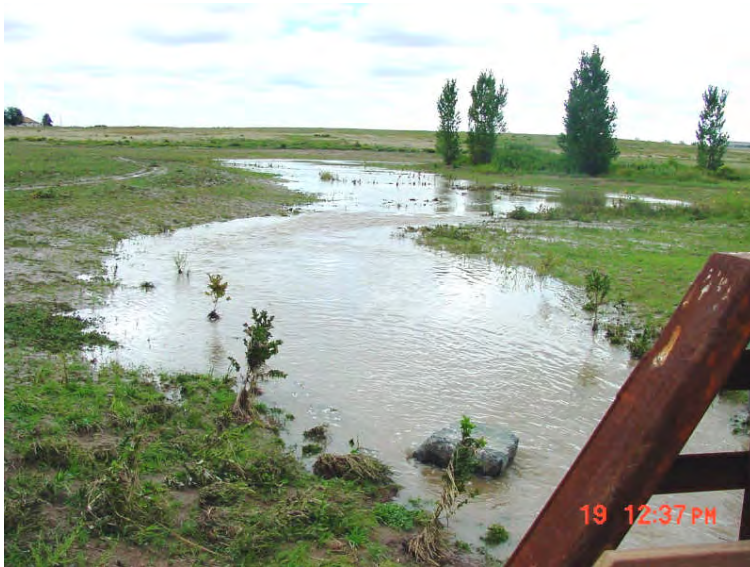
Cottonwood Creek Reclamation Phase 1 was completed in early August 2004 with the first flood occurring on August 18, 2004. Based on water-marks at Peoria Street, the peak flow entering the newly constructed channel was estimated to be 1400 cfs, which compares to the projected 100-year event of 4,000cfs. The photo below shows the restored creek during the flood event. The success of the project is attributed to the "low-energy" design. This approach flattens the channel slope decreasing velocity (kinetic energy) and allows the flood to spread over larger areas, increasing flow area and decreasing velocity.

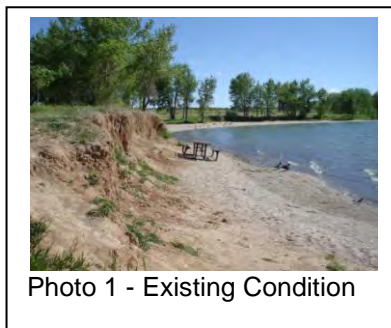
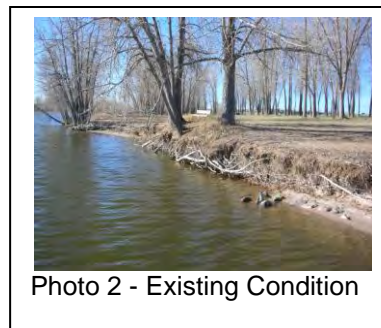
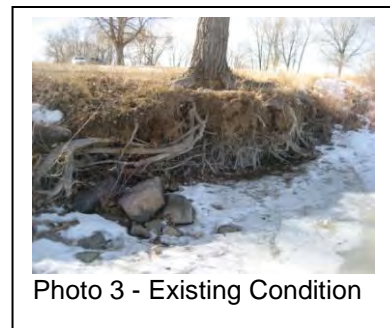
Wave action, wind, ice push and shoreline users have each contributed to erosion of the reservoir shoreline and major cut banks. This point along the shoreline is exposed to wind and wave actions during every season of the year. As the ice cover breaks up each spring, the north wind pushes ice to the south shore and in particular this point. Typical pre-project conditions are shown on Photos 1, 2 and 3.

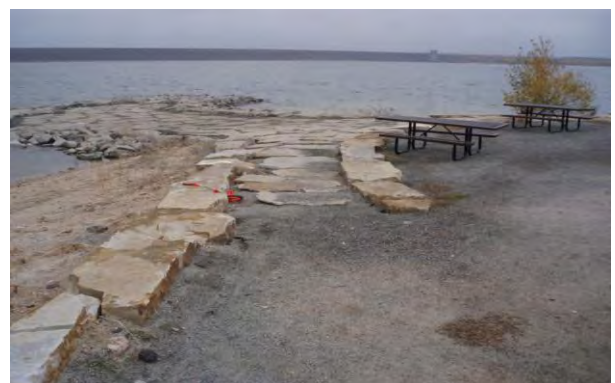
Photo 4 - Constructed Lake Loop Point

Construction of the boulder point with riprap bank protection provides armoring at the Lake Loop point. The boulders were anchored on the reservoir side with Type H riprap sloping at a 3:1 grade into the water. This detail pushes any ice upward and onto the top of the boulders rather than displacing them. A photo of the constructed point is shown as Photo 4 - Constructed Lake Loop Point.

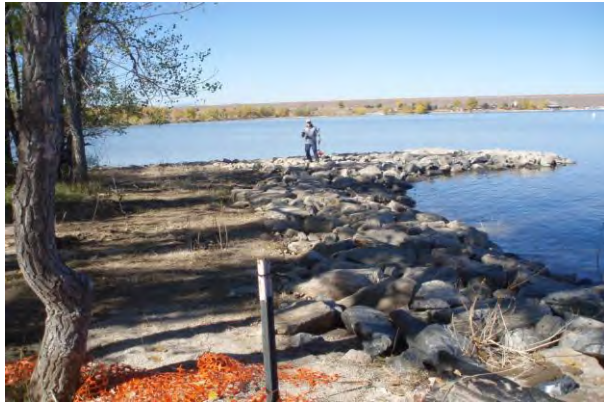
Photo 5 - Constructed Mountain Loop Point

The shape and location of the point (at Lake Loop and at Mountain Loop) protects adjacent shoreline from the direct prevailing winds and wave action.

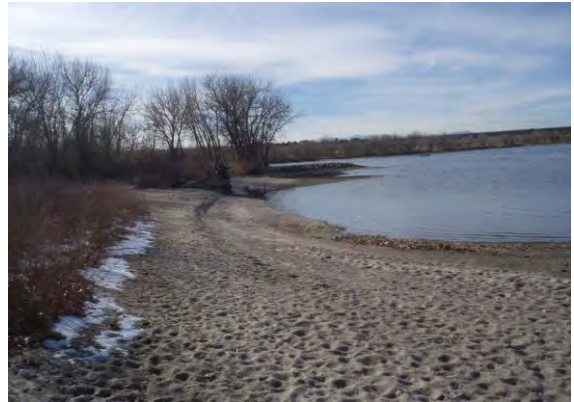
Photo 6 - Beach Area

The beach areas were re-established along the shoreline for recreational uses. The beach areas along the Mountain and Lake Loop project are in continual use by park users for picnics, fishing or a day in the sun as well as providing a convenient location to launch kayaks and long boats.

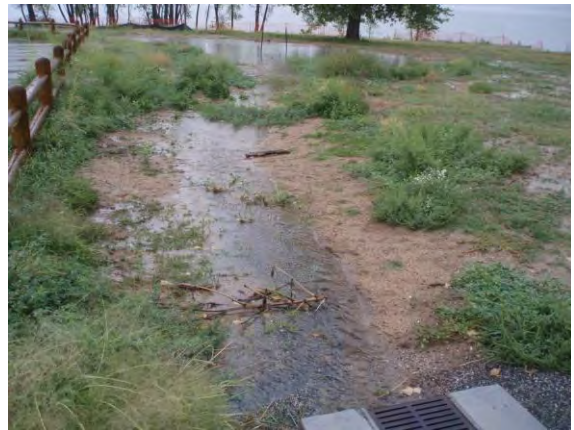
Photo 7 - Infiltration Basin @ Parking Lot

Infiltration basins were incorporated at both the Mountain Loop parking lot and the Lake Loop parking lot. These BMP's are intended to capture minor storm events from the parking lot and provide filtration and infiltration treatment of the runoff. Photo 7 shows an infiltration basin in action at Lake Loop.

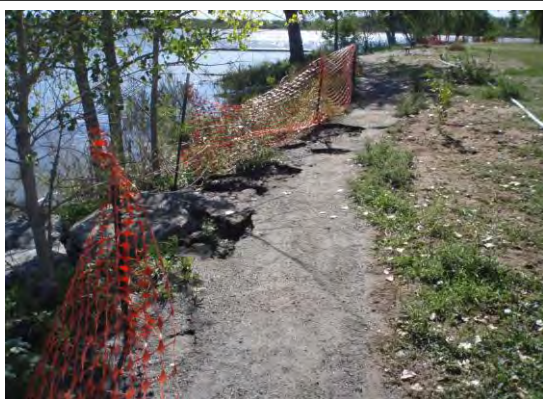
Photo 8 - Trail Damage

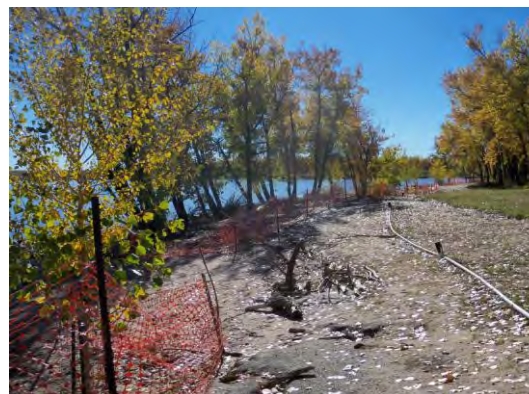
Photo 9 - Sand Deposition on Trail & Vegetation

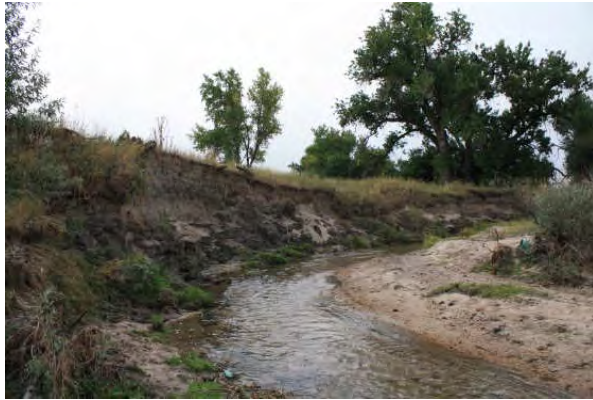
Photo 1 - Pre-Project

Because of the severity of the channel degradation, areas of extreme topographical constraints, and floodplain regulations limiting increases in flood elevations, the approach to the Project reach resulted in

a more formal approach to reclamation of Cherry Creek. For instance, essentially all of the existing channel bank and riparian vegetation had to be removed and replanted due to substantive changes in channel geometry necessary to accommodate topographic and floodplain limitations. The preferred design approach for reclamation is to retain and protect as much of the existing vegetation as possible, minimizing disturbances and improving the chances of re-vegetation success.

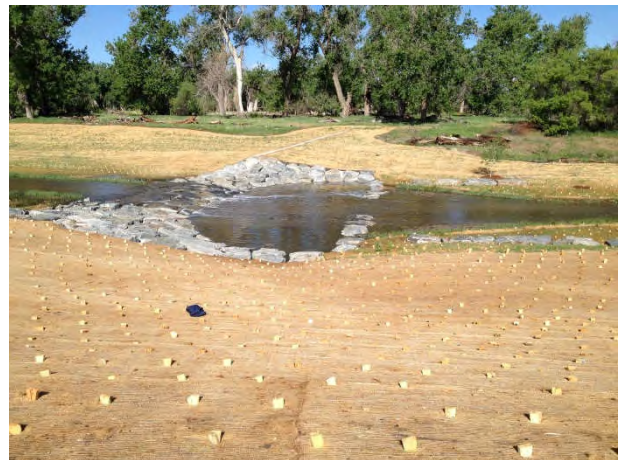
Photo 2 - Post project drop structure

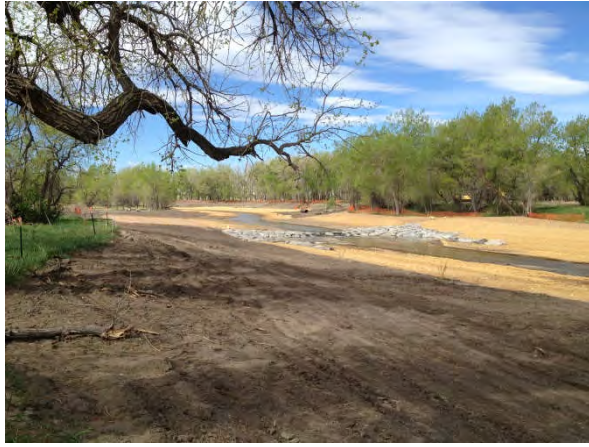
Photo 3 - Post project with side channel

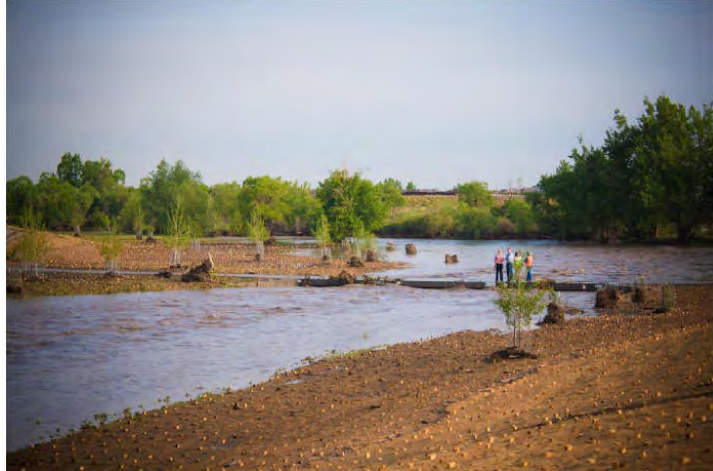
Photo 4 Post project flood June 6, 2012

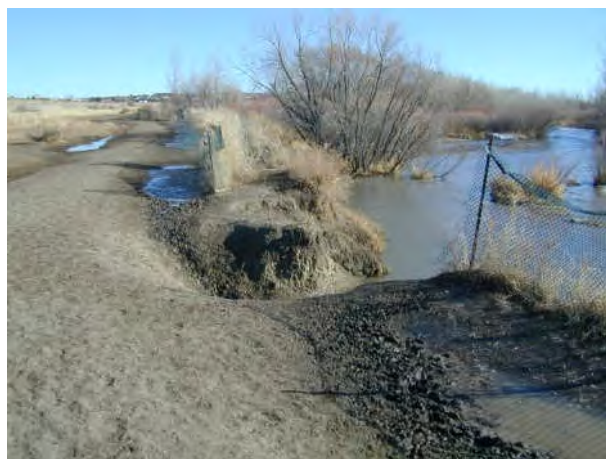
Photo 1 - Cherry Creek 01-28-2008

In 2007, Cherry Creek State Park (Parks) and the Authority inspected the reach of Cherry Creek along the “big-bend” in the Creek adjacent to the dog off-leash area near the south east area of the Park. Severe

damage to bank vegetation and channel erosion were observed throughout the area where people, dog, and horse activity were concentrated (see Photo 1). The Authority evaluated the water quality impacts from these activities and decided to investigate the technical feasibility of stabilizing the channel banks. Funds for investigation were included in the 2008 capital improvement program (CIP).

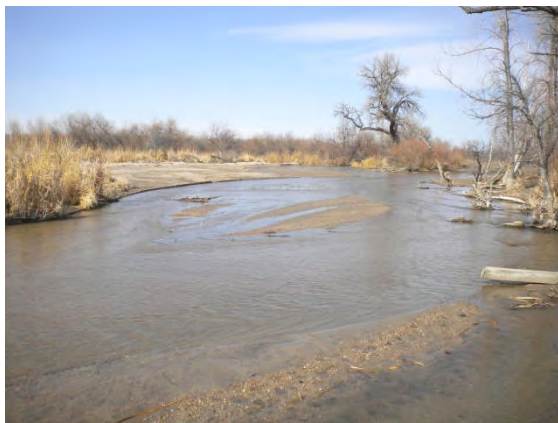
Photo 2 - Wetlands damage from breach

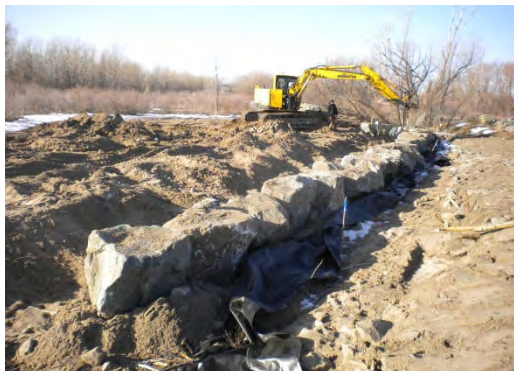
Photo 3 - Boulder Toe Wall

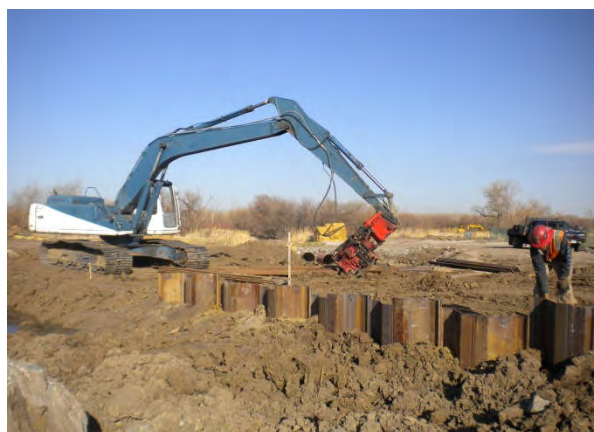
Photo 4 - Sheet Pile Cut-Off Wall

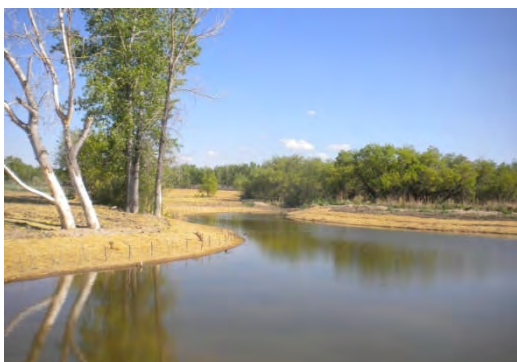
Photo 5 - Restored Wetlands

for use in the 12-Mile Park project, the Authority directed the contractor to haul sediment from the Cottonwood Wetlands project and place it at the 12-Mile Park project to reclaim the wetlands damaged during breach of the Cherry Creek channel. This exchange of material between projects reduced costs to import materials for the 12-Mile Park project and export materials from the Park to preserve flood storage volume². Photo 5 shows the restored wetlands and Photo 6 shows the restored right bank of Cherry Creek that had breached.

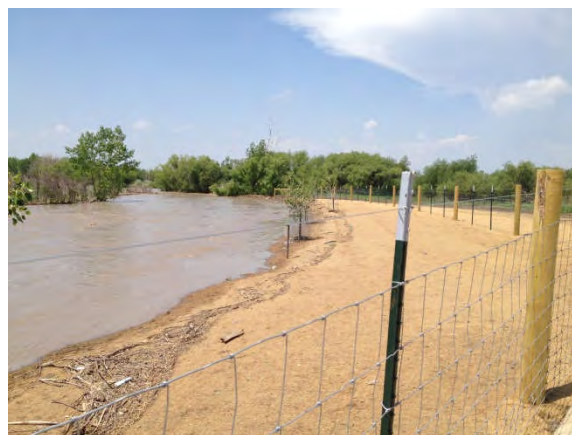
Photo 6 - Restored Breach Area

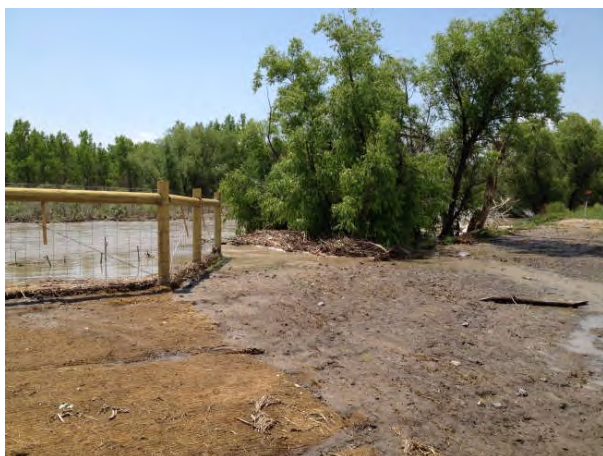
Photo 7 - Bank Overflow Area

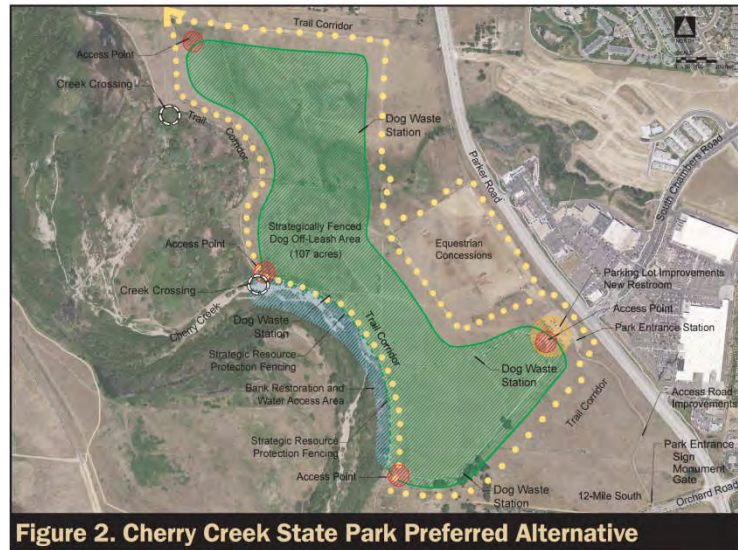
Figure 2. Cherry Creek State Park Preferred Alternative
