**2013 ANNUAL REPORT  
CHERRY CREEK STREAM RECLAMATION AT  
12-MILE CHERRY CREEK STATE PARK – PHASE I  
ARAPAHOE COUNTY, COLORADO  
CORPS FILE NO. NWO-2011-2648-DEN**

**2013 ANNUAL REPORT**  
**CHERRY CREEK STREAM RECLAMATION AT**  
**12-MILE CHERRY CREEK STATE PARK – PHASE I**  
**ARAPAHOE COUNTY, COLORADO**  
**CORPS FILE NO. NWO-2011-2648-DEN**  
**JANUARY 7, 2014**

PHOTO LOG  
CHERRY CREEK STREAM RECLAMATION AT 12-MILE CHERRY CREEK STATE PARK  
ARAPAHOE COUNTY, COLORADO  
NOVEMBER 12, 2013

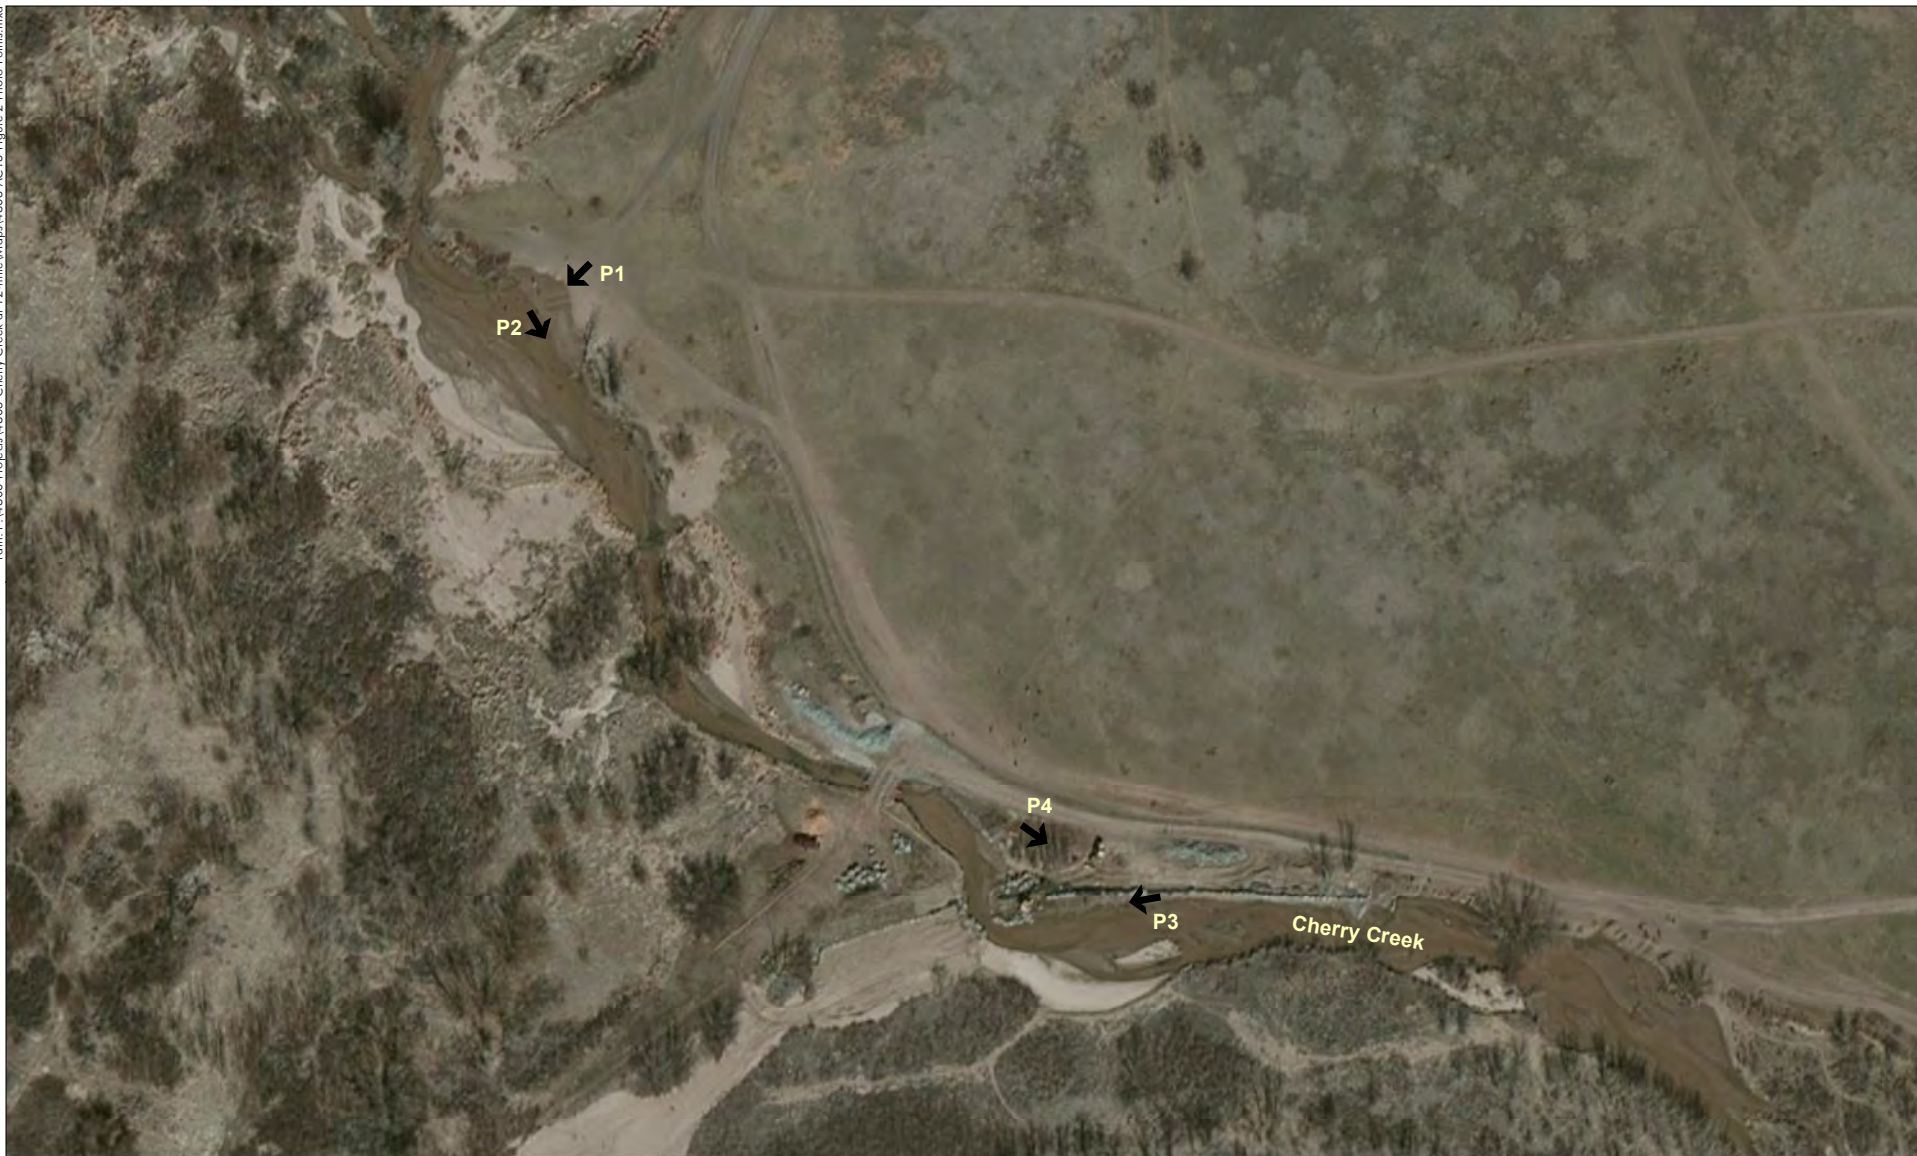
## Figure 2 Photo Points

Courtney Marne with ERO conducted the annual site visit on November 12, 2013 (2013 site visit). During the 2013 site visit, ERO took photos to establish photo points in the project area (Photos 1 through 4). Representative photos of the site are attached and photo points are indicated on Figure 2. ERO qualitatively assessed the vegetation cover and composition in the wetland and upland areas. Hydrology, soil moisture conditions, noxious weed infestations, erosion problems, and other pertinent factors were noted, if present, and the general success of the site was evaluated.

➔ Photo Point

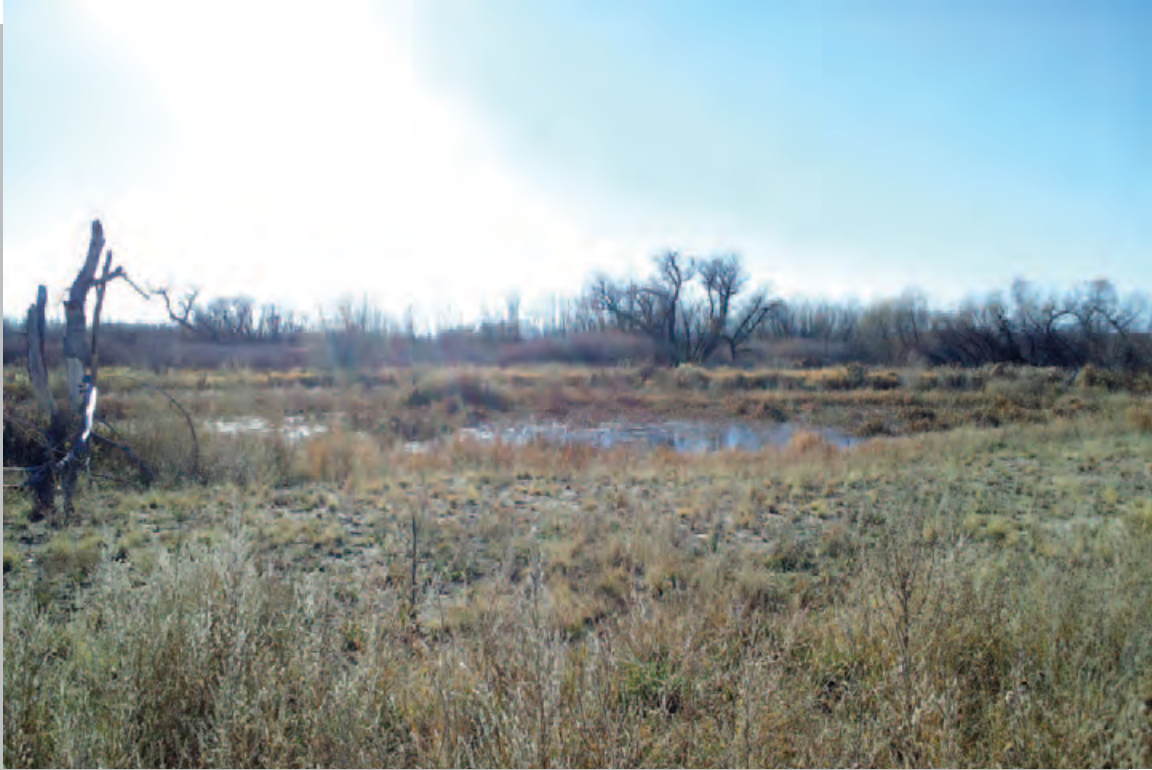
Vegetation is establishing along the constructed berm, the concrete trail, and within the disturbed upland buffer areas with the average cover of 75 percent (Photos 1, 3, and 4). A footpath has been created by people and dogs between the constructed path and boulder edging (Photo 3). It is unlikely vegetation will develop in this area because of its frequent use; however, the area appears stable. Upland vegetative species observed in the project area include blue grama (*Bouteloua gracilis*), sideoats grama (*Bouteloua curtipendula*), switchgrass, kochia (*Bassia sieversiana*), sweetclover (*Melilotus officinalis*), slender wheatgrass (*Elymus trachycaulus*), and common sunflower. No noxious weeds were observed in the project area at the time of the 2013 site visit.

**Photo 1** - Overview of the restored pond with upland and wetland vegetation establishing. View is to the south.

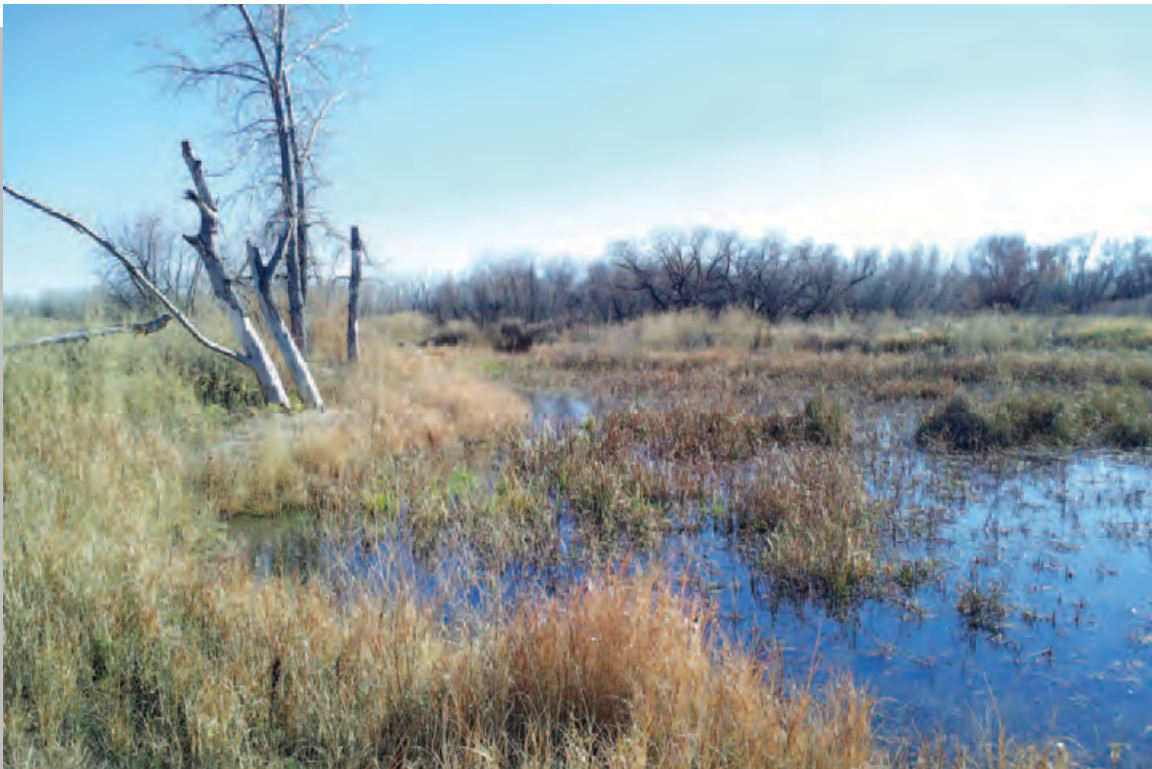
Based on project plans and field observations, it appears the project is successful and was constructed as planned. Project activities have restored the historic alignment of Cherry Creek and no erosion concerns were observed in the project area during the 2013 site visit. The small pond has been restored and wetland vegetation is reestablishing in the pond and along the edges (Photos 1 and 2). The dominant species observed in the establishing wetlands include switchgrass (*Panicum virgatum*), Baltic rush (*Juncus arcticus*), spikerush (*Eleocharis palustis*), prairie cordgrass (*Spartina pectinata*), and

broadleaf cattail (*Typha latifolia*). Sandbar willow (*Salix exigua*) shrubs were also observed resprouting around the pond edges in the project area.

**Photo 2** - Wetland vegetation reestablishing within the restored pond. View is to the southeast.

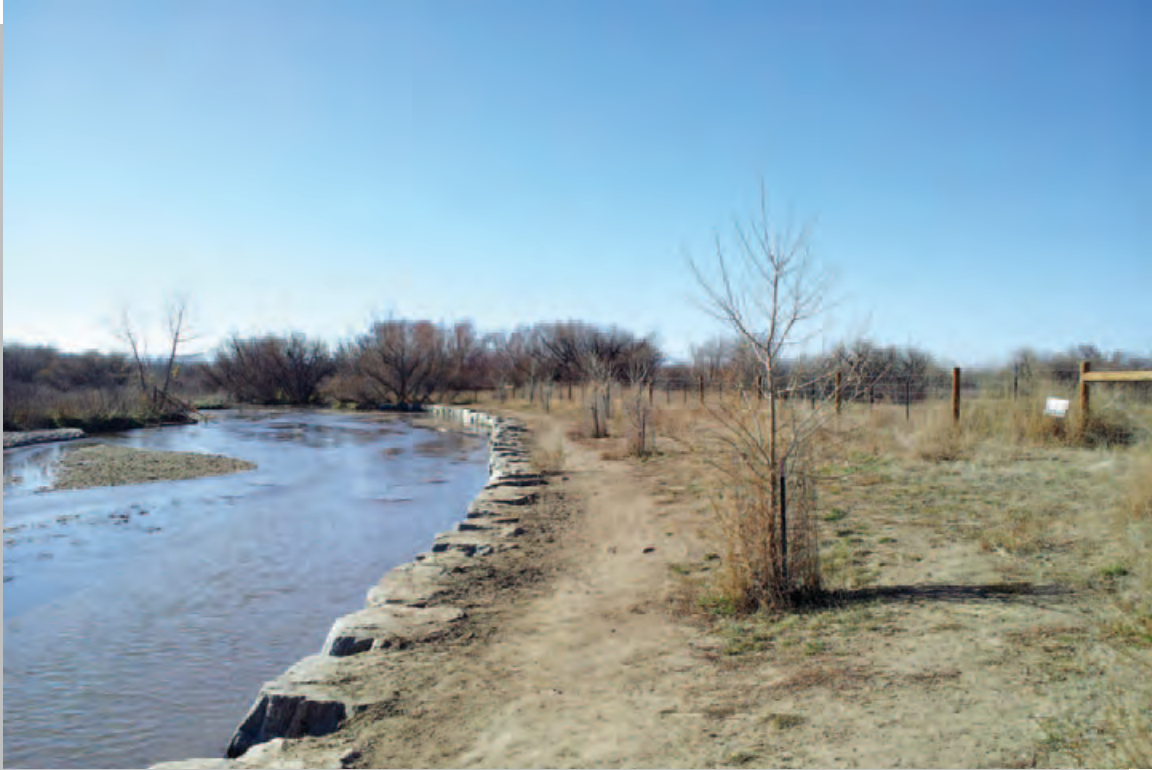
As part of the project plans, 10 plains cottonwood trees were to be planted in the project area along the constructed concrete trail. At the time of the 2013 site visit, all of the planted trees appeared alive and healthy (Photo 3).

**Photo 3** - Installed boulder edging and planted trees along the stabilized bank. View is to the west.

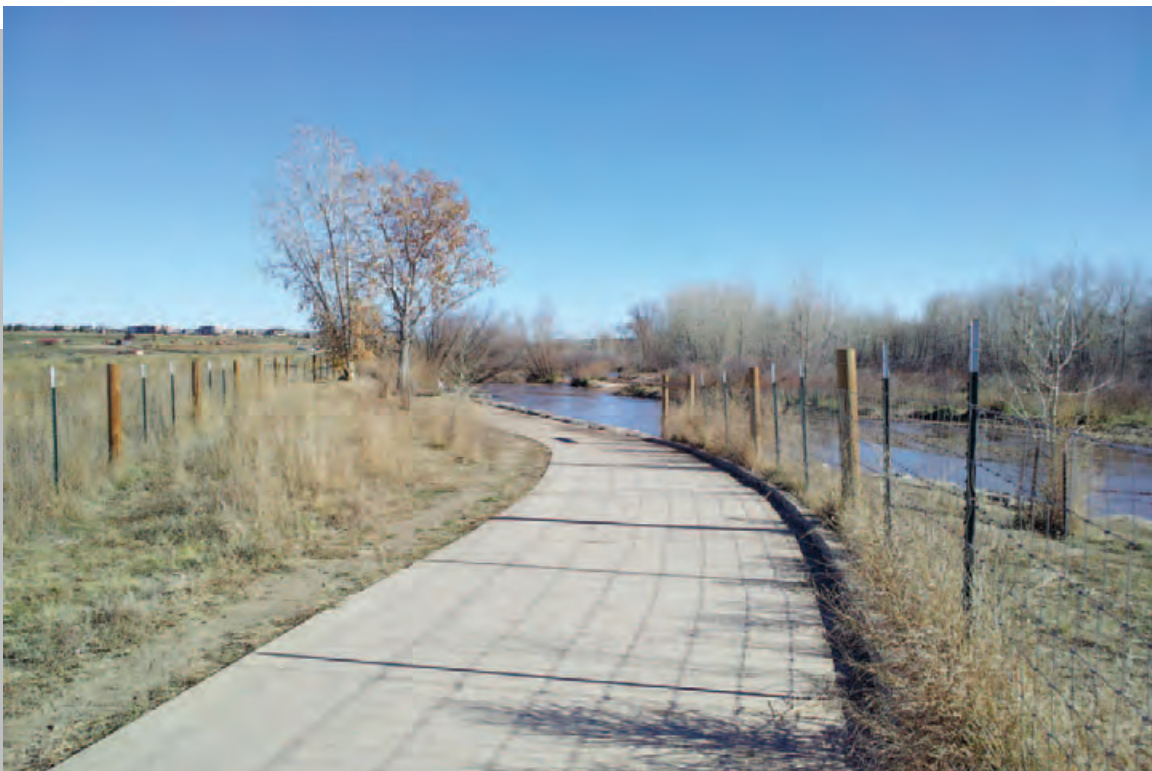
**Photo 4** - Upland vegetation establishing along the constructed trail within the project area. View is to the southeast.
