## Cherry Creek State Park- Mountain and Lake Loop

Shoreline Stabilization and Water Quality Improvement

Preliminary Design Recommendations and Memorandum December 1, 2008

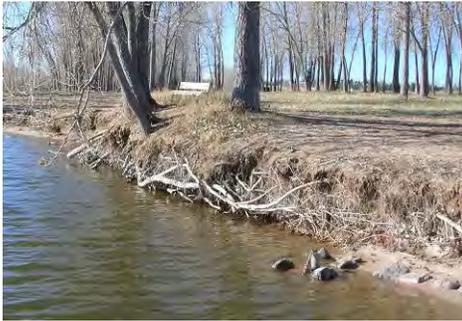
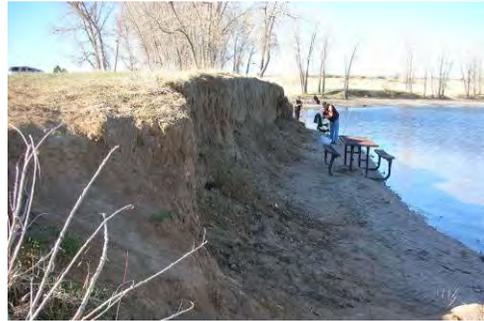
Cut bank erosion examples at Lake Loop area

Wave action, wind, and ice “push” contribute to major cut bank conditions and erosion of shoreline. Cut banks range from 6 inches to more than 8 feet, averaging 2-3 feet.

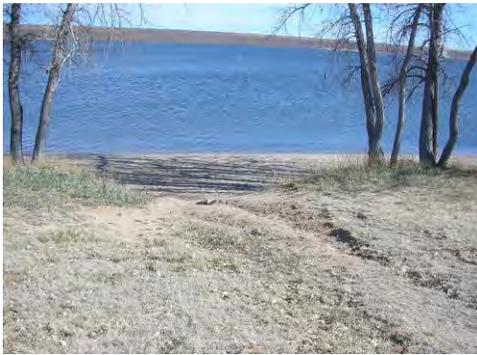
Example of social trail and concentrated flows

Existing social trails and concentrated flows are contributing to higher rates of surface erosion in areas where high levels of activity occur. Surface erosion contributes to higher particulate quantities in runoff and the loss of vegetation. Areas anticipating increased use are therefore vulnerable to the undesirable impacts of runoff erosion and concentrated flows.

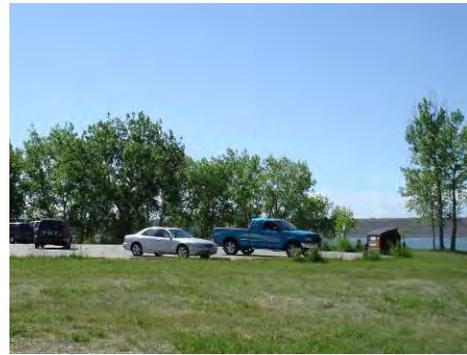
Paved parking area at Lake Loop

Runoff from parking areas is not currently being treated for pollutants before entering the reservoir. Among pollutants commonly found in parking lot runoff, petroleum, rubber, and road grime are prevalent.

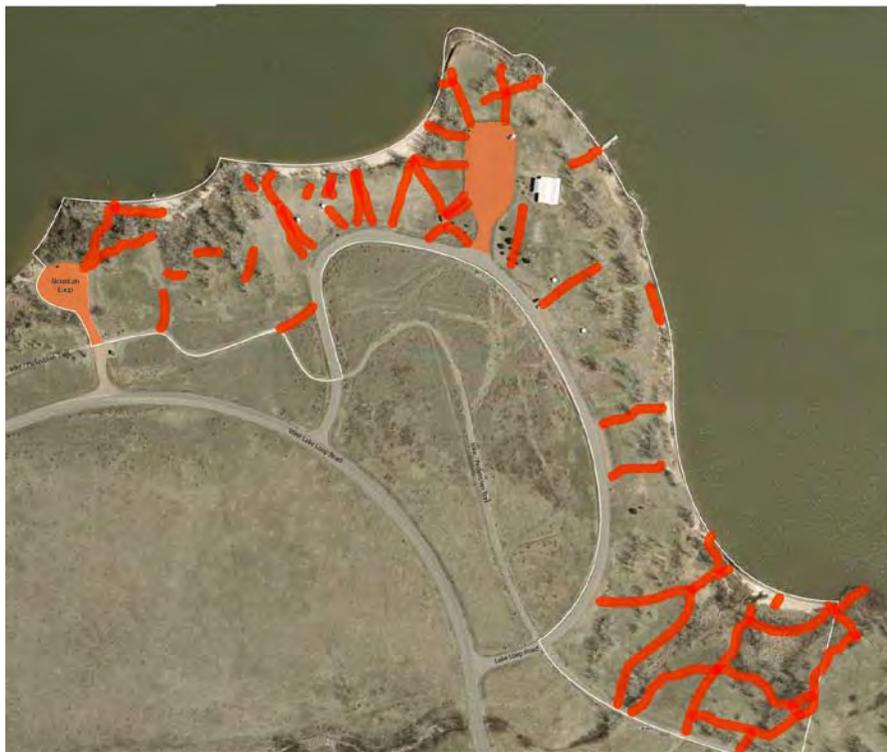
Existing social trails are shown in red. Parking areas are shown in orange: Lake Loop Study Area Resource Management Plan- Stephen Hoover

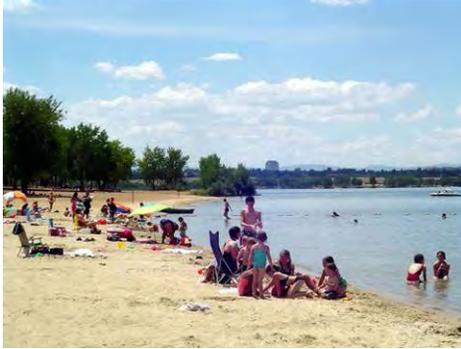
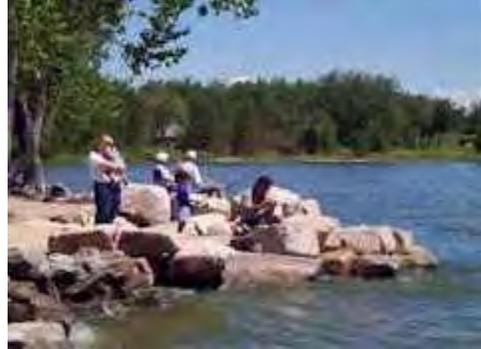
Existing beach and recreation areas are crowding forcing overflow to move to less developed areas.

According to Cherry Creek State Park officials, use is increasing beyond designed capacity at existing developed recreational areas around the reservoir forcing users to overflow into less developed areas of the Park such as the Lake Loop and Mountain Loop. These areas are experiencing increasing visitor days and higher usage levels. According to officials, these areas are expected to develop into “medium to high” use areas within the next 5-10 years creating concern for increased erosion due to loss of vegetation, compaction of soils, and concentrated use in areas like paths, fishing areas, and beaches and picnic areas.

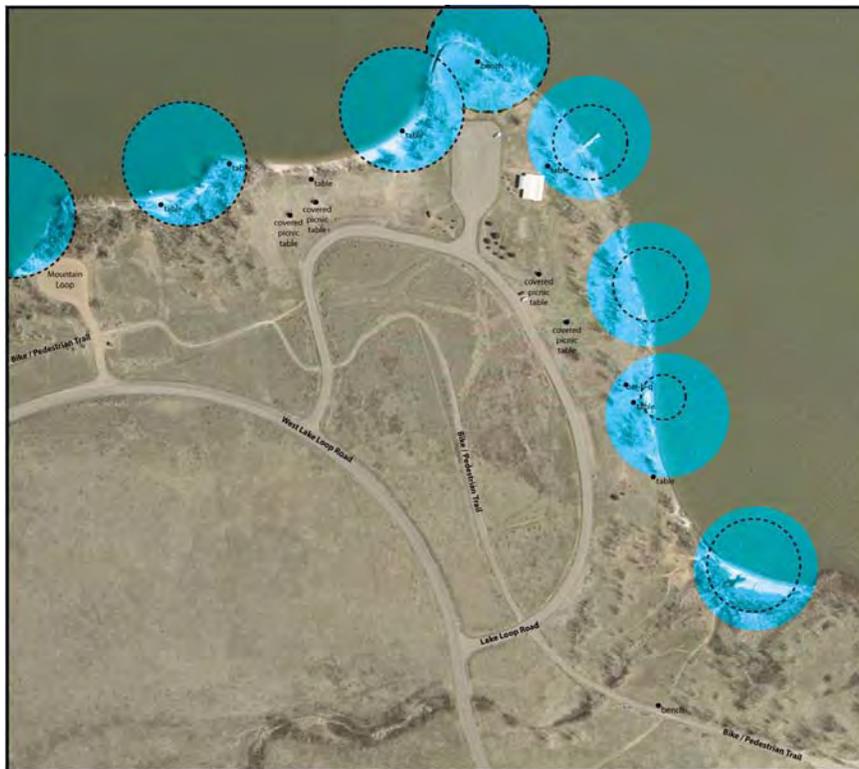
Existing activity areas expected to increase in utility are shown in blue. From Lake Loop Study Area Resource Management Plan- Stephen Hoover

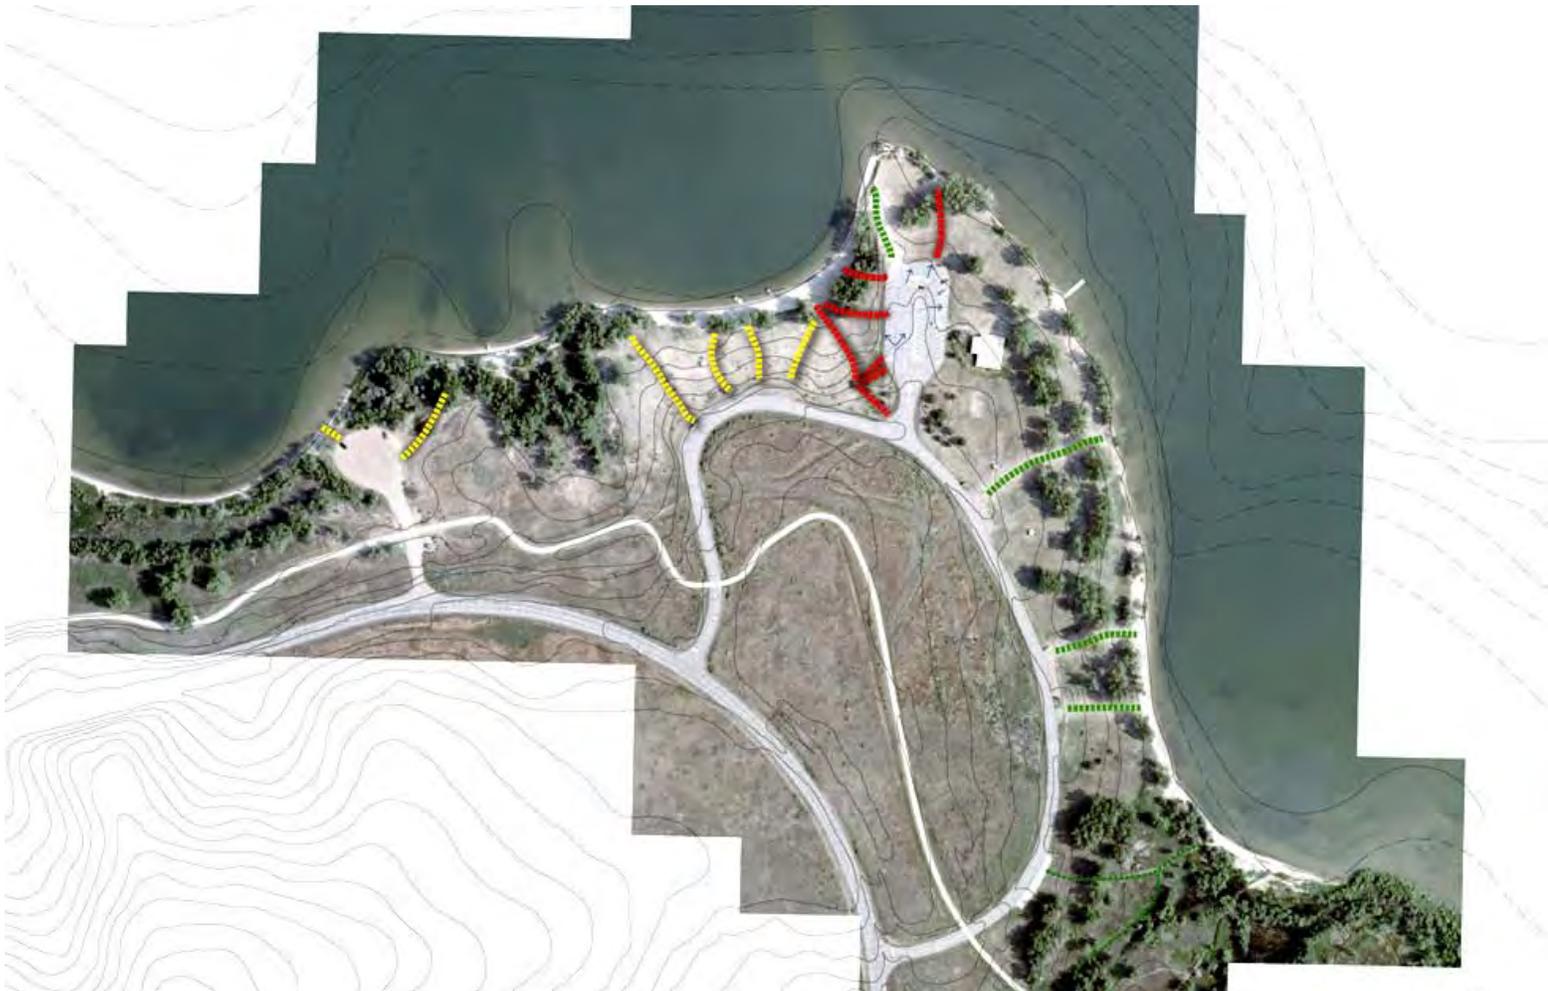
The diagram below illustrates the condition of an existing social trail system and prioritizes improvements as follows:

**Green** trails have generally shallow slopes and receive low to moderate volumes of foot traffic resulting in only minor erosion. *Green trails do not have recommended improvements under this scope of work.*

**Yellow** trails have moderate slopes and receive higher traffic volumes resulting in moderate erosion. *Minor improvements to Yellow trails are recommended under this scope of work.*

**Red** trails have steeper slopes, high volumes of social traffic and concentrated flows from adjacent impervious areas resulting in major erosion issues. *Major improvements to Red trails are recommended under this scope of work.*

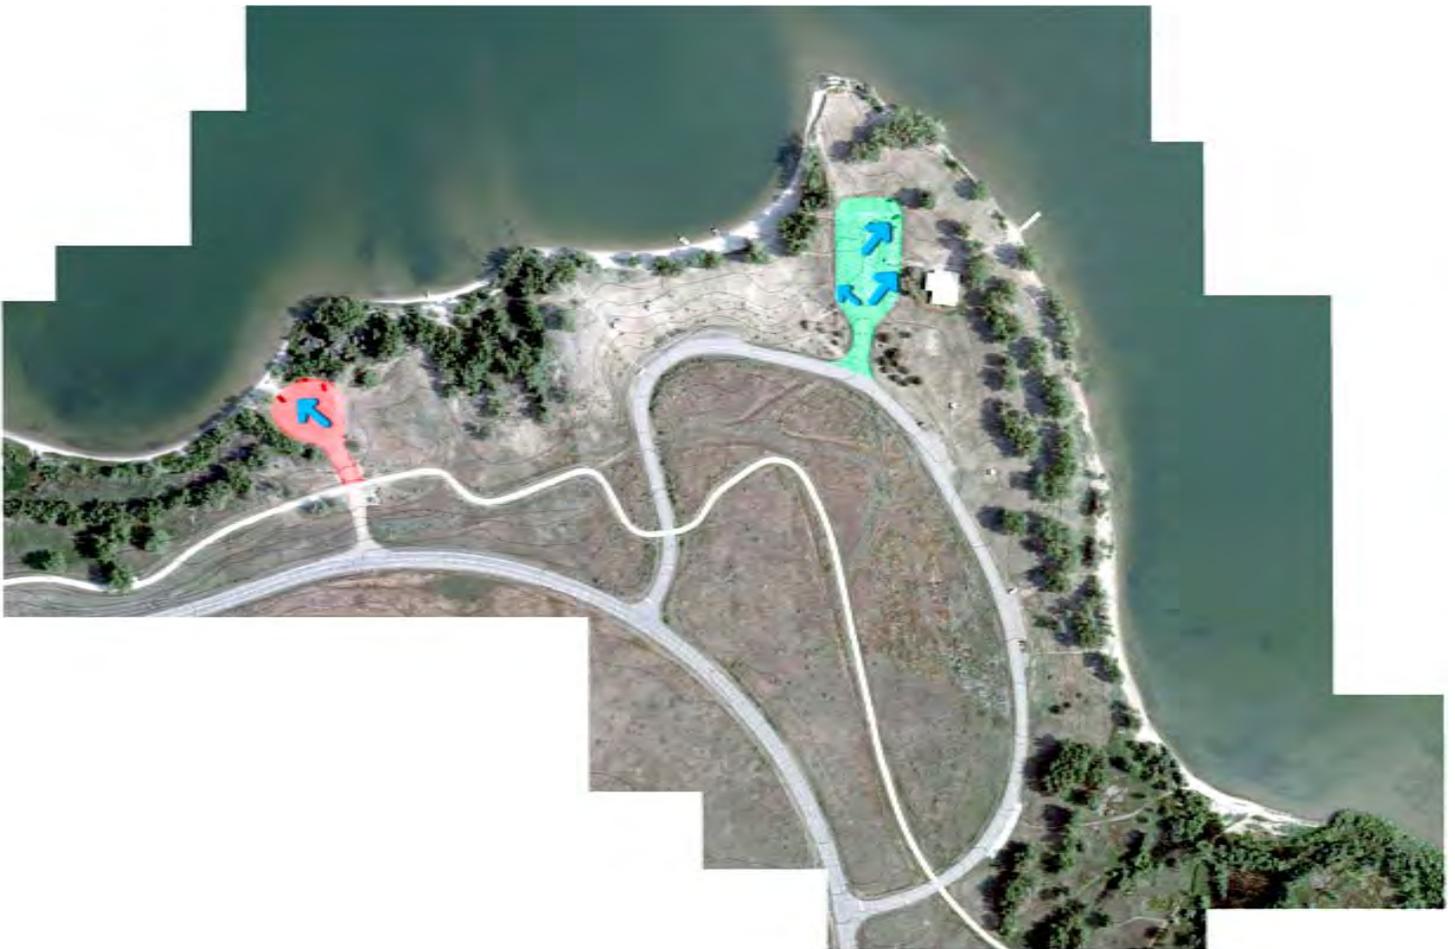
The diagram below illustrates the existing parking areas.

The Lake Loop parking area (shown in green) is paved with asphalt. Drainage generally moves North and East towards the reservoir. *Improvements are not recommended to the parking surface itself, however, mitigation of runoff is recommended.*

The Mountain Loop parking area (shown in red) is paved with gravel/road base. Drainage generally moves North and West toward the reservoir. This parking area is extremely close to the shoreline and runoff moves along social trails and without any buffer directly into the reservoir contributing to sediment loads. *Recommended improvements include reconfiguration of the parking area in order to provide buffer and mitigation of runoff.*

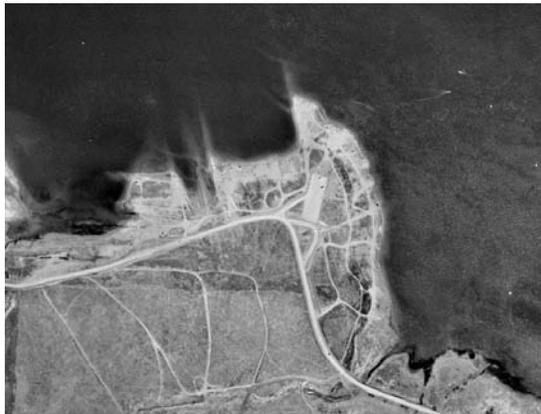
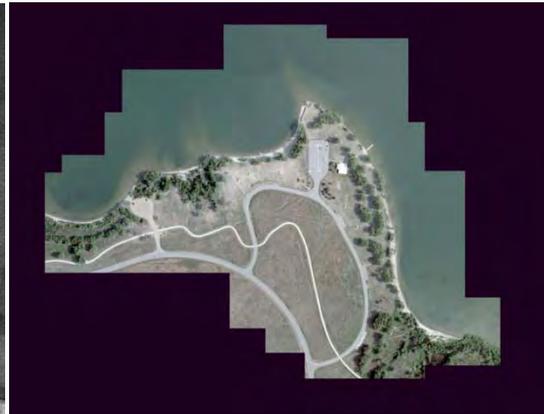
Of particular interest, are noticeable differences in the formation of beaches that have developed from particulate movement due to erosion and deposition and resulting in a general “smoothing” of the shoreline.

Aerial photo of Mountain and Lake Loop area 1966.

Aerial photo of Mountain and Lake Loop area 2007.

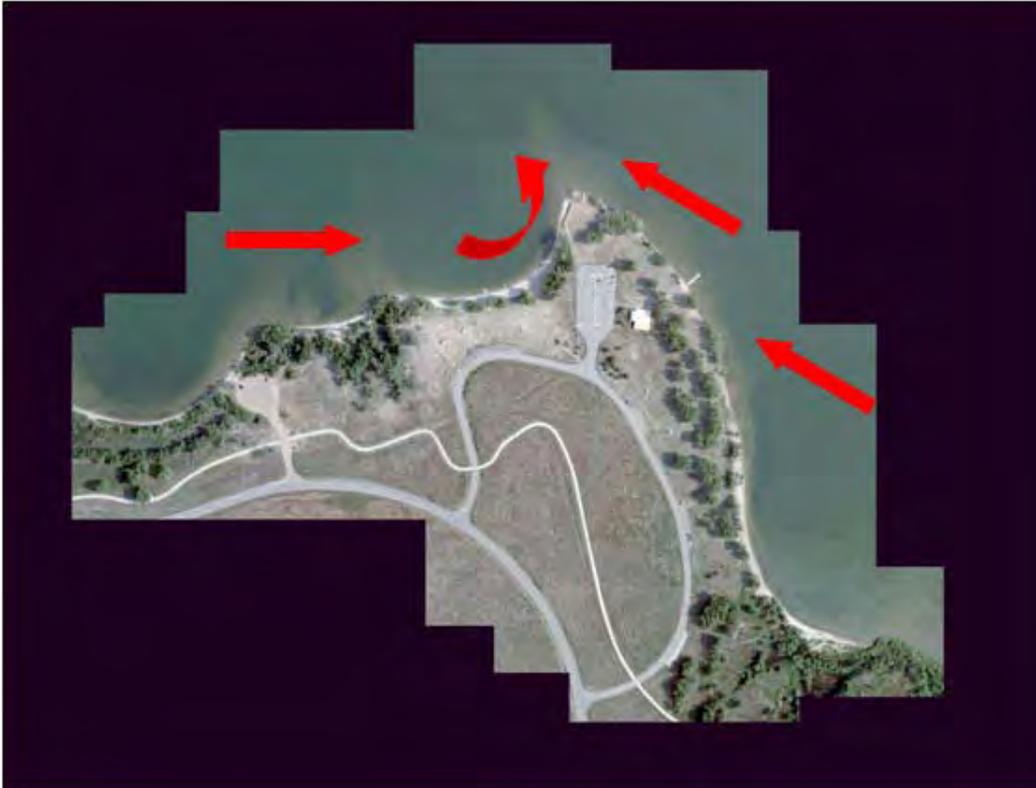
The observed pattern of erosion at the site appears to differ from one side of the site to the other. As the diagram below illustrates, empirical analysis from site observations indicate that prevailing forces (wind and wave action) on the East side of the site tend to move from the East towards the site and are deflected to the North, whereas the forces impacting the West side tend to move from the West and also deflect to the North. It is therefore recommended that stabilization techniques should respond to differing force directions.

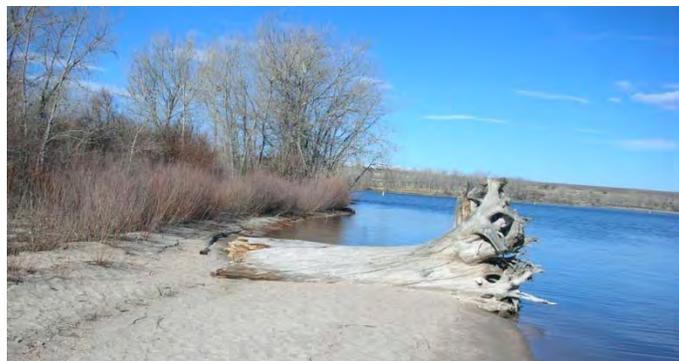
Many natural processes are visibly at work around the site. Specifically, there are several examples of bank stabilization as a result of established vegetation, and beach deposition occurring behind natural points created by established vegetation and debris like the stump shown below. These natural processes show the effectiveness of, and encourage the use of, stabilization strategies such as points and/or jetties which both stabilize shoreline and encourage the buildup of healthy beach areas by reducing sediment movement.

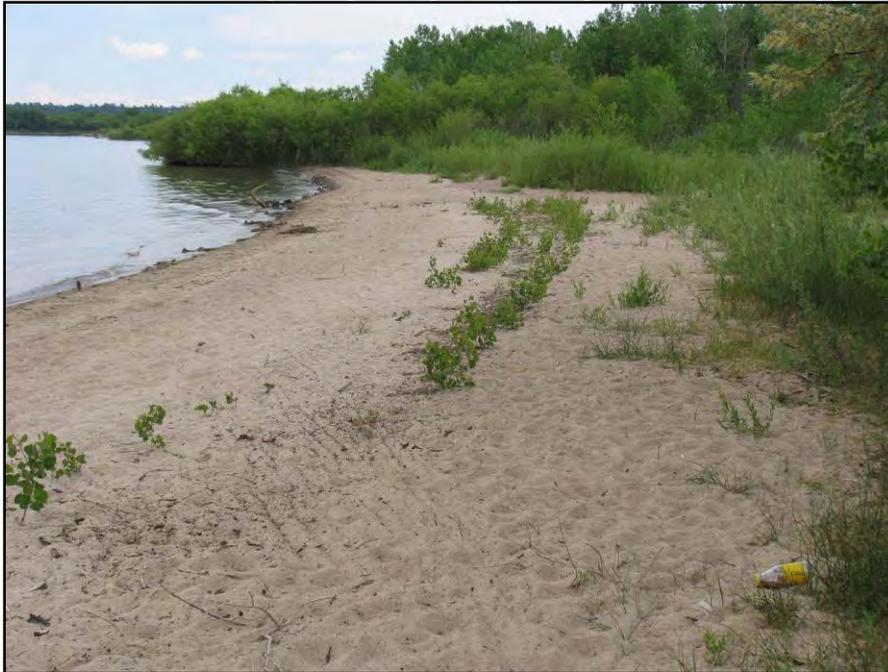
**Figure 1.** A beach area east of the Lake Loop, with young cottonwood seedlings. These trees may be uprooted by wave or ice action before they can mature to saplings.

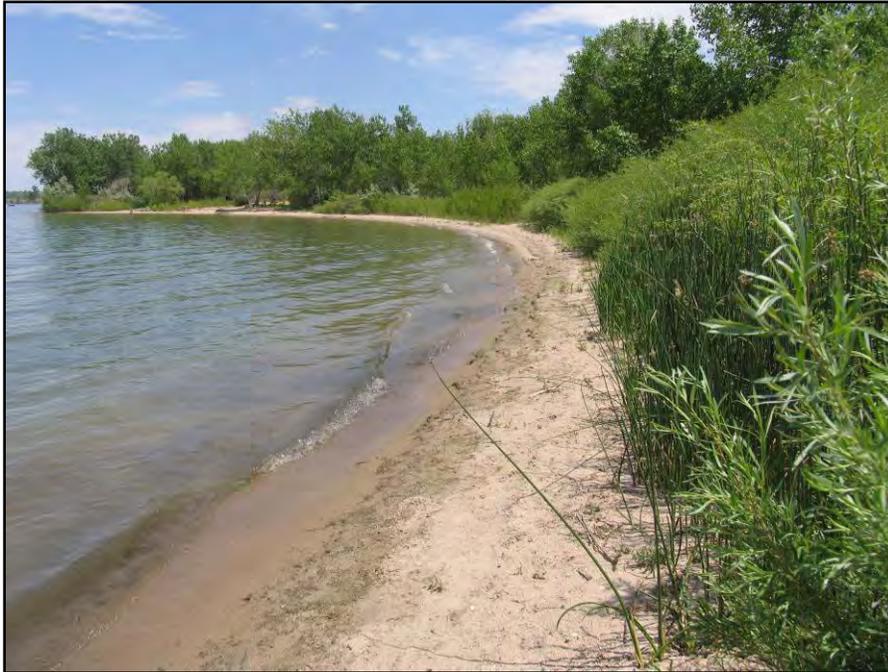
Figure 2. Beach Margin wetland west of the Mountain Loop beach area. Bulrush and sandbar willows are visible on the low sandy berm at the rear of this beach.

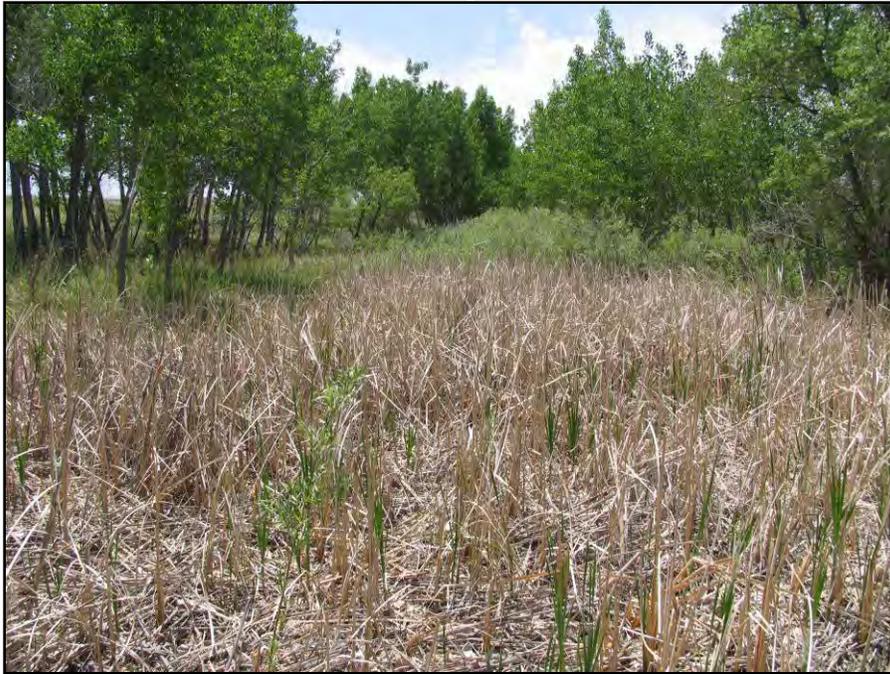
Figure 3. Marsh wetland with narrow-leaved cattail in the wet central area, ringed by sandbar willows and riparian woodland. Mountain Loop.

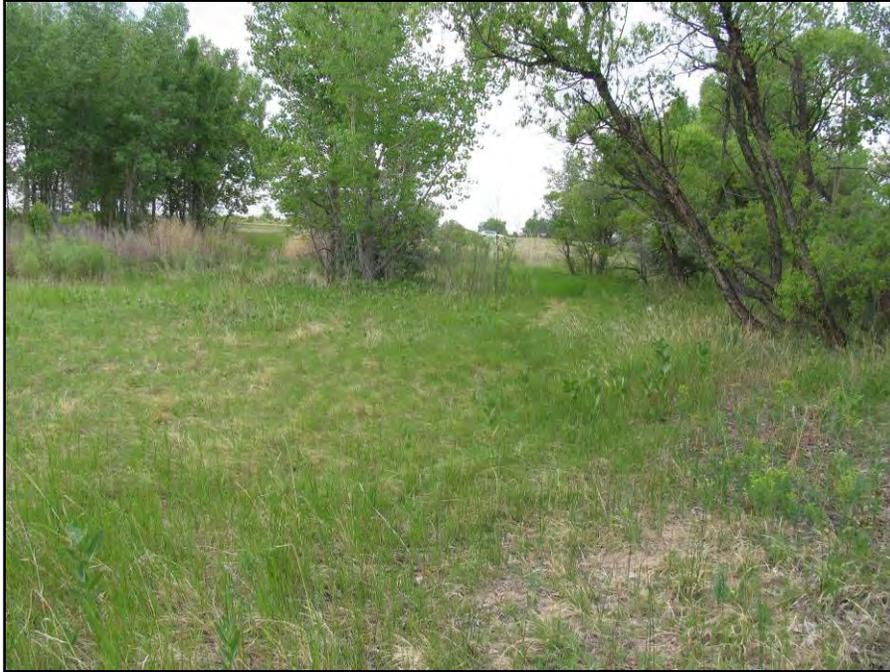
Figure 4. Riparian woodland and meadow in the eastern portion of Lake Loop.

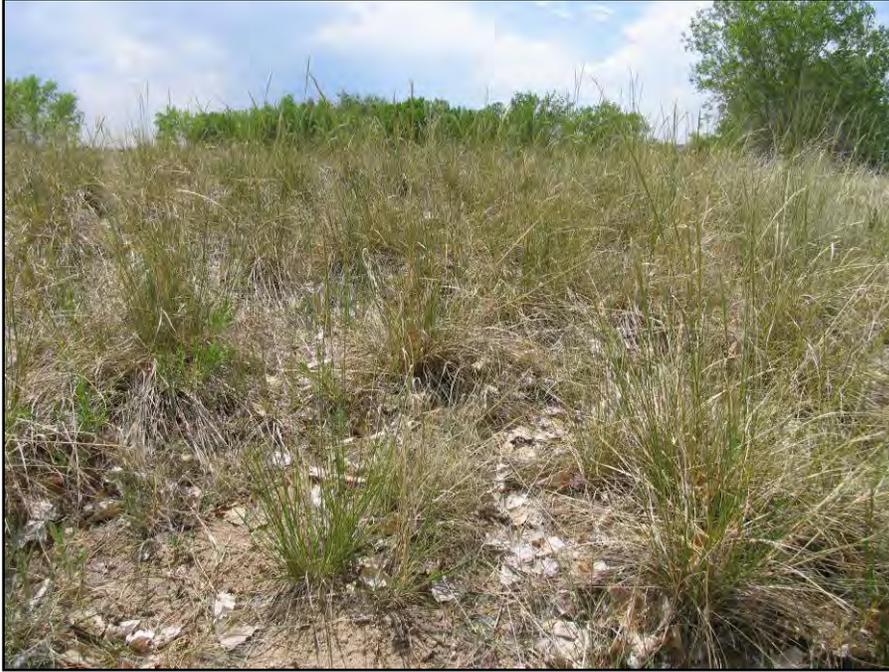
Figure 5. Native upland prairie in Mountain Loop, with the native bunchgrass needle-and-thread grass in the foreground.

Plant diversity of this prairie remnant has been reduced by a variety of recent disturbance events, but surviving species include: buffalograss (*Buchloe dactyloides*), blue grama (*Chondrosum gracile*), western wheatgrass (*Pascopyrum smithi*, aka *Agropyron*), sideoats grama (*Bouteloa curtipendula*), three awn (*Aristida purpurea*), green needlegrass (*Nasella viridula*, aka *Stipa*), needle-and-thread grass (*Hesperostipa comata*), golden aster (*Heterotheca villosa*), (*Psoralidium tenuiflorum*, aka *Psorlea*), scarlet globe mallow (*Sphaeralea coccinea*), and rubber rabbitbrush (*Chrysothamnus nauseosus*). Numerous weedy species also are present, including: great mullein (*Verbascum thaspus*), leafy spurge, cheatgrass (*Anisthana tectorum* aka *Bromus*), and Japanese brome (*Bromus japonicus*). Two non-native grasses smooth brome and crested wheatgrass occur occasionally, probably due to interseeding. In places (especially just west of the lake

Loop Parking area) the moister edge near the reservoir is densely colonized by the introduced yellow sweet clover, which can grow up to 6 feet in height.

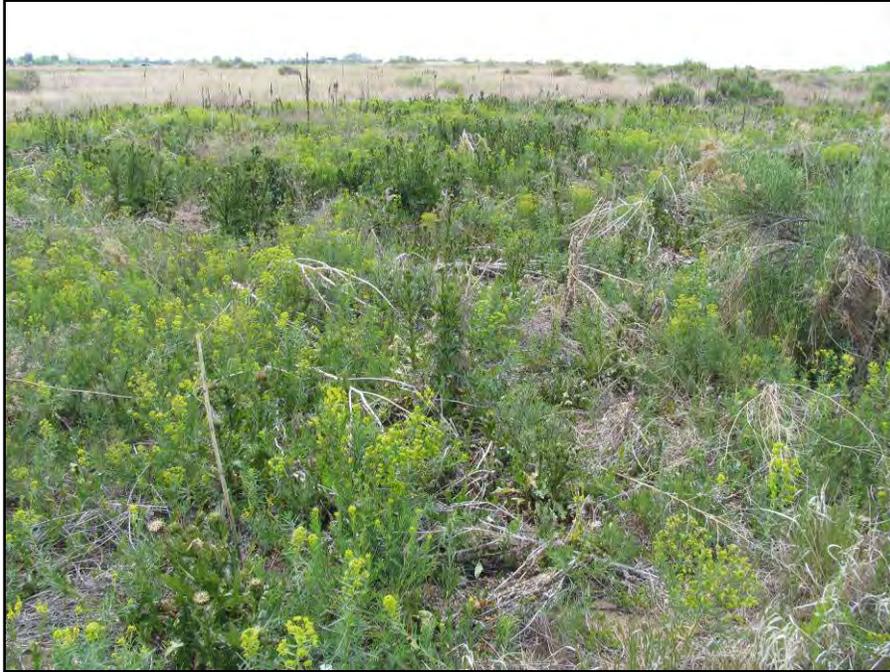
Figure 6. A weedy area within the disturbed upland grass vegetation type, showing weedy species: musk thistle and leafy spurge.

This is the most extensive of all the mapping units in the study area. Much of the upland areas south and west of Mountain and Lake Loop support this vegetation type. Reclamation activities following dam construction, inter-seeded with non-native grass species: smooth brome and crested wheatgrass. Soils here are the typical silt loams found elsewhere around the reservoir. A few native species persist where the exotic grasses failed. Species with windborne seeds have become established in the **disturbed upland grasslands**, including the native shrub, rubber rabbitbrush and the noxious weed, musk thistle (*Carduus nutans*). Leafy spurge, another noxious weed is also present.

While the non-native grasses which dominate the **disturbed upland grassland**, do provide cover for soil and forage for grazing animals, the lack of native prairie grasses and diverse wildflowers and shrubs greatly diminishes the habitat and aesthetic values of this largely disturbed cover type.

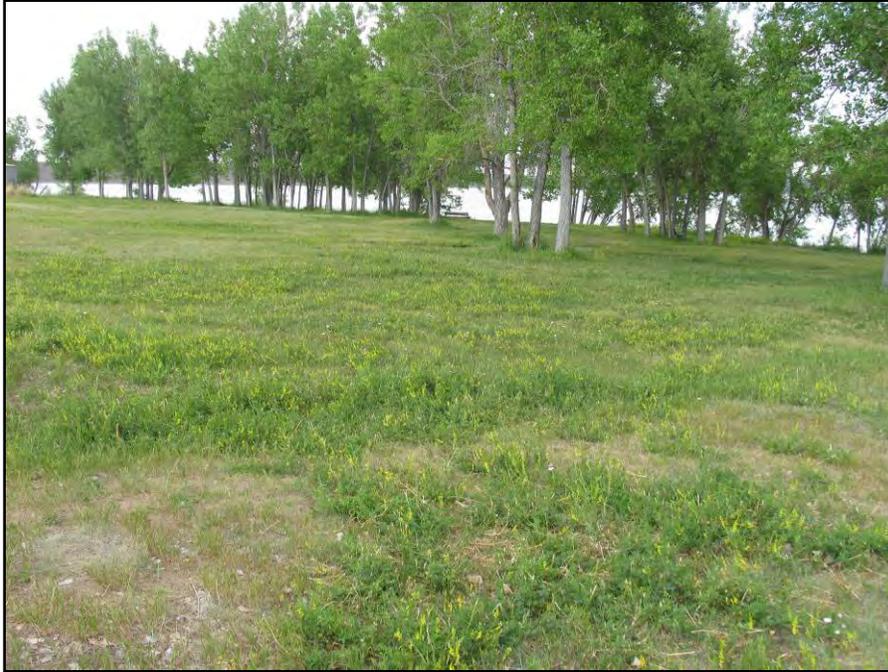
Figure 7. Mowed lawn in the Lake Loop area showing diverse mowed species with closely growing mid-sized cottonwood trees.

The largest vegetation type is represented by the **mowed lawn** at the Lake Loop. The vegetation within this lawn area has species elements found elsewhere in riparian woodland and meadow, as well as remnant upland prairie and disturbed upland grassland cover types. The soils supporting this mowed vegetation are the typical native silt loam and silty clay loam. Scattered stands of mid-sized cottonwoods occur throughout, reaching to the shore where the native soils approach the water's edge. The cottonwood stands consist of closely spaced young trees, much as those found in the riparian woodlands elsewhere on the site. Stands of trees near the water occasionally have small peach-leaved willows, as well. Unmowed taller grasses under the trees, discourages foot traffic and picnicking, thus protecting the tree roots from excessive compaction, which can kill these trees. Some weedy non-native species are present, mostly represented by yellow sweet clover. Although the lawn *is not* irrigated Kentucky bluegrass, it serves well as a landscape for picnicking and other beach related recreational activities. This area is very important to the recreational users of the park.
