CHERRY CREEK STREAM RECLAMATION AT ECO-PARK

Cherry Creek Basin Water Quality Authority

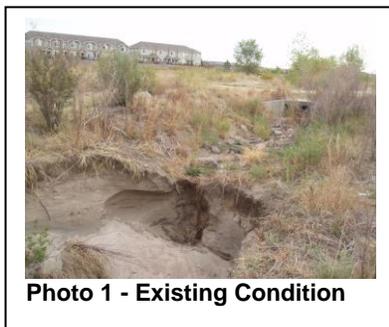
Photo 1 - Existing Condition

Urbanization and the resulting increase in the rate, frequency, duration and magnitude of stormwater runoff accelerated degradation of the streambed and banks. Typical pre-project conditions are shown on Photos 1, 2 and 3 documenting that Cherry Creek has degraded up to 10-feet within the streambed.

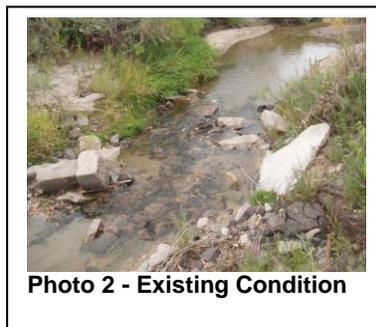
Photo 2 - Existing Condition

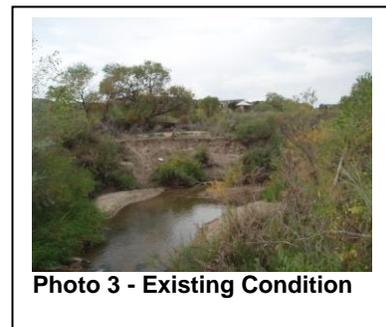
Photo 3 - Existing Condition

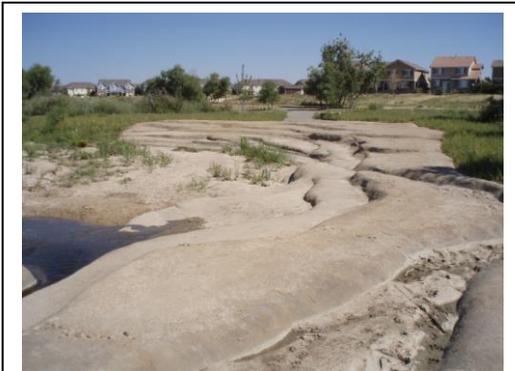
Hand sculpted concrete drop structures, as shown on Photo 4, are incorporated into the project to flatten and control the longitudinal grade, with sheet pile cut-off walls to protect the structure from damages during the larger flood events. Riffle-pool structures, constructed entirely of rock, were constructed in the channel to aide in conveyance of the mean flood event in the narrower channel. Larger floods in these areas then spread over the broader floodplain, This design approach lowers the runoff velocities allowing for more filtration and infiltration.

Photo 4 - Sculpted Concrete Drop

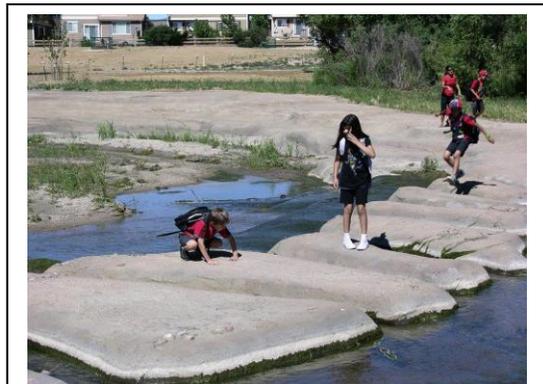
The Project included secondary channels in two locations, three sculpted concrete drops, one sculpted concrete splitter drop, one lateral weir drop, and six riffle drops. The sculpted concrete splitter drop, located closest to the the Eco Park trail access bridge over Cherry Creek provides for an interactive creek crossing, see Photo 5.

Photo 5 - Sculpted Drop Creek Crossing

The lateral drop weir and the sculpted concrete splitter drop each divert stream flows into a secondary channel section as the water level in Cherry Creek rises to the diversion invert elevation. This design feature allows for the stream flow to widen out into two channels and further reduce velocities. The secondary channels are beneficial for reconnection of the water table with portions of the floodplain. Six different types of bioengineered bank protection details were installed along the realigned/reshaped channel through the project. The bank protection types were unique for

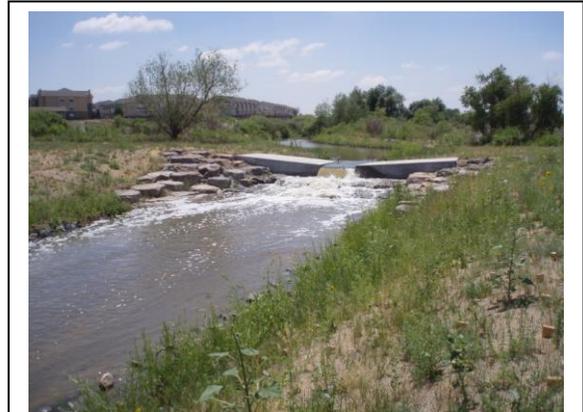
A flow monitoring and sampling station was installed near the lower end of the project to provide a data collection point for the Authority as shown on Photo 6. This data collection point is one of a series used by the Authority along Cherry Creek to monitor nutrient loading and stream flows within the Cherry Creek Basin.

Photo 6 - New Monitoring/Sampling Station

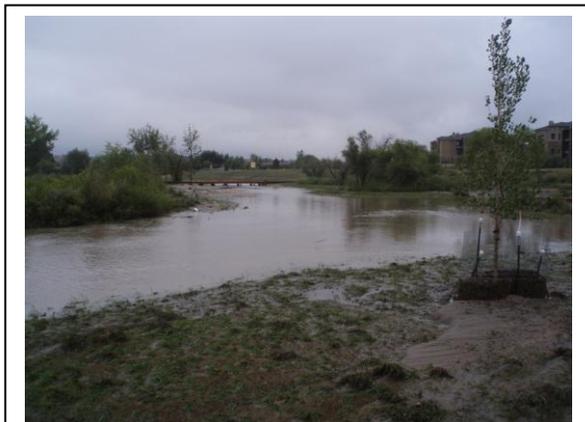
Photo 8 - Flooding Damage

An on-site inspection followed that found that all major structures designed and installed to control the minor and significant storm runoff events each functioned as expected. None were damaged or adversely impacted. The upper banks where the revegetation work had not re-established itself yet, received the majority of the damage. Seeded areas had eroded, upper bank material was displaced and low areas filled in. Crusher fine trails were washed out in specific locations where runoff was concentrated. The project team quickly assessed the damage and the project consultant prepared an overall restoration plan. Restoration work began promptly to repair areas impacted by the flooding. It was anticipated that the flood damages would have been minimal if the project vegetation had a season or two to establish itself. This is confirmed following a brief site visit to the Parker Jordan Centennial Open Space project immediately upstream of Eco Park. It is strong testimony that bioengineering design works for stream reclamation after the vegetation is established.

Photos 8, 9, 10 and 11 show some of the typical damage from the storm.

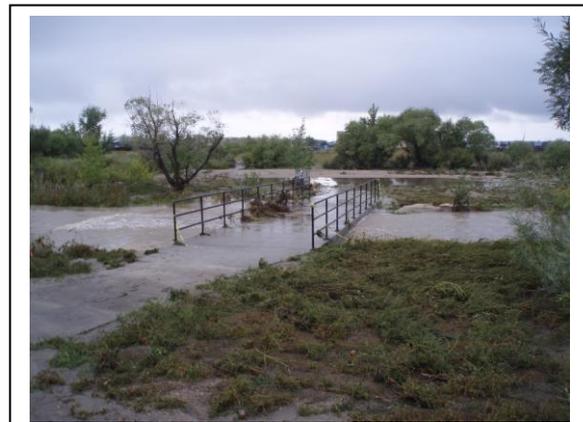
Photo 9 - Flooding at a Trail Crossing

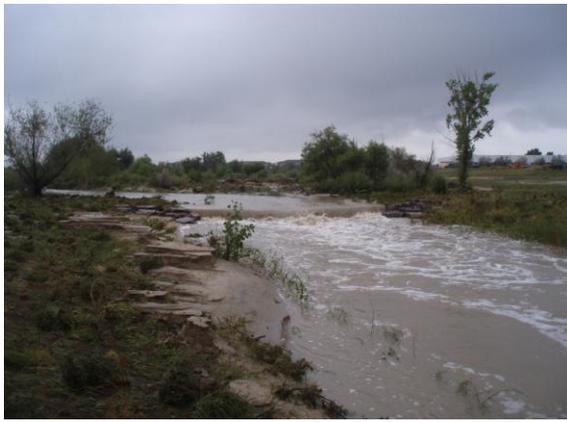
Photo 10 - Flooding Damage

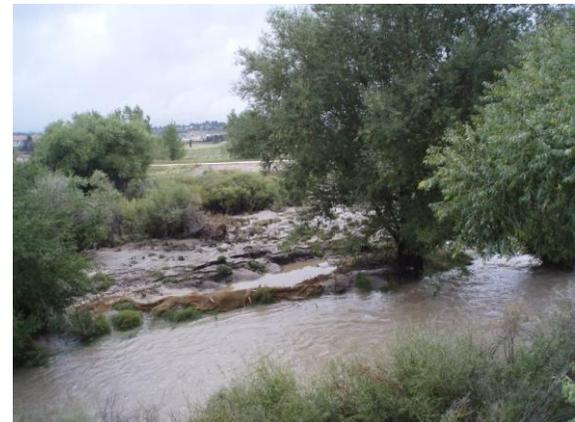
Photo 11 - Flooding Damage
