SHORELINE STABILIZATIONS

East Shade Shelter, East Boat Ramp, Tower Loop, and Dixon Grove

Memorandum

To: Chuck Reid, Manager, CCBWQA
CC: Rick Goncalves, Chairman, TAC
From: William P. Ruzzo, P.E.
Date: December 27, 2013
Re: Early Shoreline Stabilization PRFs – Project Summary Report

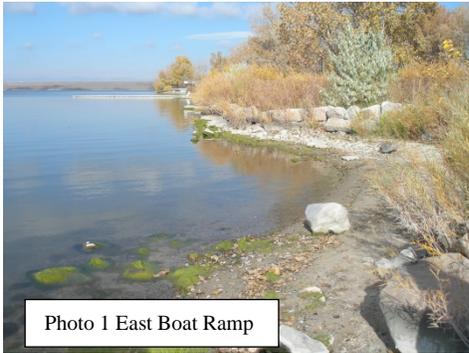
Photo 1 East Boat Ramp

The dominant shoreline stabilization method is to use riprap and large boulders supplemented with willow, bushes, trees, and other suitable vegetation plantings. See Photos 1, 2, and 3. Runoff from parking lots is addressed by creating wetland retention areas (see Photo 1) or infiltration areas that filter pollutants in the runoff minimizing the discharge into the reservoir.

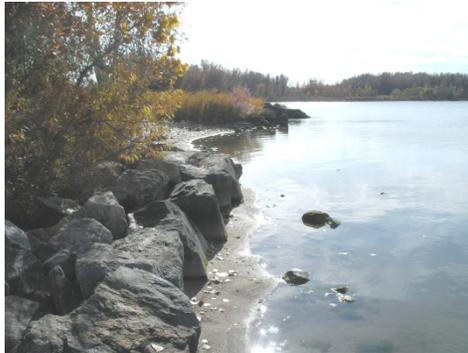
The boulder sizes exceed rock sizes needed to protect the shoreline from wave erosion. However, it was observed during some winter and early spring periods that ice forces were able to move and displace some large boulders at the east shoreline projects and, for

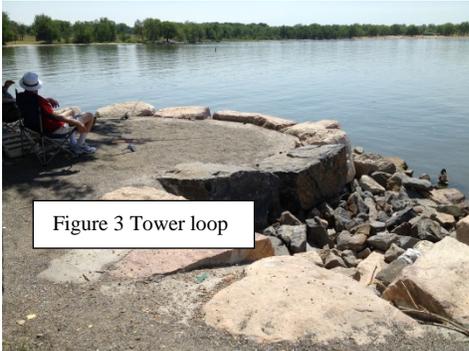
Figure 3 Tower loop

The earlier shoreline PRF's placed large boulders, typically 36" or larger, along the water's edge with the top of the boulder about 18" above the normal maximum water surface (i.e.: 5550 feet) in the Reservoir. For the Tower Loop project (Photo 3), boulders were stacked two and three high creating a wall that raised the fishing platforms constructed along the steep shoreline slope.

Tower Loop, resulted in failure of the boulder walls. The impact of ice forces on shoreline erosion was investigated and changes to the design approach have evolved over the years. See report² for findings and recommendations regarding the Authority's approach.

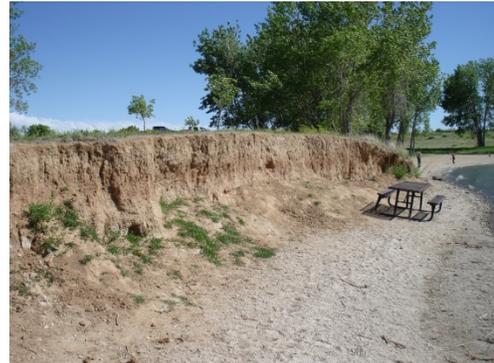
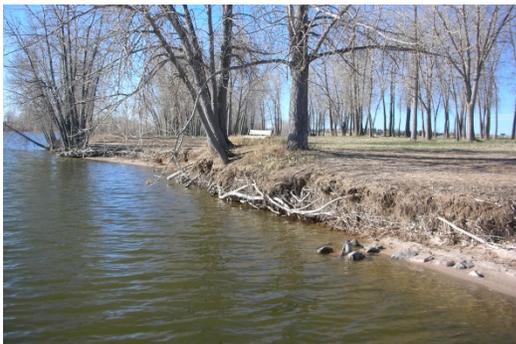
wave and ice forces acting on the shoreline soils, but also from pedestrian and domestic animal uses that destroy vegetation exposing bare soils that are more readily eroded. Examples of shoreline erosion at Cherry Creek are shown on the Photos 4 and 5.
