## **CHERRY CREEK STREAM RECLAMATION AT 12-MILE PARK, PHASE I**

**To:** Chuck Reid, Manager, CCBWQA  
**CC:** Rick Goncalves, Chairman, TAC  
**From:** William P. Ruzzo, P.E.  
**Date:** January 28, 2013  
**Re:** Cherry Creek Stream Reclamation @ 12-Mile Park Phase I – Project Summary

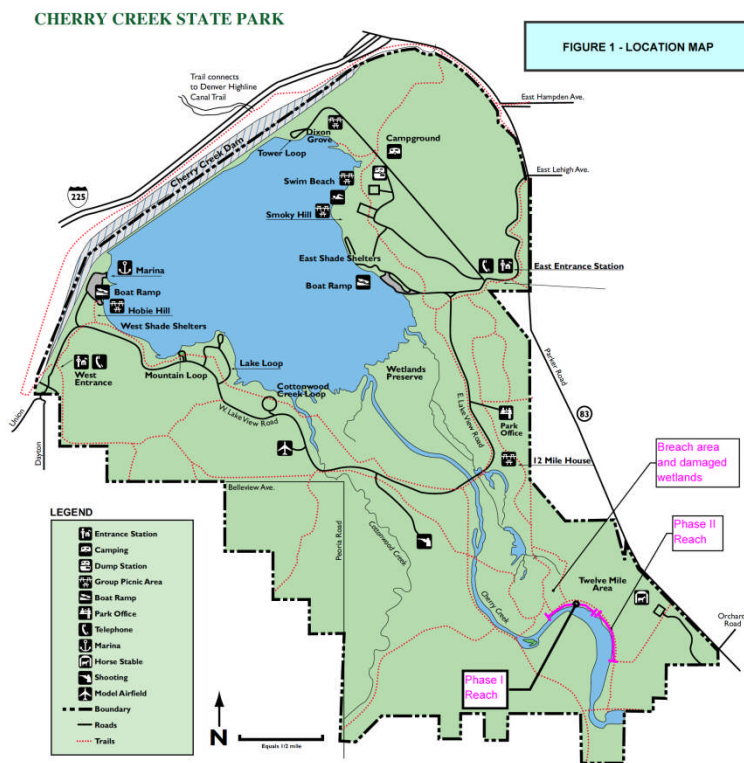
The Authority advertised for engineering consultants to prepare a stream reclamation plan for the entire reach of the Project (see Figure 1) and contracted with CH2M Hill for the work on May 20, 2010. Prior to selection of a consultant, the right bank of Cherry Creek breached causing the creek to change course through the downstream cottonwood grove, damaging the wetlands which is evident in Photo 2. Therefore, the engineering contract included a task to develop an immediate solution to repair the breached right-bank.

CH2M Hill provided a draft alternative evaluation report<sup>1</sup> and recommended permanent repairs to the breached bank area, dividing the Project into two phases. The Authority then amended the CH2M Hill contract on January 20, 2011 for final design of the breach area (Phase I) and again on October 1, 2011 for bidding and construction services.
