## Existing Conditions – Cherry Creek and Piney Creek

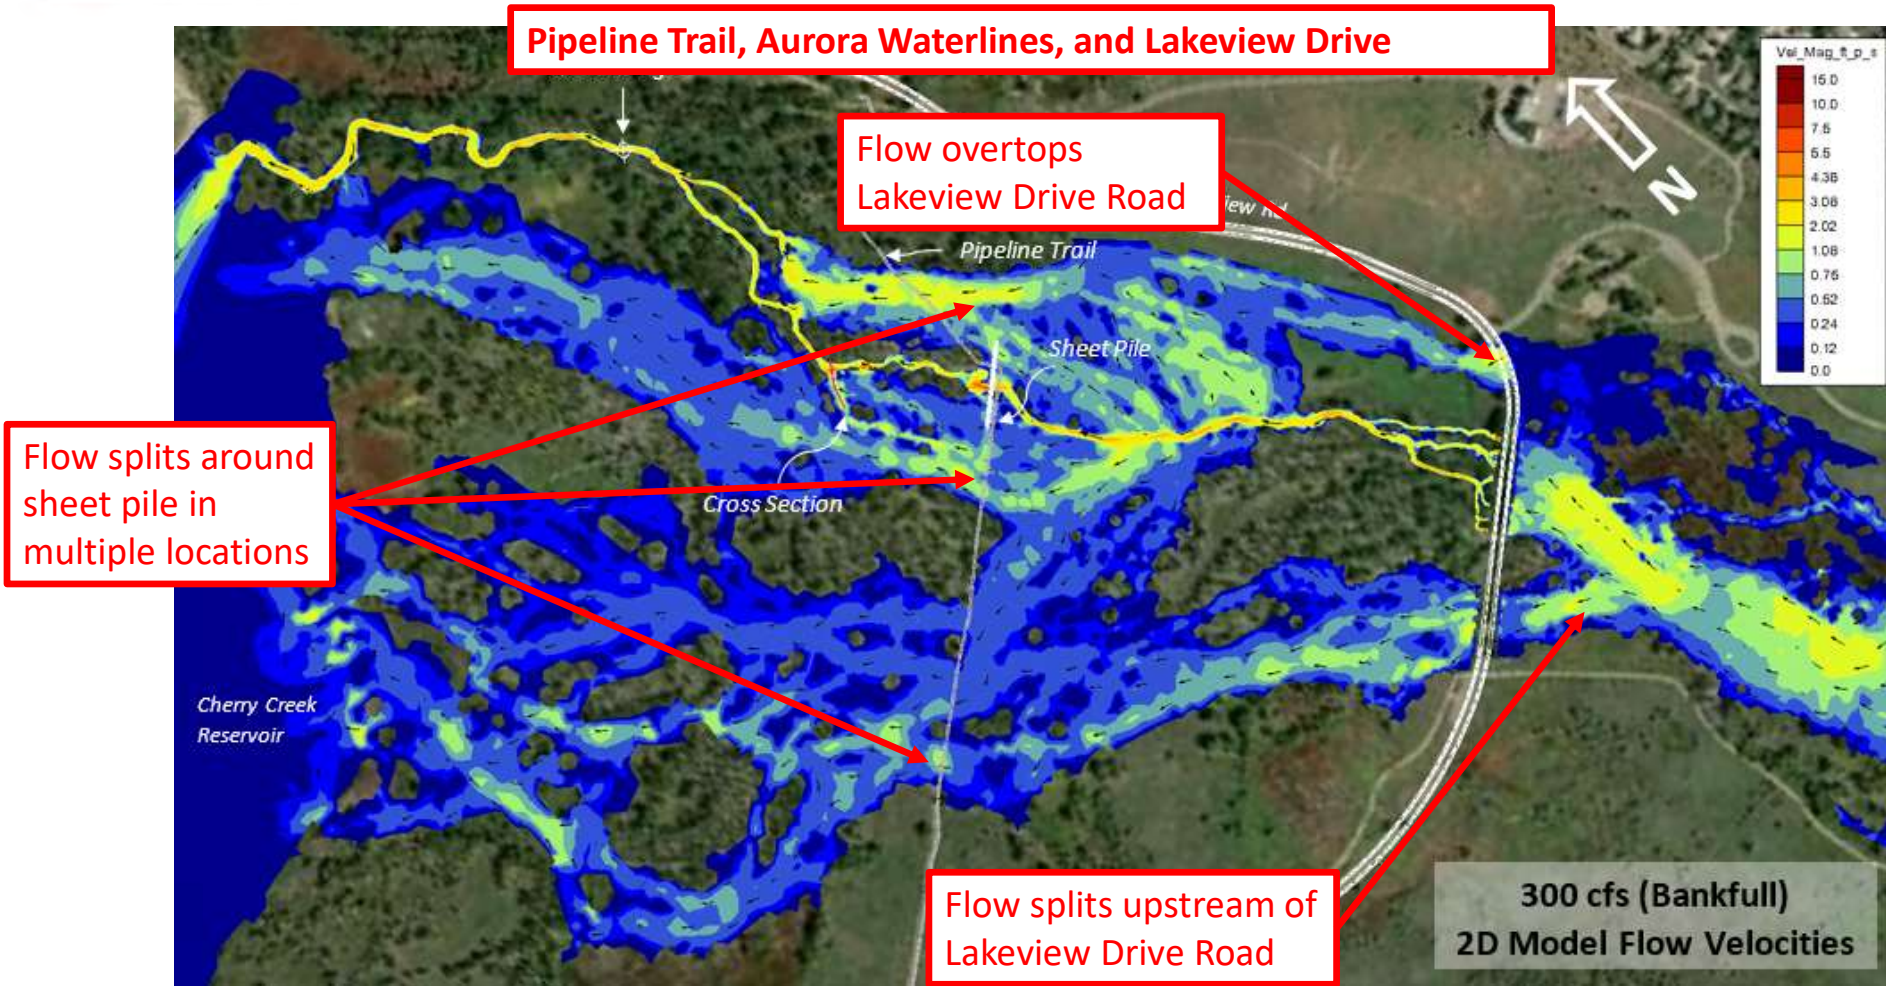
Reach 1 Monitoring Cross Section: Downstream of Pipeline Trail

**History of Widening:**

- Roughly 8' lateral migration since 2013

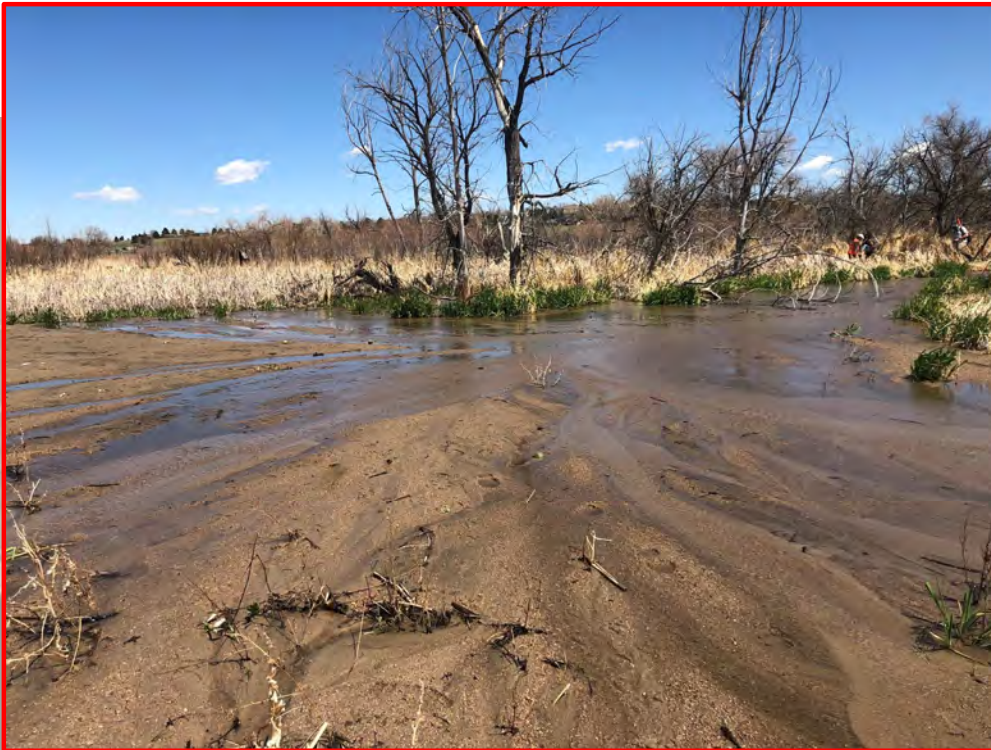
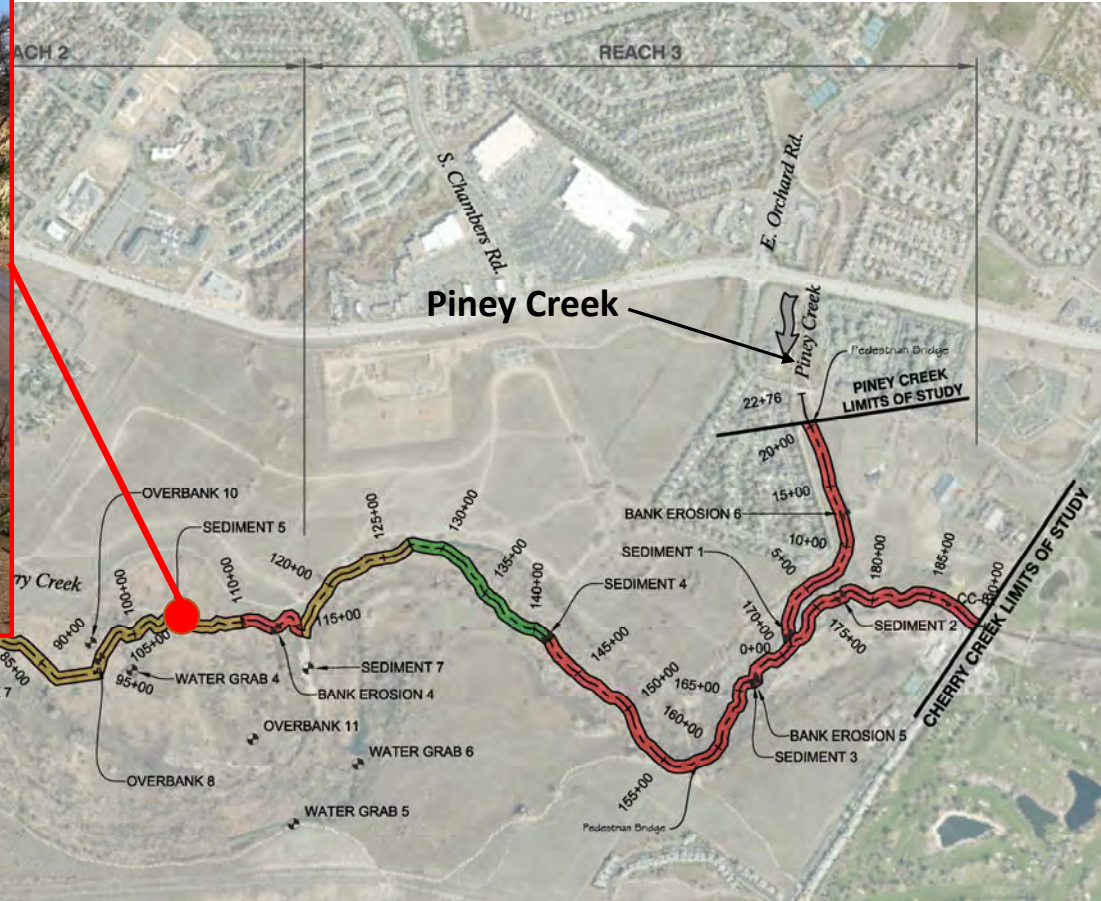
**Pipeline Trail and Aurora Water Lines:**

- Waterfalls occur where flood flows re-enter channel.
- Erosive velocities at re-entry points will lead to secondary channels that can travel outside of existing countermeasures.

- **Preserve PRF Function of Reach 2**
- **Reduce Risk of Degradation in Reach 2**

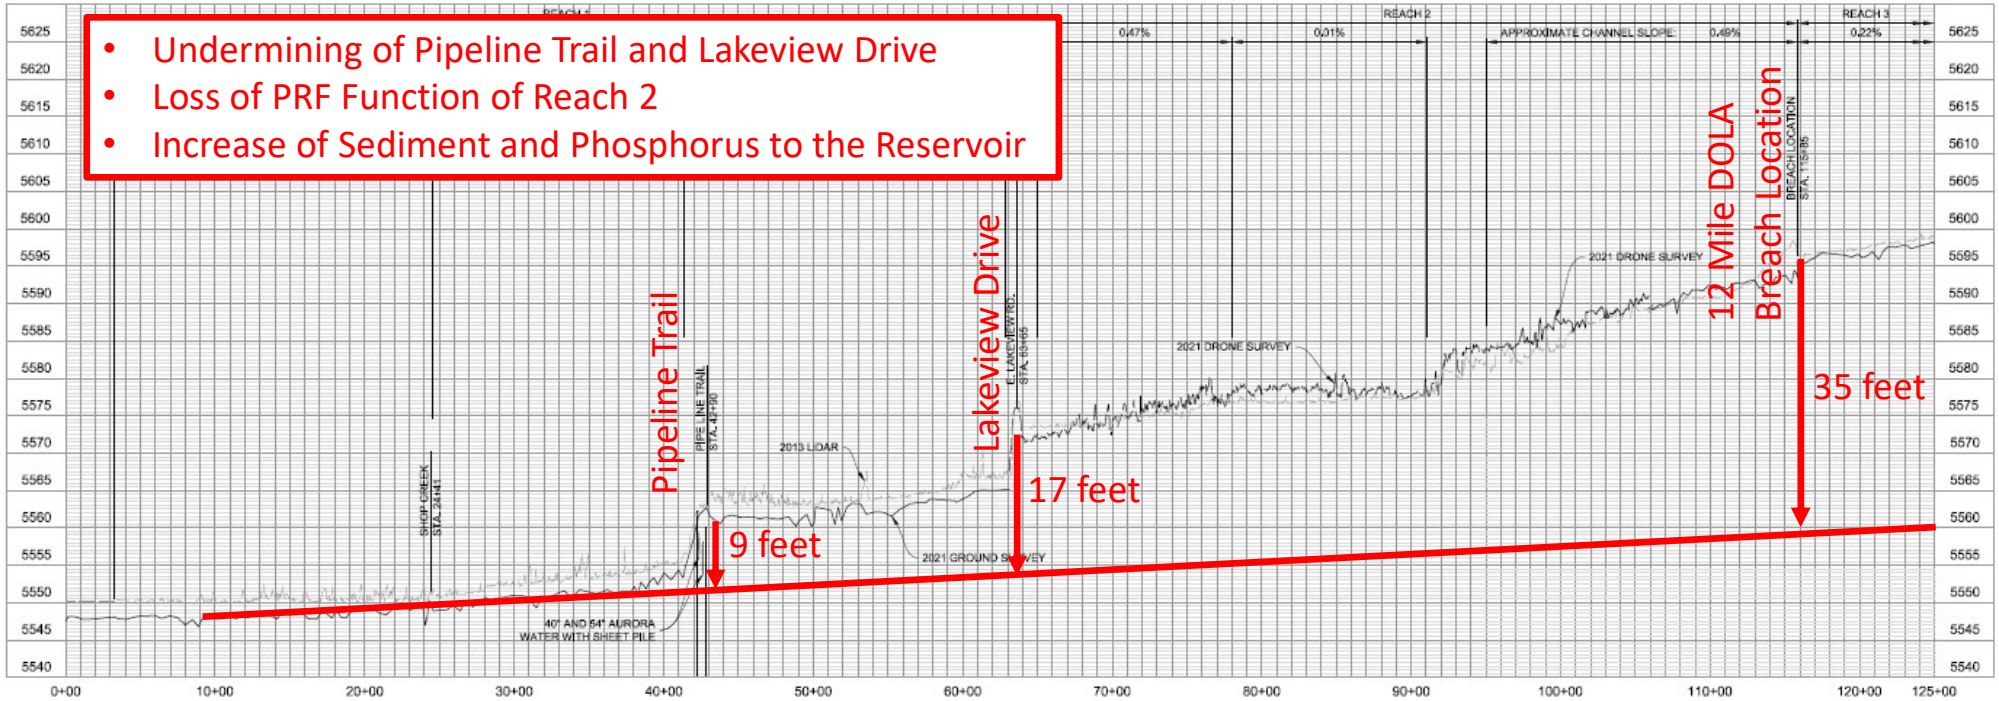
### Channel Degradation

- Undermining of Pipeline Trail and Lakeview Drive
- Loss of PRF Function of Reach 2
- Increase of Sediment and Phosphorus to the Reservoir
