**CHERRY CREEK RESERVOIR  
DESTRATIFICATION SYSTEM**

**OPERATION AND MAINTENANCE  
ANNUAL REPORT  
2025**

January 2026

# CHERRY CREEK BASIN WATER QUALITY AUTHORITY RESERVOIR DESTRATIFICATION SYSTEM OPERATION AND MAINTENANCE ANNUAL REPORT 2025

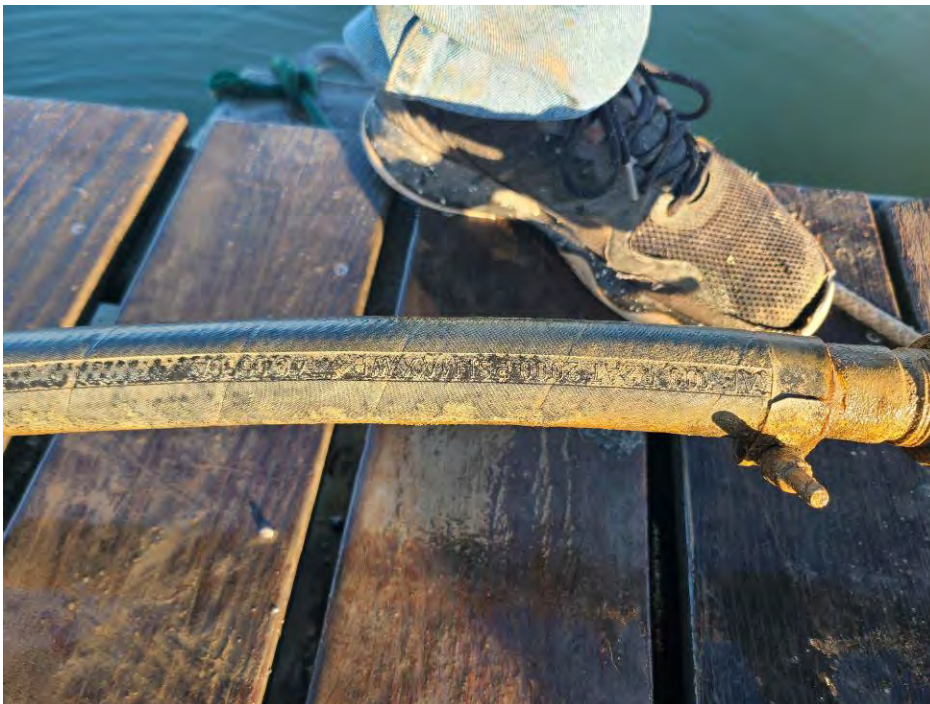
- 50 cam levers. The new ones do not fit most of the existing stainless steel risers currently used in the basin.
- Pin & cam samples left on shelves of compressor building for sizing. One riser similar the what exists is also there.
- 200 lin ft +/- hydraulic hose, size 1" & 700 lin ft of 1 ¼" hose, specs stamped on existing hose
