**CHERRY CREEK RESERVOIR
DESTRATIFICATION SYSTEM**

**OPERATIONS AND MAINTENANCE
ANNUAL REPORT
2024**

**Prepared by:
Ricardo Goncalves, PE
January 2025**

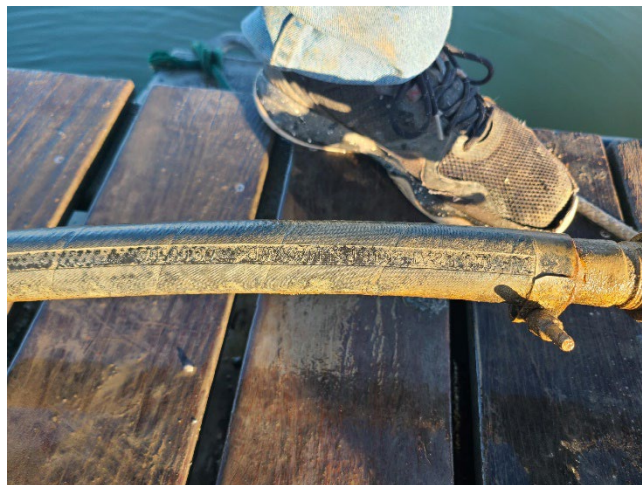
- 25 cam pins, better off to get 200 to last for several years
- 50 cam levers
- Pin & cam samples left on shelves of compressor building for sizing
- 20 plastic protective cones
- 200 lin ft +/- hydraulic hose, each size 1" & 1 ¼", specs stamped on existing hose
