# Cherry Creek 12-Mile Park Proposal: Reclaiming the Stream while Enriching the Dog Park Experience

Stephan Hall / Amanda Jeter Master's of Landscape Architecture Students / University of Colorado at Denver LA-5573 Advanced Ecology / Instructor Charlie Chase Project Advisor Mr. Bill Ruzzo

### INTRODUCTION

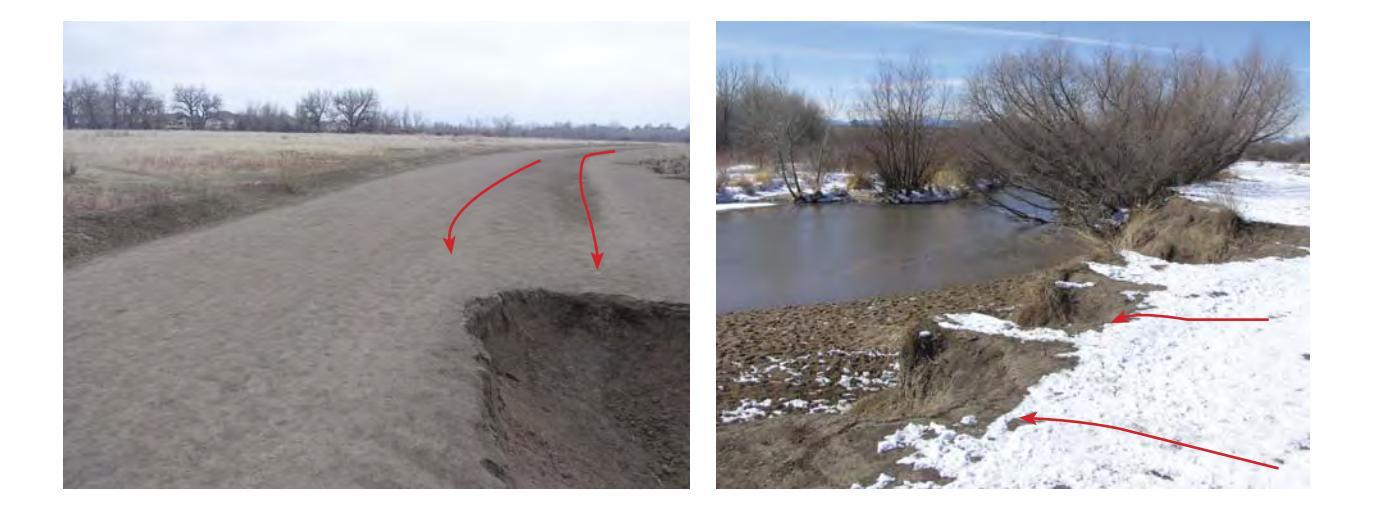
Left: This image shows Cherry Creek Trail and an eroded gully. The red arrows show how water travels on the trail and empties into the gully.

Right: This images shows how runoff runs directly into the eroded gullies. Vegetation or armored gullies would slow the speed and deflect the force of the runoff.

or snow melt events. The park naturally drains towards Cherry Creek and initial gullies have expanded due to additional factors of vegetation loss and social paths created by users. The Cherry Creek Trail also directs runoff into the gullies causing more erosion.

- Restore vegetation to slow down storm water runoff.
- Regrade Cherry Creek Trail to drain away from the creek at a 2% slope into the existing swale. Expand the swale and vegetate to help filter and slow down surface May need to do additional work to runoff. improve infiltration for dog park runoff treatment.
- Pick key gullies to redirect runoff, and reinforce those gullies with rock armor to protect structure and slow runoff.

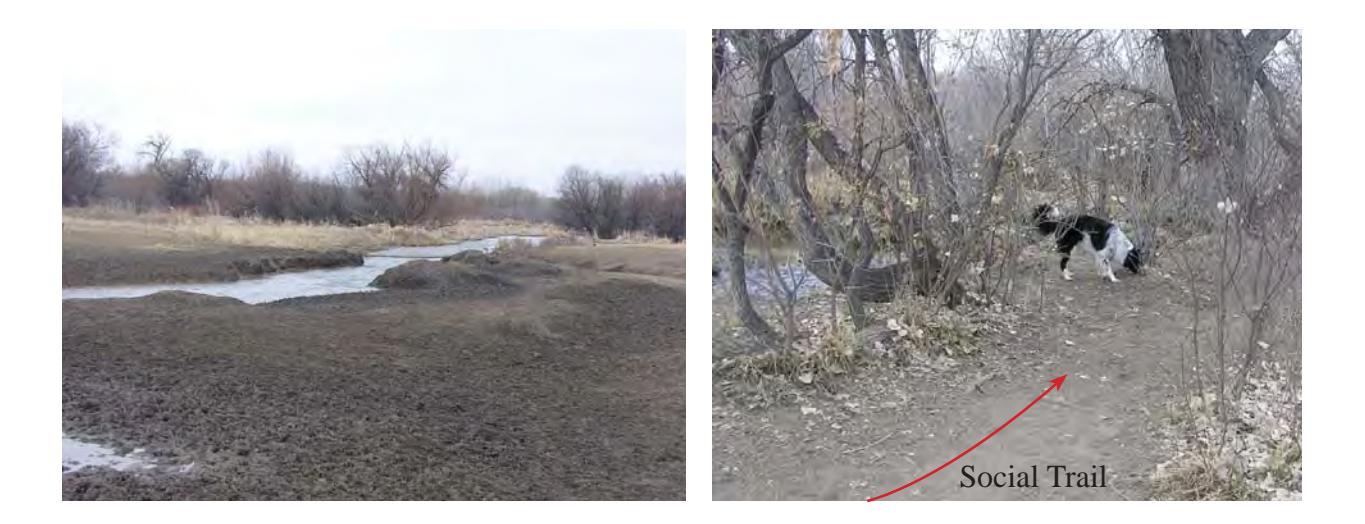
Left: This image shows the many footprints of users trying to access Cherry Creek. A makeshift wood bridge has been placed to cross the creek break out area. Designed spaces that can accommodate traffic and user needs is an important tool to help make these spaces work for the ecology and the user groups. Right: This images shows a happy dog exploring the creek. Social trails are extensive throughout the park. Although exploring the park is a valued experience, this can cause damage to vegetation and erosion.

grassland ecosystems of Cherry Creek. Popular trails and social trails lead to soil compaction and vegetation destruction. To access the creek, people and dogs must climb down steep, eroded slopes, further adding to the erosion into the creek

- Regrade Cherry Creek Trail and improve the trail surface to handle the amount of traffic.
- Create accessible points for people and dogs to access Cherry Creek without causing more erosion. Limit other points for restoration.
- Add interpretive programs and signage to help educate users to stay on trails and become stewards of the park.

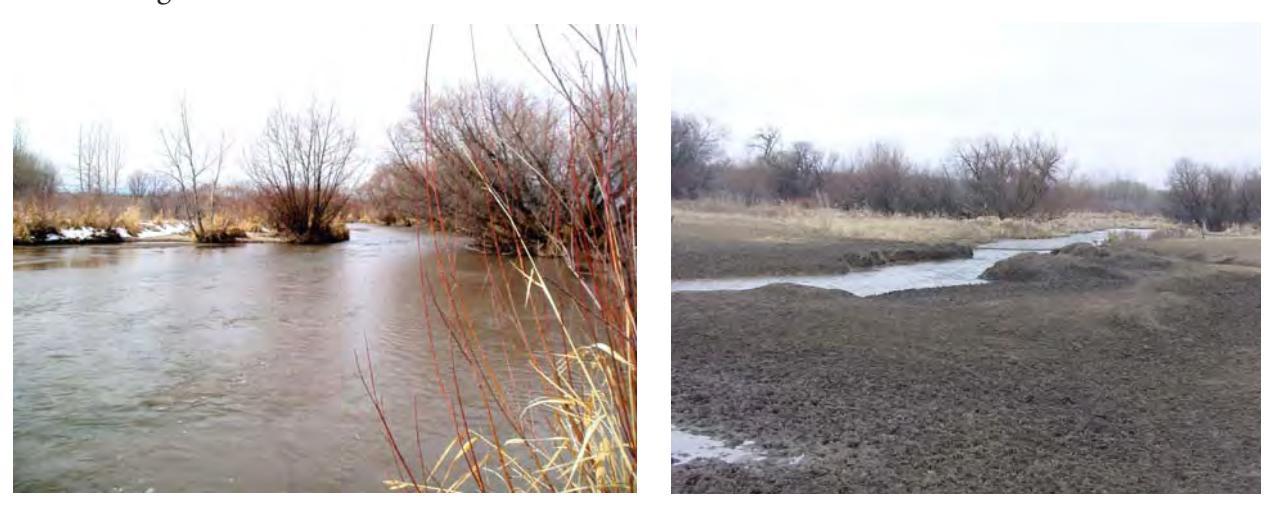
Left: A typical view of Cherry Creek at 12-Mile Park. The creek naturally moves large sand particles to form sand bars where willow and other species grow. Erosion adds smaller particles of loam that carry naturally occurring phosphorus that causes water quality problems. Right: The break through of Cherry Creek. The creek originally ran to the left of this area.

A break through of Cherry Creek occurs at the north portion of the site. This break throughhas re-routed the flow of Cherry Creek into a established a project objective fast, steep drainage. The Basin Authority has setthe criteria to restore the drainage and stop thebreak through area.

- Lay invert bed to slow velocity of Cherry
  Creek and the break through area.
- Use existing disturbance at break through area as a potential shoreline access area for people and dogs.

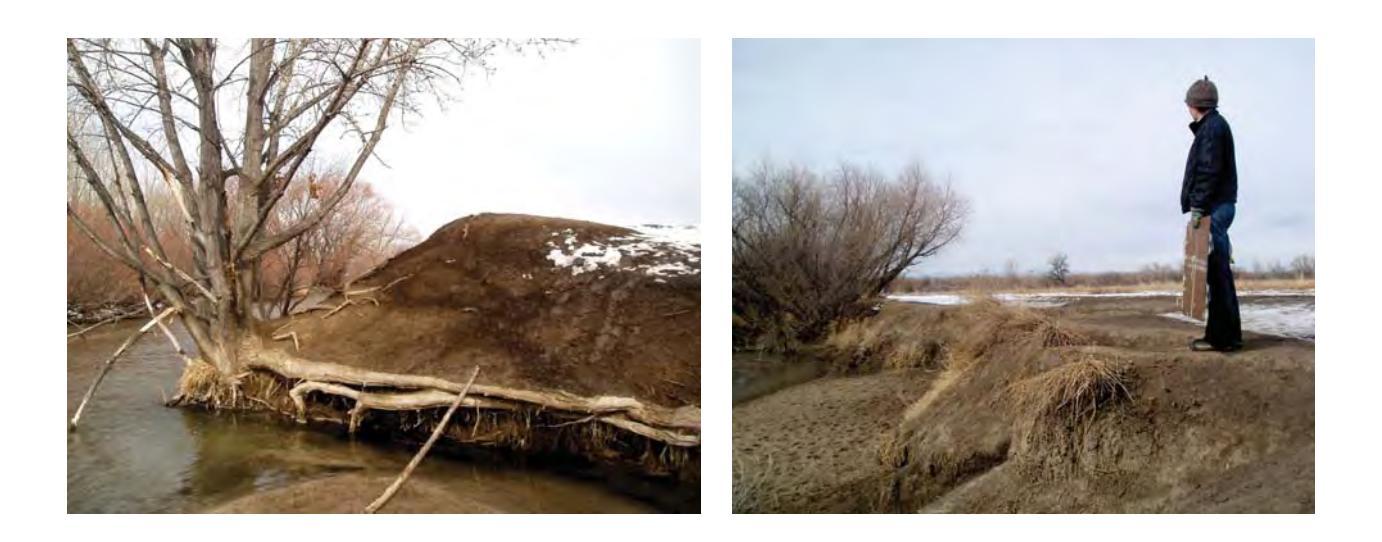
Left: A typical access point to the creek is highly eroded and denuded of vegetation. The remaining tree is in danger of dying. Right: People with physical impairments (permanent or temporary) can not access the creek. **SLOPE & KEY POINTS**

- Choose key access points and reinforce those areas for erosion while designing universal accessibility for all users.
- Over half of the stream bank is eroded. Limit access to the key points and protect the remaining areas.
- Regrade, revegetate and reinforce the protected areas.
