Cherry Creek Stream Reclamation at 12-Mile Park - Channel Sedimentation

PREPARED BY: Aaron Cook / CH2M HILL

DATE: December 31, 2013

PROJECT NUMBER: 407259

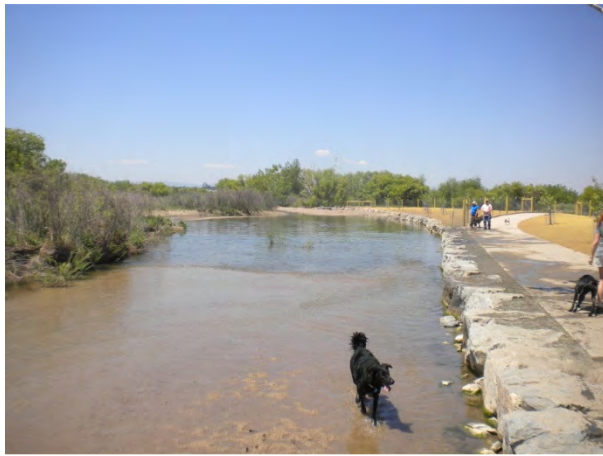
Photos 1 and 2 show the boulders constructed during Phase 1. At the time of construction, the 3-foot diameter boulders were approximately 1-foot buried and 2-foot exposed. Currently, the boulders are approximately 6 to 8 inches exposed

Photo 1: Phase 1 boulders (May, 2013)

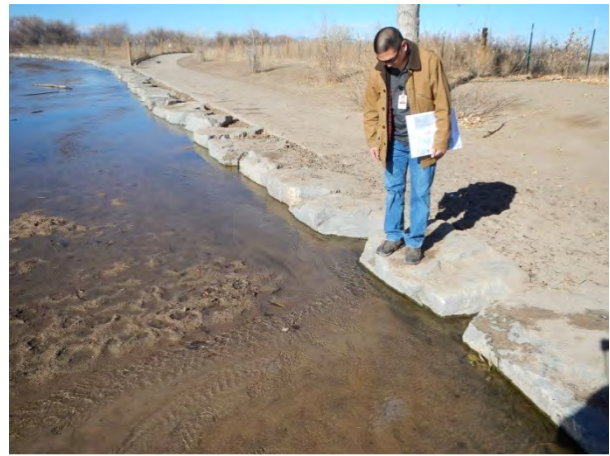
Photo 2: Phase 1 boulders (November, 2013)

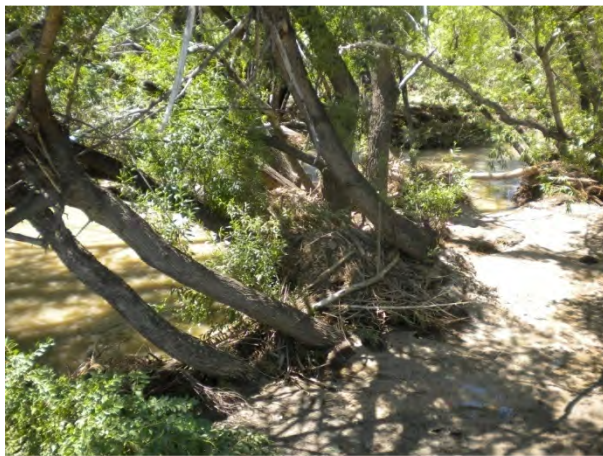
Photos 3 and 4 show an overbank area near control line TS2 Station 4+40. In June, 2012, the overbank area was above the invert of Cherry Creek and dry. The photo taken in December, 2013 shows the invert of Cherry Creek has raised and the overbank area is wet.

Photo 3: Overbank area (June, 2012)

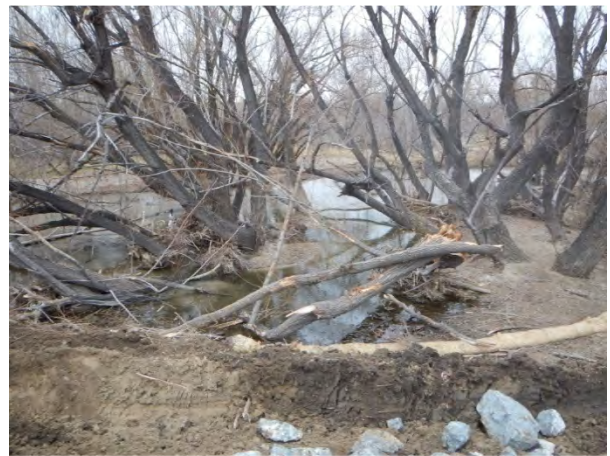
Photo 4: Overbank area (December, 2013)

- Downstream of Creek Access #4, transition local grading to a 1 foot increase in the top of boulder elevation. Maximum transition length will be 10 feet.
- From Station 6+62 (downstream edge of Creek Access #4) to Station 10+07 (upstream edge of Creek Access #6, raise top of boulder elevations by 1 foot.
- From Station 10+07 to Station 10+17, transition top of boulders elevation from a 1' rise to no rise (transition back to the original vertical alignment over 10 feet).

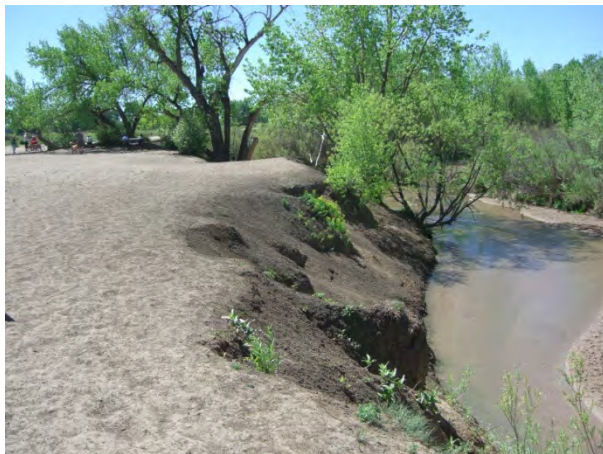
In Photos 5 and 6, a tree is shown extending horizontally from the bank. In the photo from May, 2012, the horizontal section of the tree is above the channel invert. The photo from December, 2013 shows the horizontal section of the tree is at the channel invert.

Photo 5: Tree extending from bank (May, 2012)

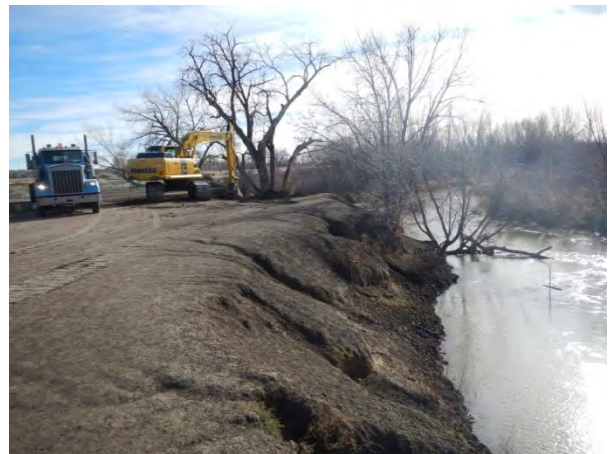
Photo 6: Tree extending from bank (December, 2013)
