COTTONWOOD CREEK RECLAMATION PHASE I & II

Stream Stabilization Approach to Urban Runoff Quality

Cherry Creek Basin Water Quality Authority

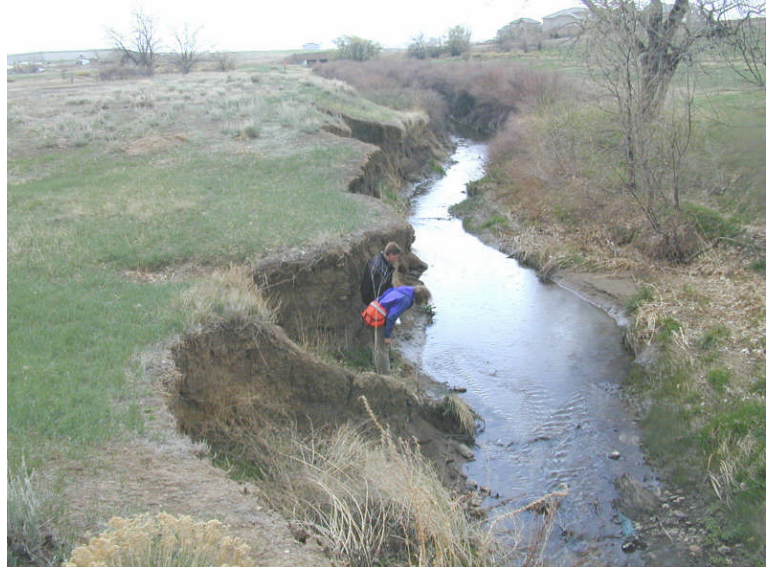
Urbanization of the Cottonwood Creek watershed (8.5 square miles) greatly increased during 1980's and continues today. Urbanization increases the rate, frequency, duration and magnitude of storm runoff, all of which increases erosion of the streambed and banks. This erosion is evident in the adjacent photo, which shows that the Creek had degraded up to 10-feet within Cherry Creek State Park. These soils, along with other associated pollutants, particularly phosphorus, are being carried into the Reservoir, degrading its quality. Soils were also being carried into the Park from upstream development and ending up in the Reservoir.

Cottonwood Creek through Cherry Creek State Park has a history of flood events that have severely eroded the channel bed and banks and confined it to a narrow section beginning at Peoria Street (see photo above). Flooding has been reported in the past at the intersection of Peoria Street and Bellevue Avenue, and within the shooting range, most recently in August 2004. Previous farming activities have apparently relocated the lower portion of the channel up on a ridge through the shooting center, rather than in the valley, which has altered the flood plain.

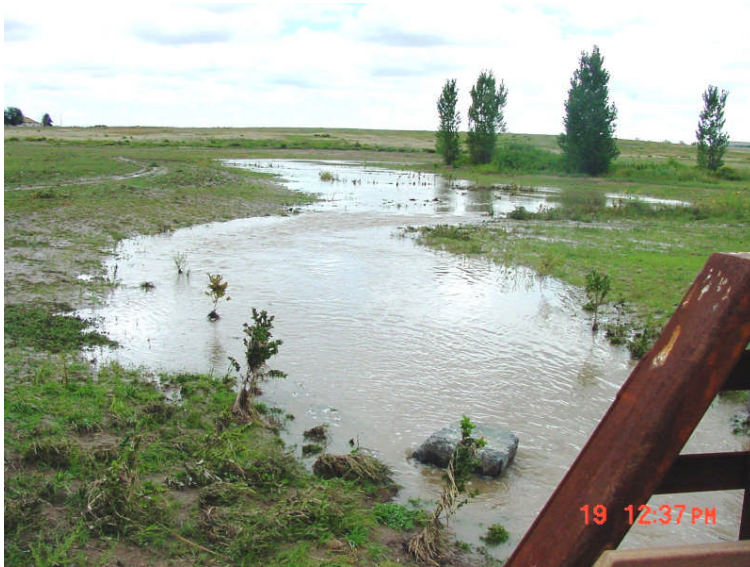
Cottonwood Creek Reclamation Phase 1 was completed in early August 2004 with the first flood occurring on August 18, 2004. Based on water-marks at Peoria Street, the peak flow entering the newly constructed channel was estimated to be 1400 cfs, which compares to the projected 100-year event of 4,000cfs. The photo below shows the restored creek during the flood event. The success of the project is attributed to the "low-energy" design. This approach flattens the channel slope decreasing velocity (kinetic energy) and allows the flood to spread over larger areas, increasing flow area and decreasing velocity.
