# **CHERRY CREEK BASELINE CHANNEL MONITORING REPORT**

## **Reservoir to State Park Boundary**

November 2022

**Muller Engineering Company**  
777 South Wadsworth Boulevard  
Suite 4-100  
Lakewood, Colorado 80226  
303.988.4939

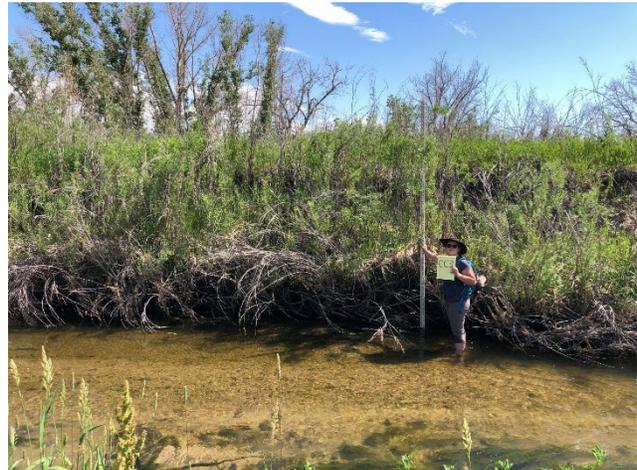
Photo 2: CC-3, BEHI - Moderate, NBS - Extreme (Sta. 170+00)
